Department:
Transport
Province of KwaZulu-Natal

REHABILITATION OF P50-1 DETAILED DESIGN REPORT From km 18+000 to km 26+000

DETAILED DESIGN REPORT

Report No: T01.PZB.000519

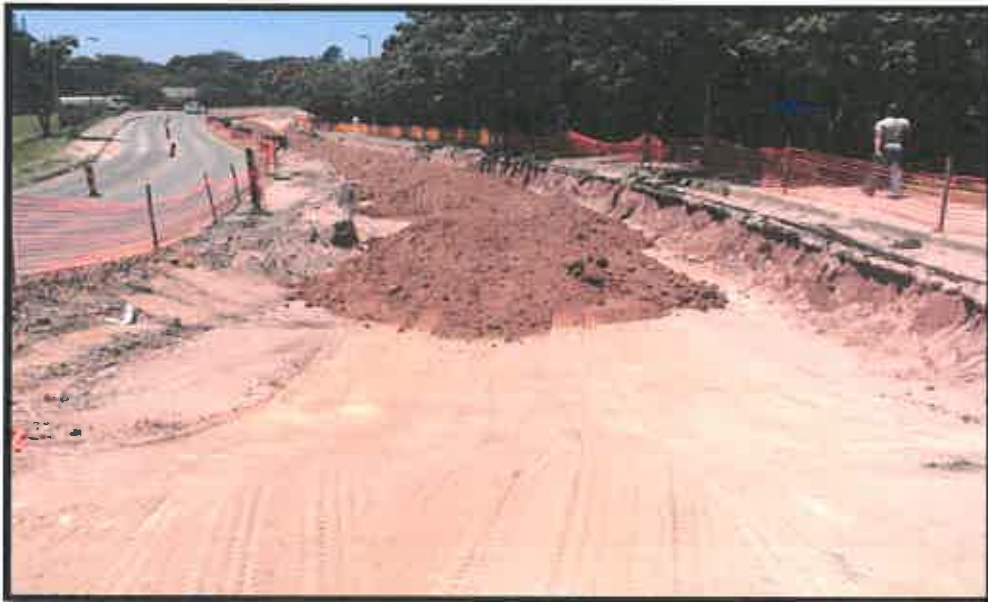
The road starts at Eshowe where it intersects with P47-5 (R66). This first section of road has recently been rehabilitated between km 0,00 and 0.60 km (intersection with Mangosuthu Buthelezi Dr) and is in a good condition . From km 0,60 up to km1,15 (intersection with Hulett Street) the road has a double carriageway with two lanes in each direction which was under reconstruction during the time of visit. This section of main road P50-1 also forms part of uMlalazi Municipality, and the rehabilitation section was funded by the Municipality.

Figure 3: Reconstruction of pavement structure at km 0,65

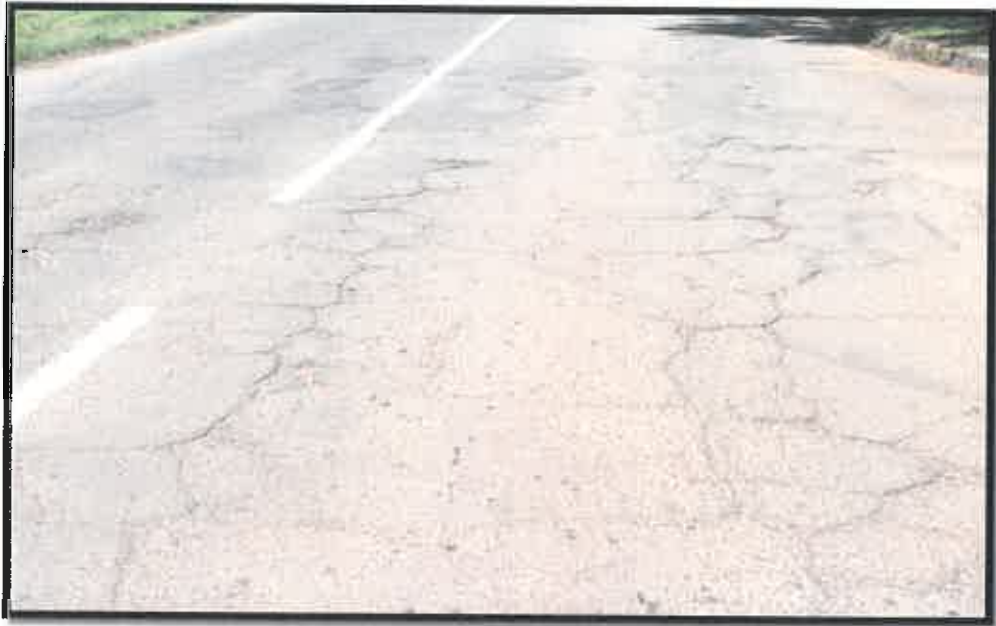
After km 1,15 (intersect with Hulett Street) the road width varies between 7.5m to 8.5m, and the surfacing characterised by dry brittle 13.2mm single seal with slurry . The section in a severe condition with the major distress presented is crocodile cracks and patches. These type of distress occurs extensive over the entire length of the section.

Figure 4: Severe crocodile cracks and patches at km1.65

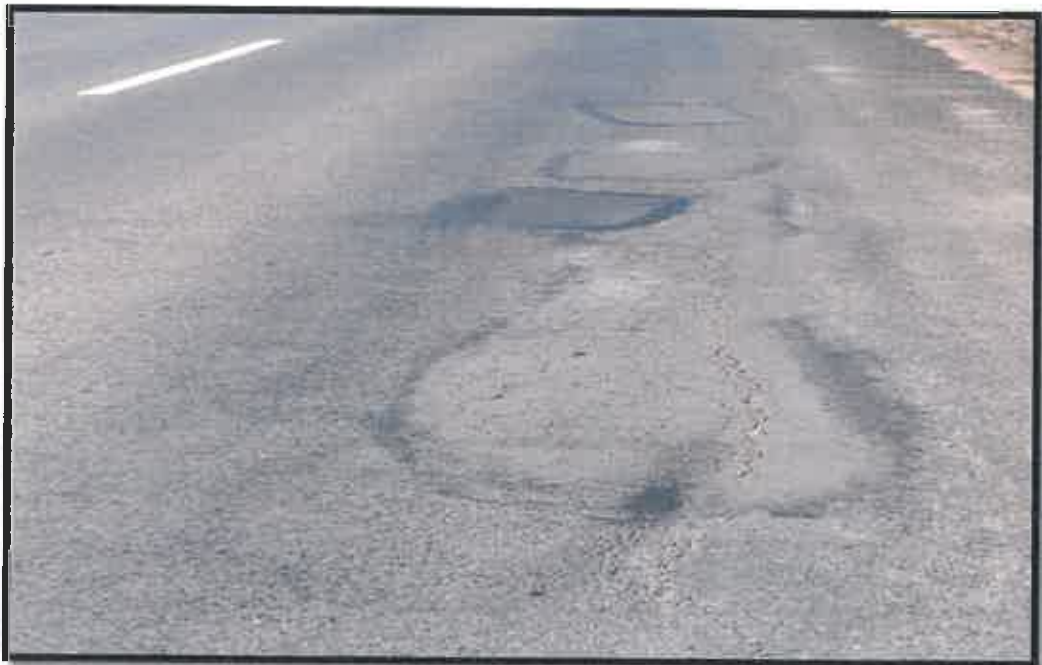
The surface road width varies from 7.5m to 8.0m with a 19mm single seal. The section is in a good condition with isolated surface cracks and patches that shows signs of distress in the form of crocodile cracks. The drainage is poor along the road and resulting in water into the pavement structure.

Figure 5: Multiple patches with cracks at km 3.4

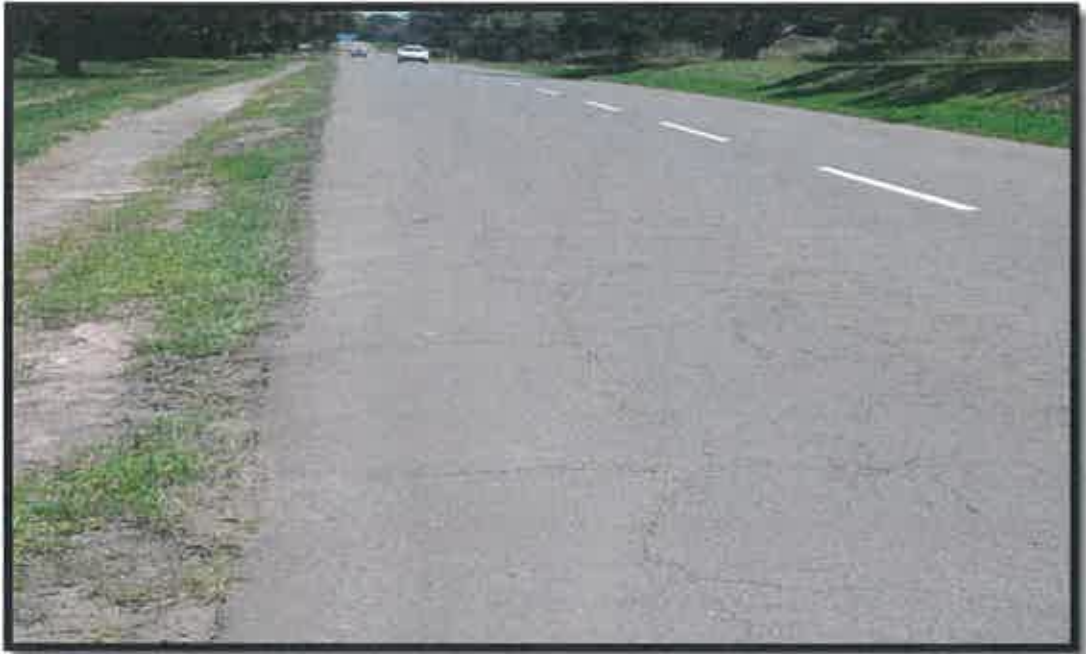
Figure 6: Block cracks at km 3.7

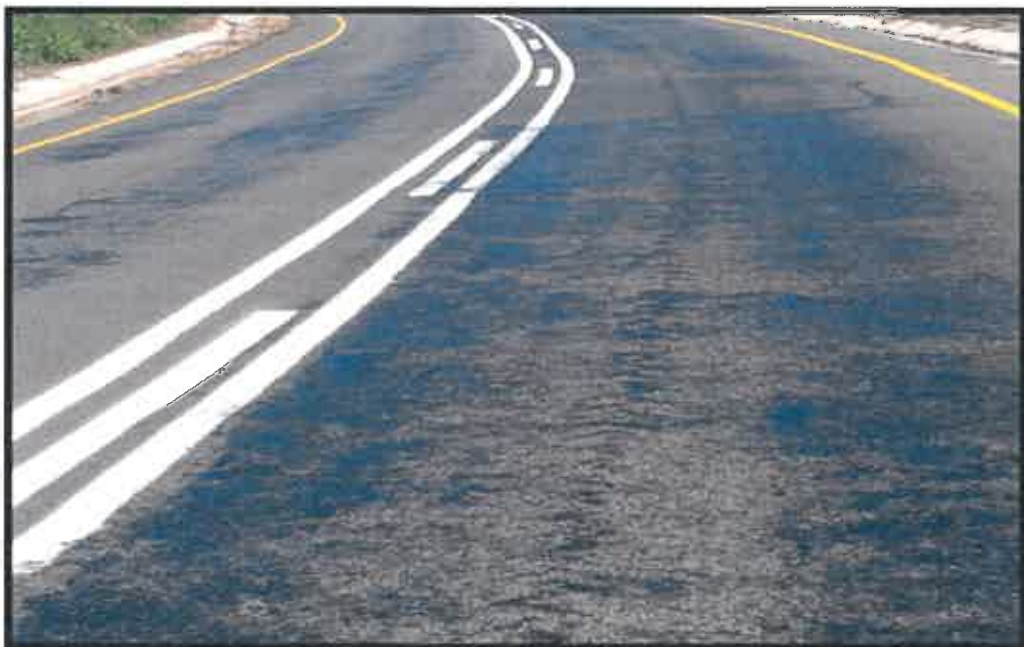
The section is 9 meters wide with two 3.5 meter lanes and narrow shoulders. The surface is brittle with stone loss and bleeding throughout the section. The section is in a good to warning condition, with few isolated crocodile cracks with pumping to a warning degree.

Figure 7: Distinct bleeding at km 8,6

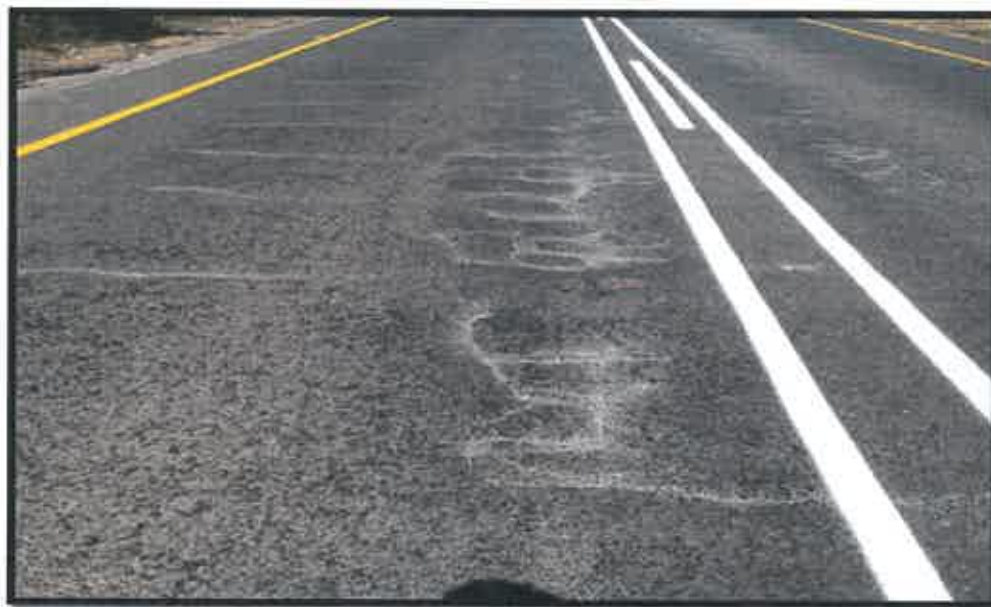
The large portion of this section is characterised by block cracks with pumping in a warning condition and multiple patches that are performing. The drainage has not been provided, as a result erosion has formed next to the edge of road surface. The vegetation verge is also overgrown resulting in water ponding on the road. The section surface consists of 19/6,7mm double seal that has a coarse texture with many voids. The surface is dry and brittle with stone loss noticeable throughout. There are isolated potholes in a warning condition.

Figure 12: Block cracks with pumping at km 10.8

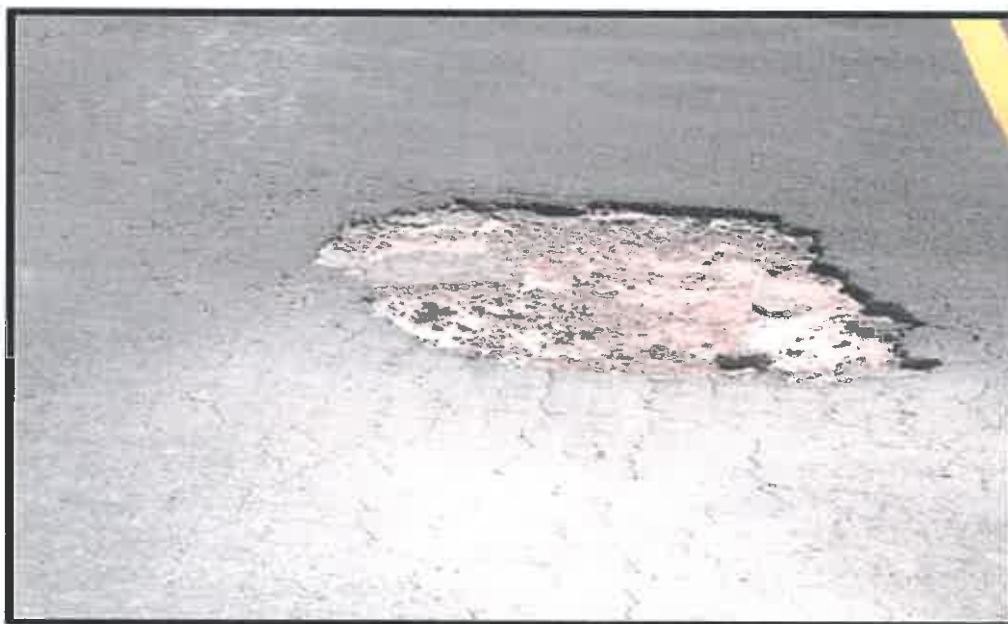
Severe isolated potholes and crocodile cracks were noted in this section. Maintenance in the form of patches has been on going and guardrail installation was in process during the time of visit.

Figure 13: Severe pothole and crocodile cracks at km 12.4

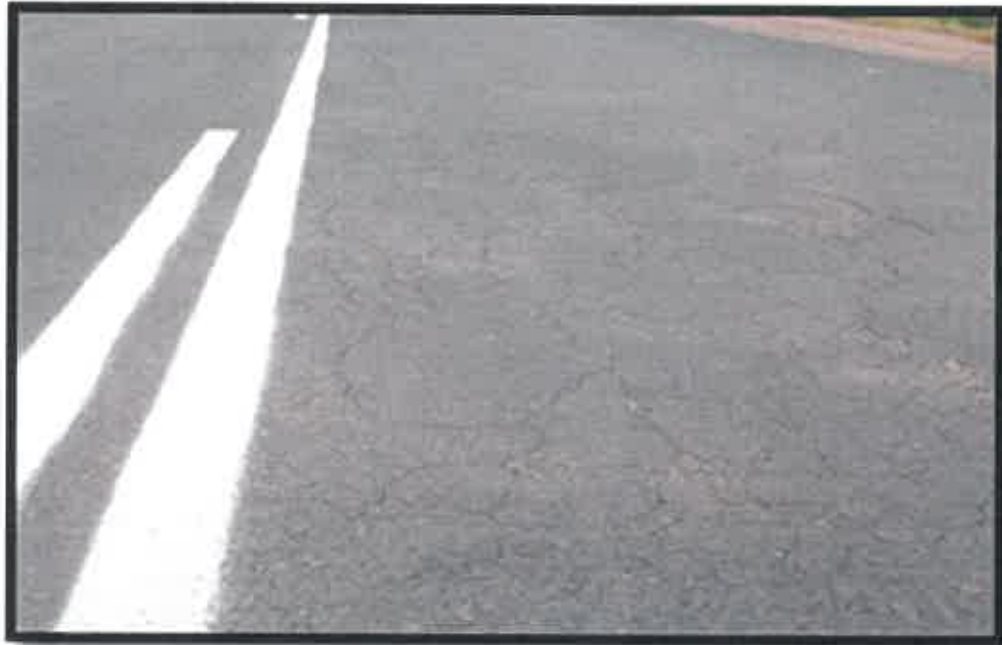
The section is 8.0 meter wide with 13.2 mm single seal that is still a fair condition. There are surfacing cracks and patches noticeable throughout the section which are in a warning condition.

Figure 14: Surface cracks at km 14.8

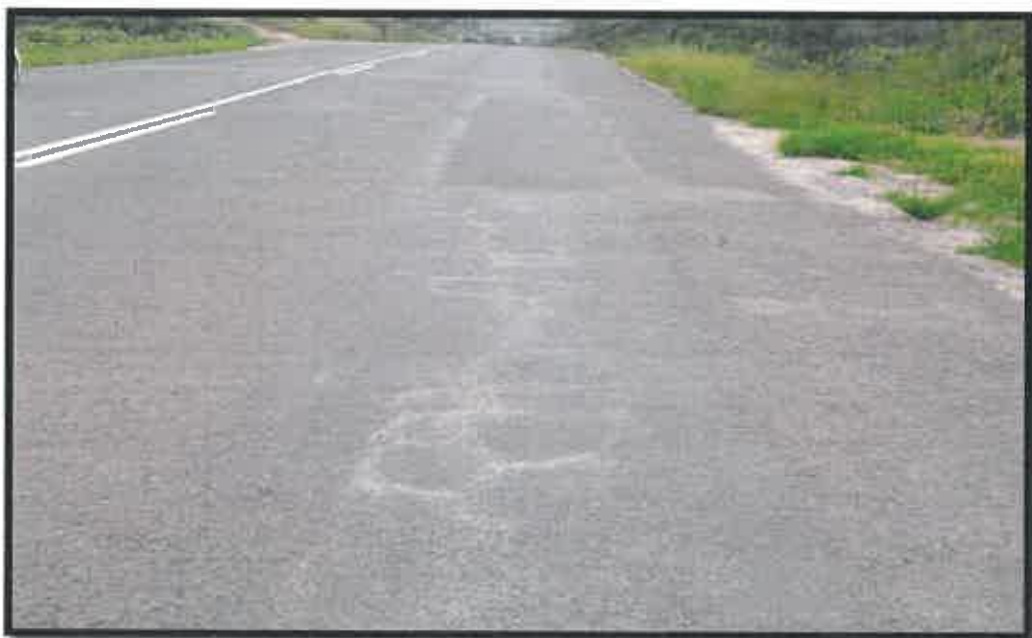
The surface road width varies from 7.5m to 8.0m with a 13.2mm single seal. The surface appears to be polished with isolated block cracks with pumping that are in a warning condition. Patches were noticeable in this section but they are in a good condition. Side drain is not provided and vegetation has overgrown on the side of the road.

Figure 15: Block crack and asphalt patches at km 17.4

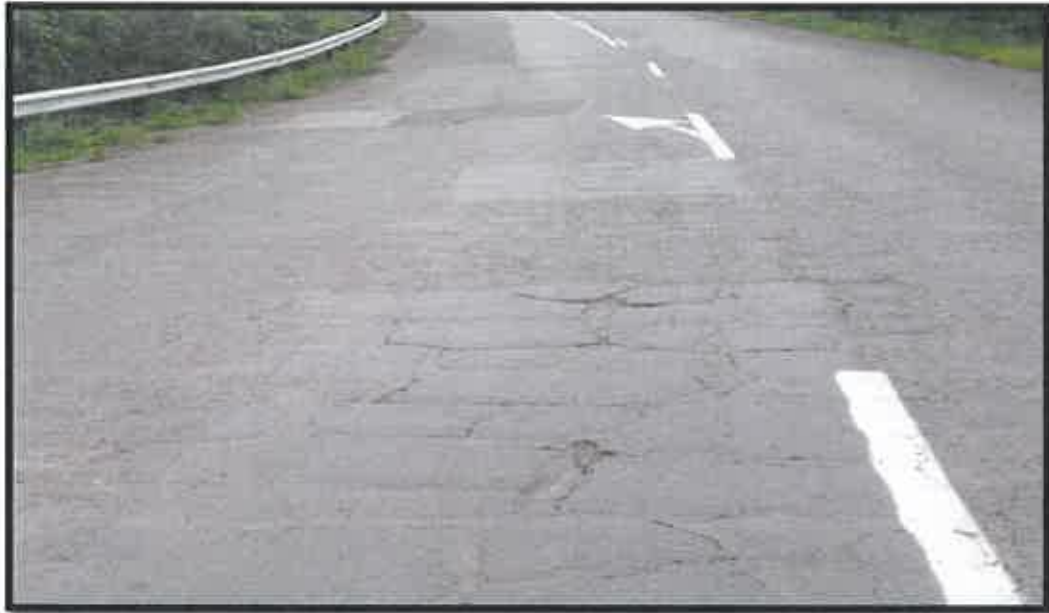
The surface road width varies from 7.5m to 8.5m with a 19/6,7mm single seal. The section is in an extremely poor condition, structural failure is evident with large potholes extensive throughout the section. Block cracks is extensive with the pumping fines are also evident throughout the section. Maintenance in the form of patches has been on-going during the time of the visit but it was noted that the patches on this section are not performing well, the road has reached its end of its design life.

Figure 16: Severe block crack and surface crack at km 18.5

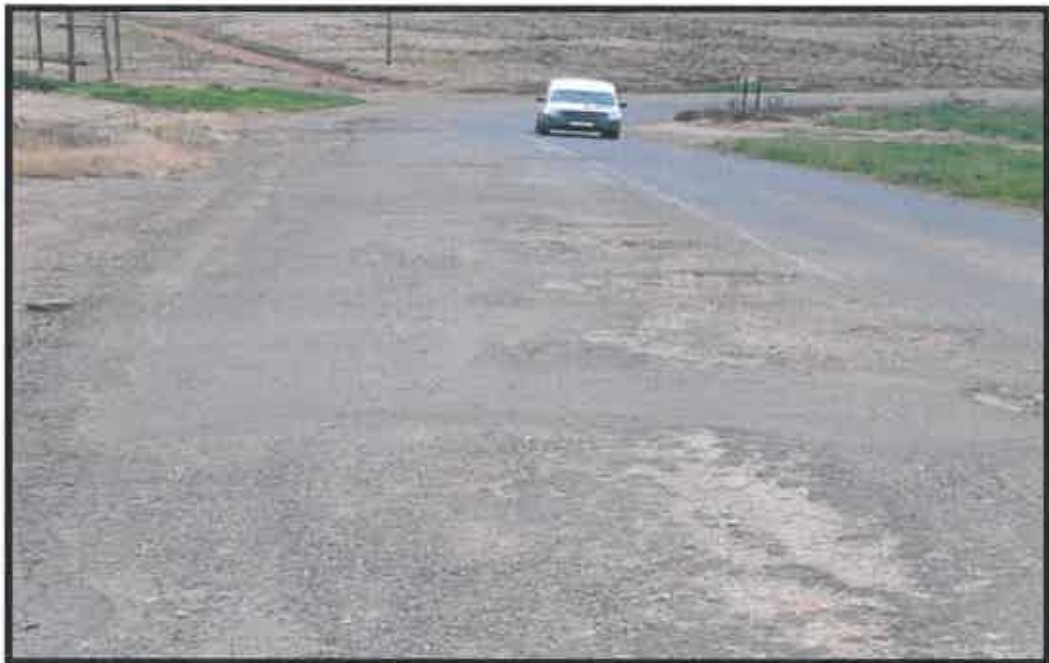
Figure 17: Extensive occurrence of potholes and patches at km 24.6

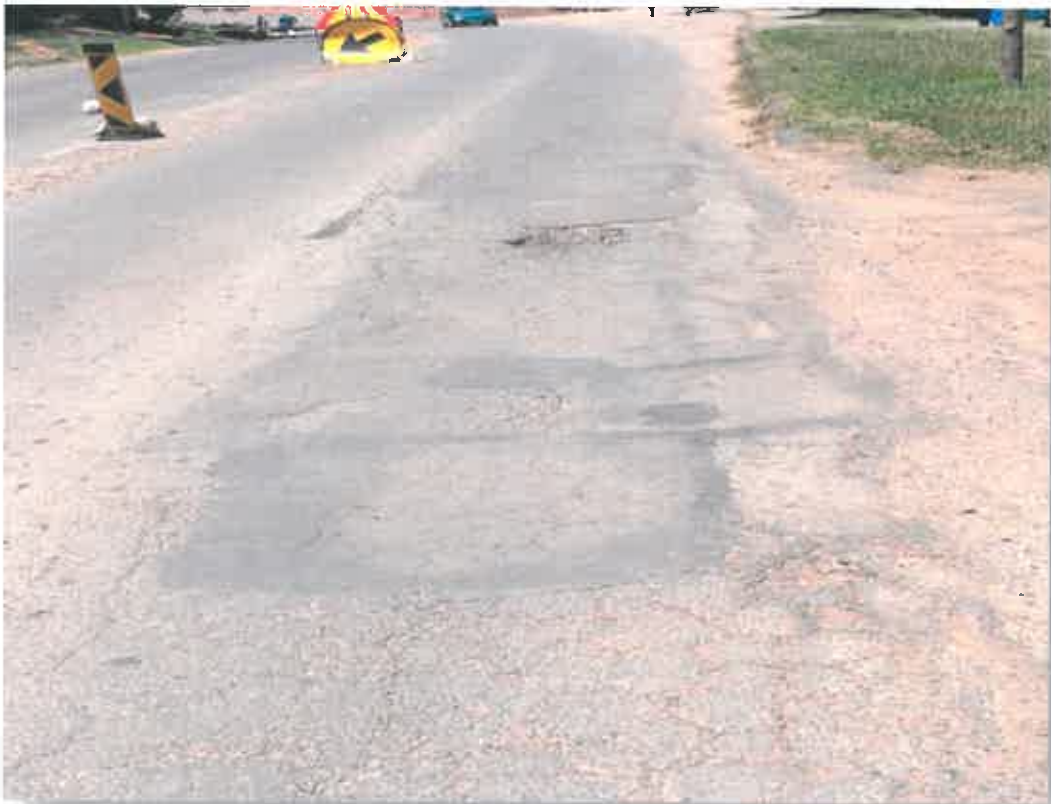
Severe Crocodiles and patching at Km 2

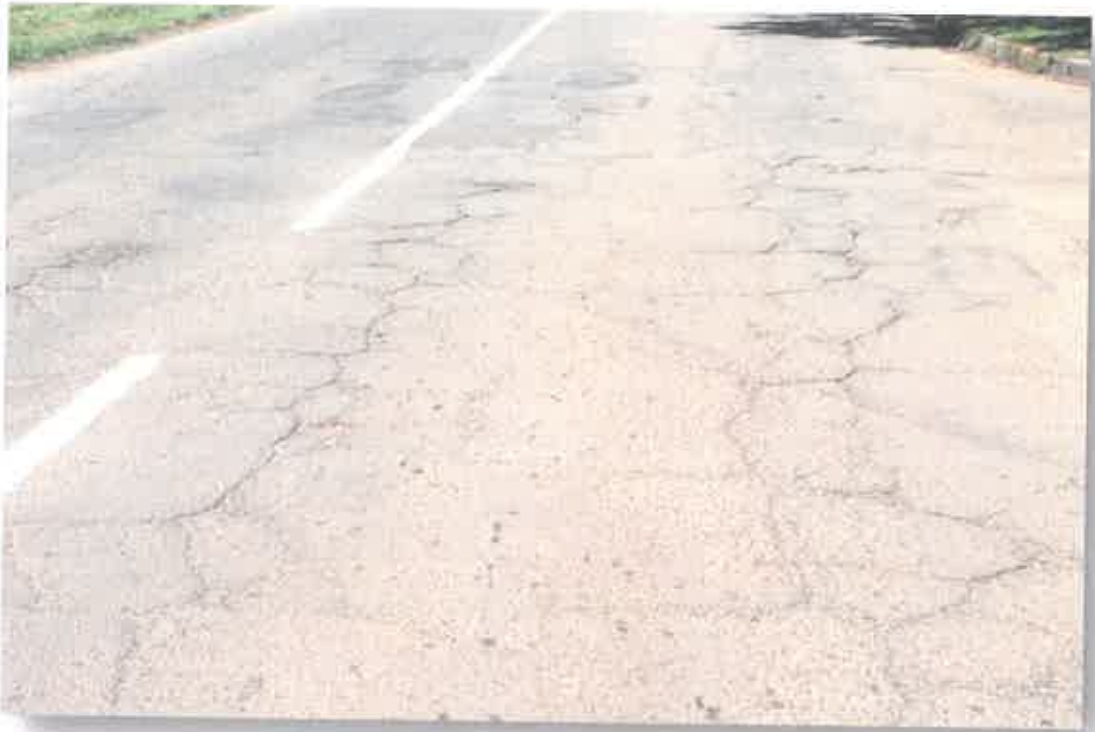
Severe crocodile cracks at KM 3, the section through Eshowe

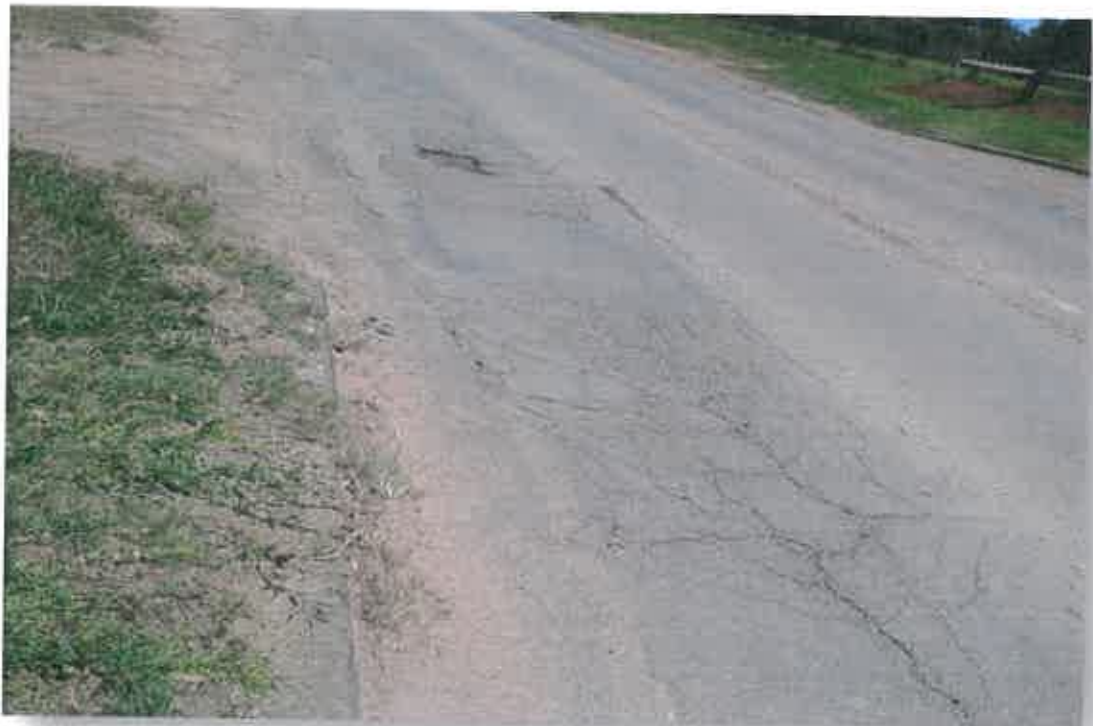
Severe crocodile cracks and distress patches.

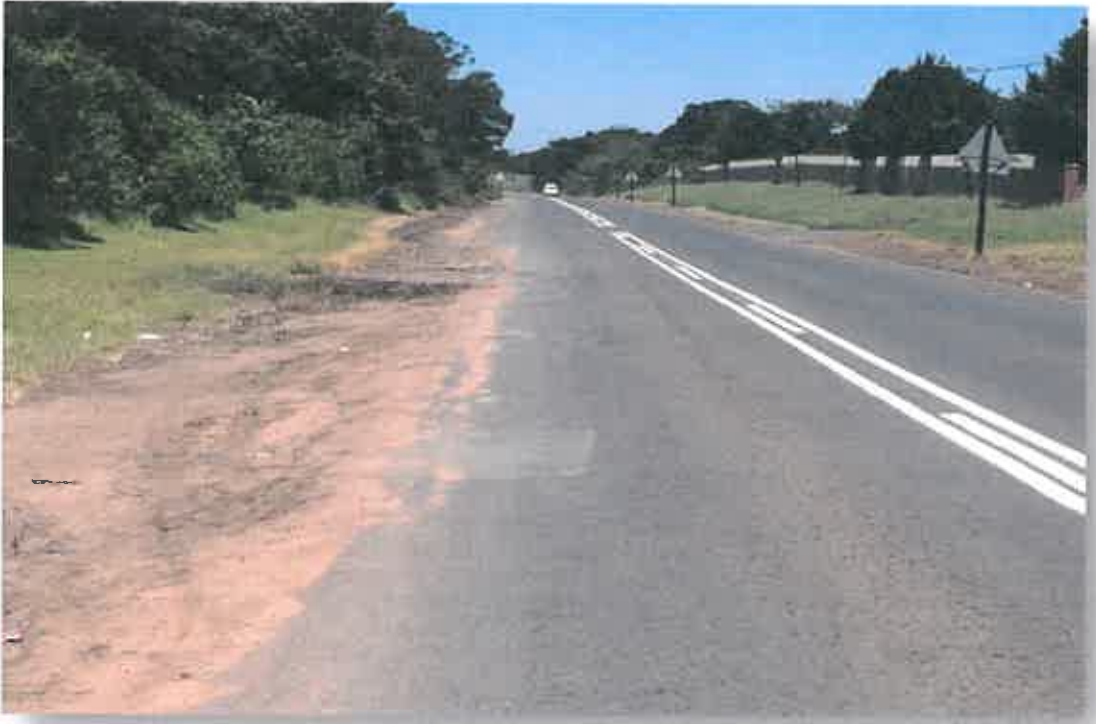
Neglected cleaning of drainage next to the road at Km 5

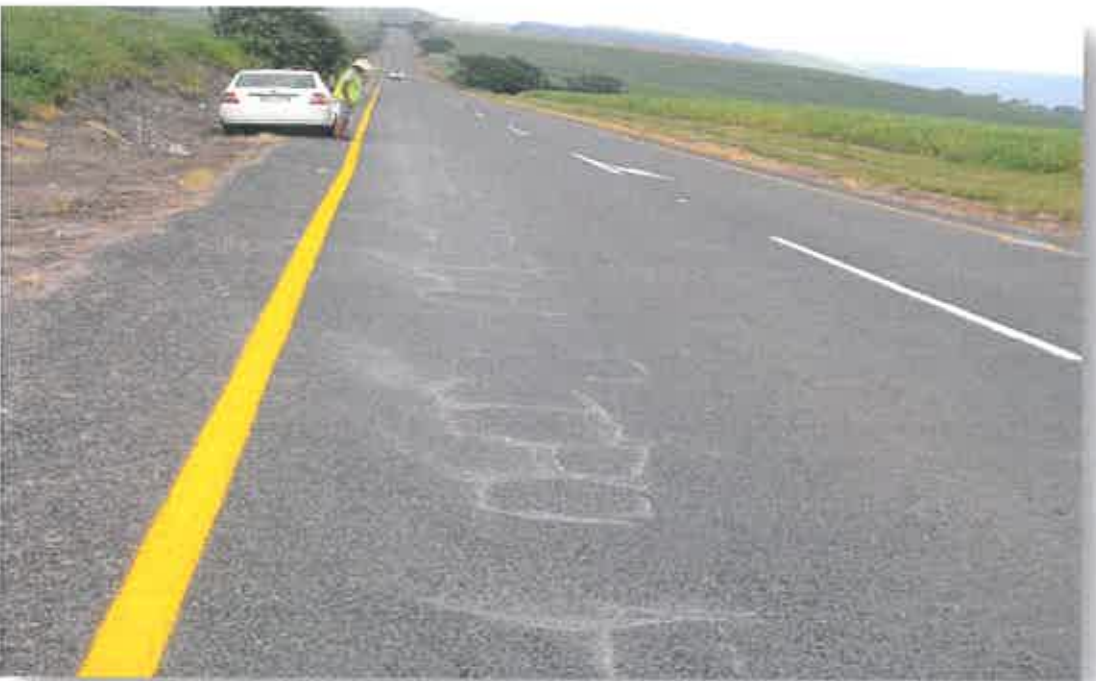
Block crack with pumping at KM 10

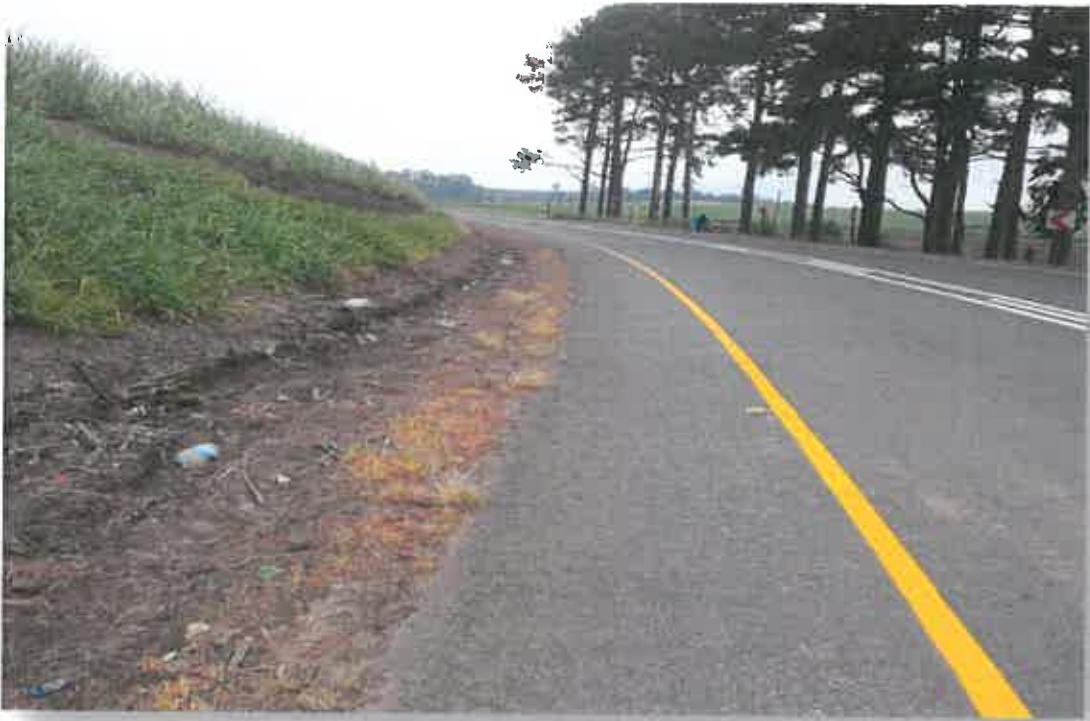
Drainage issues at the bottom of the Super elevation at Km 15

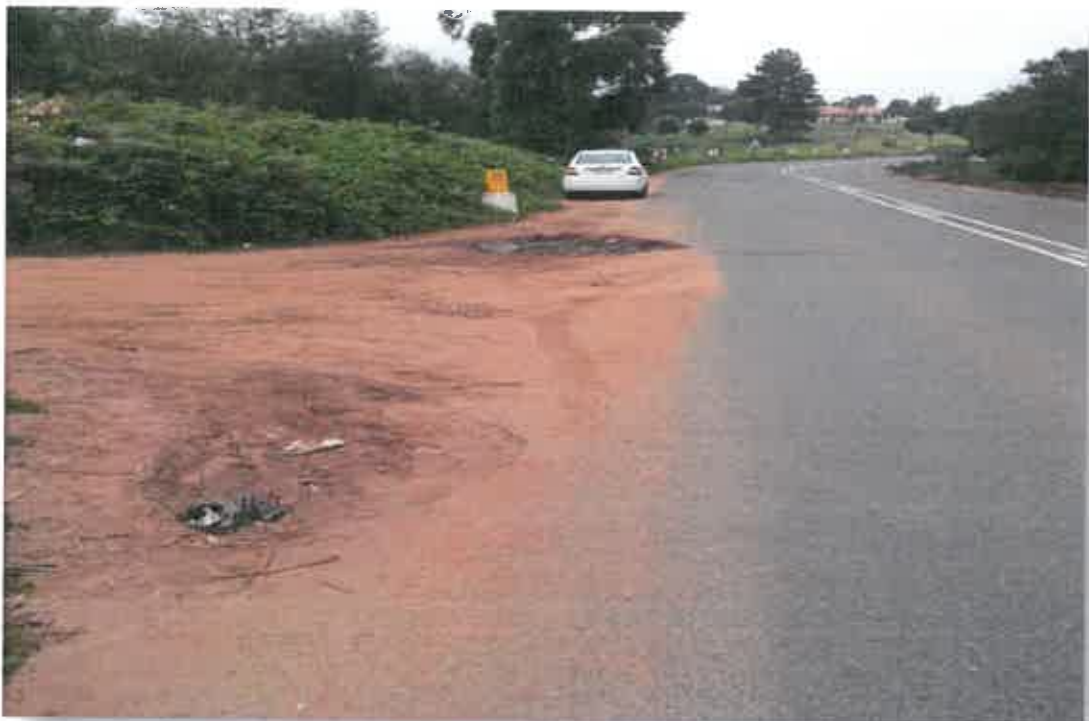
Access discharges water to pond next to the road at Km 20

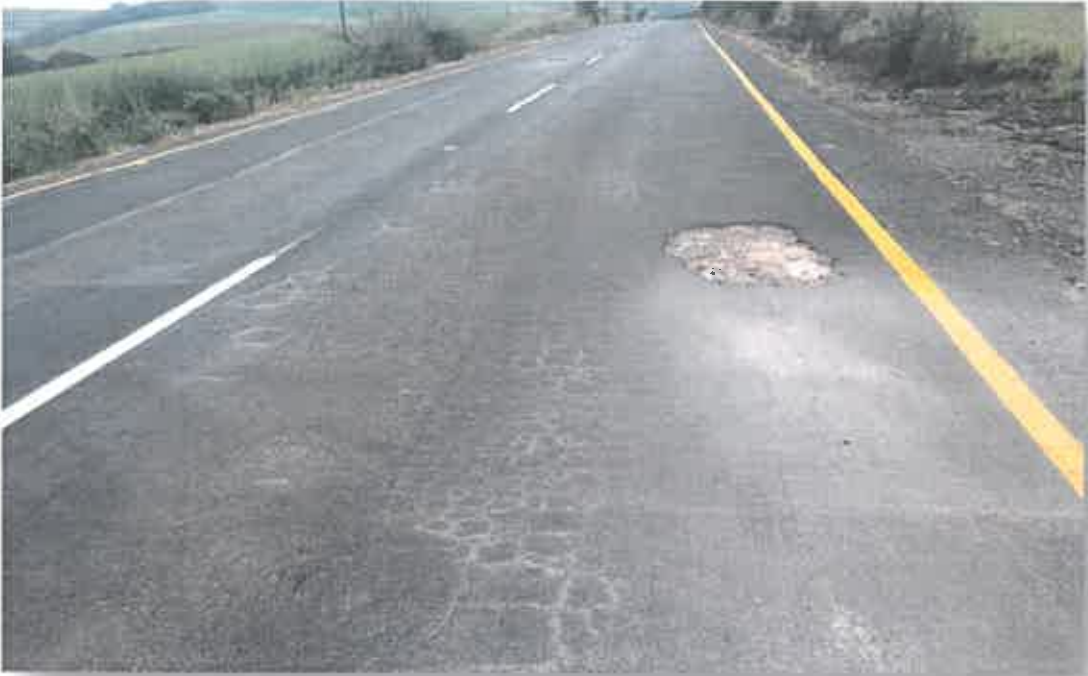
Crocodile cracks with pumping and pothole at Km 20.

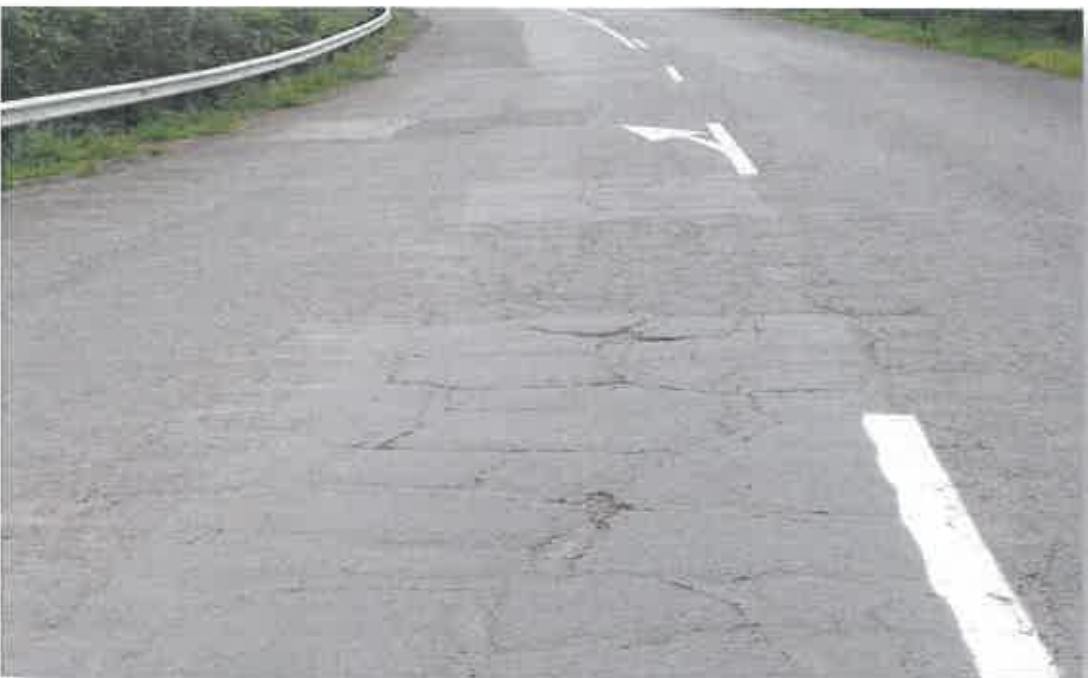
Severe block cracks at KM 21

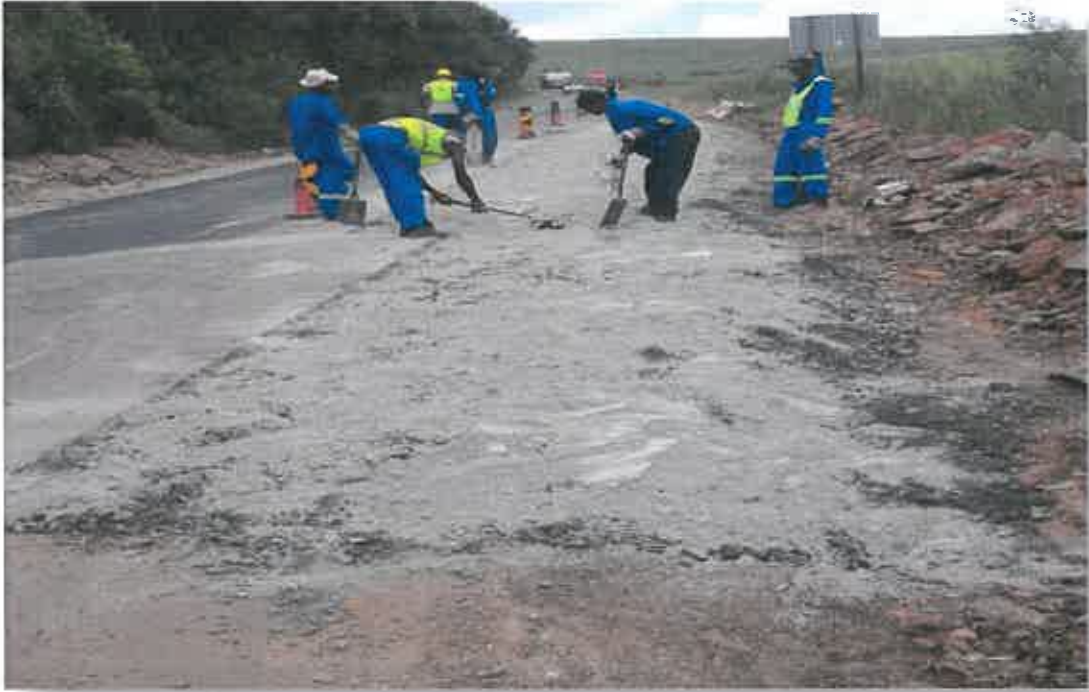
Potholes Repair at Km 22

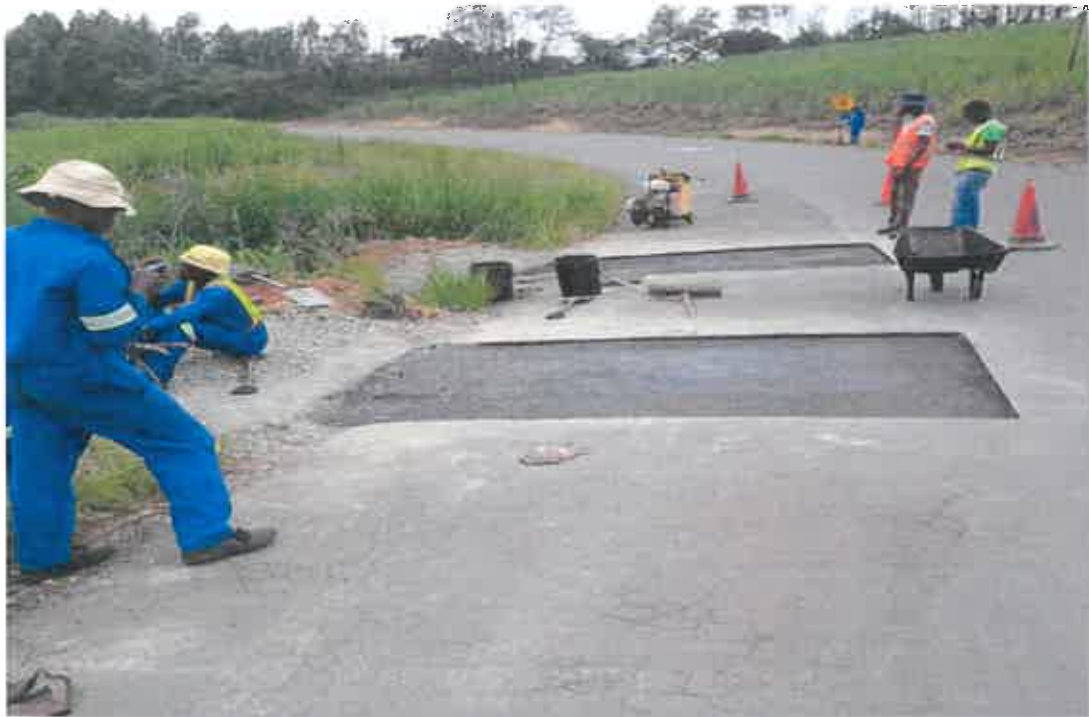
Potholes repair ongoing at Km 22

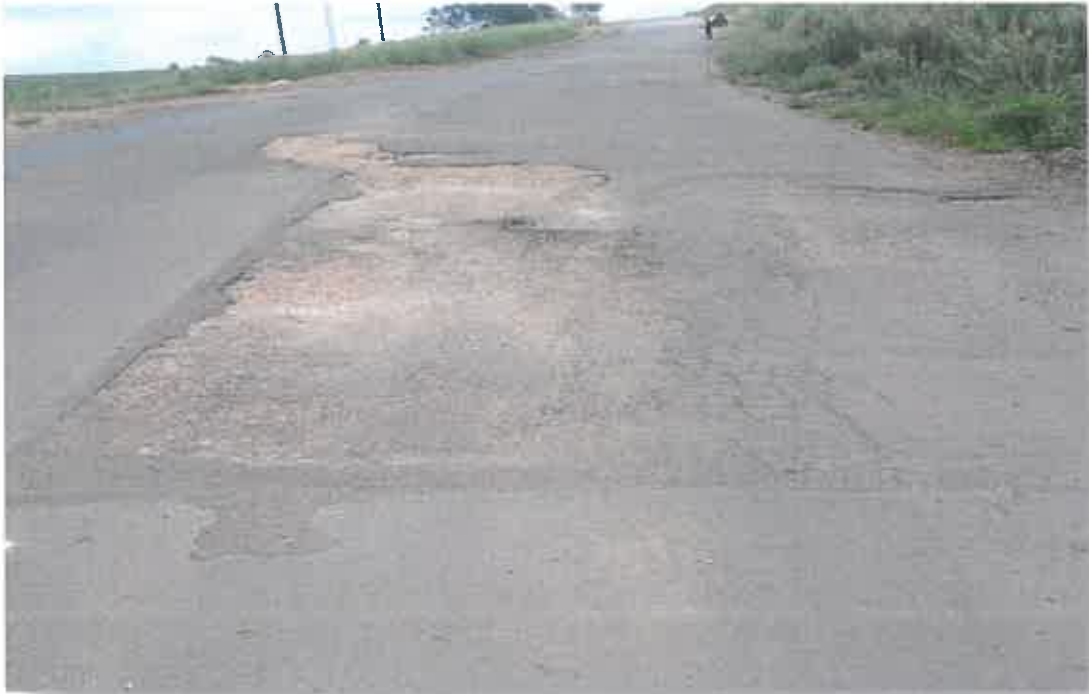
Surface Failure at Km 23

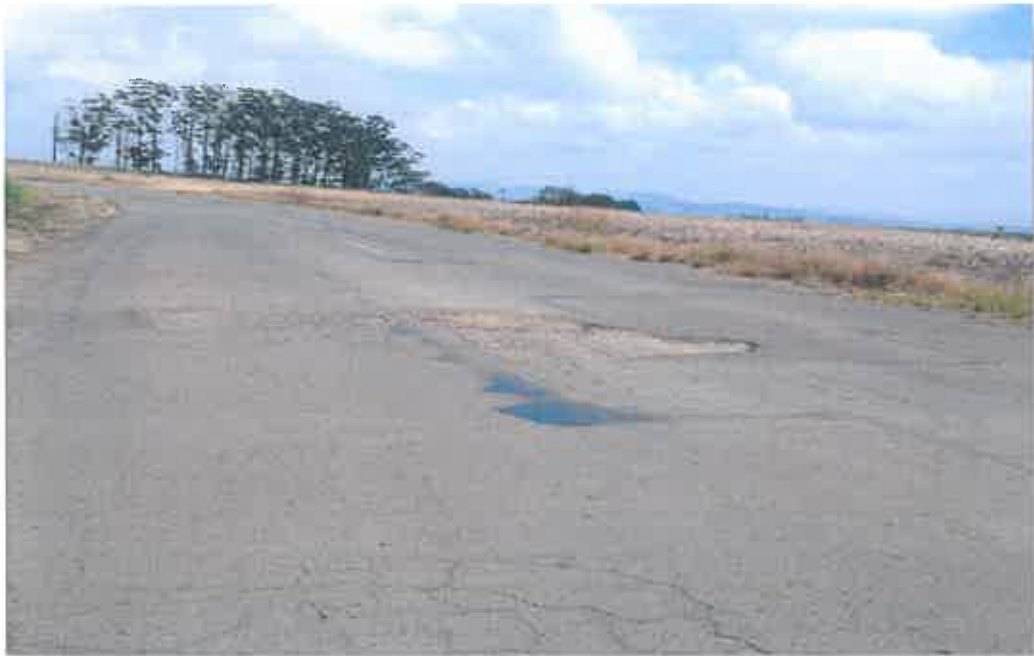
Potholes severe and extensive between Km 24 and Km 26

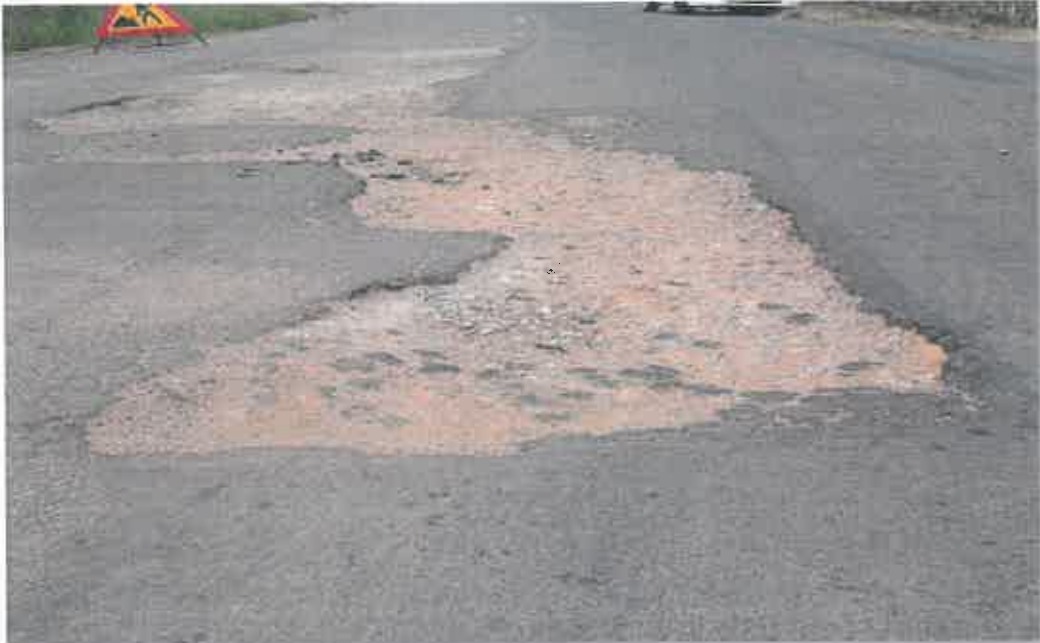
Structural failure and exposure of the base layer at Km 24
