Baseline Assessment

Tongaat Hulett Developments: Canelands East Aquatic Assessment

Reference: GTW-231215-1

Date: December 2015

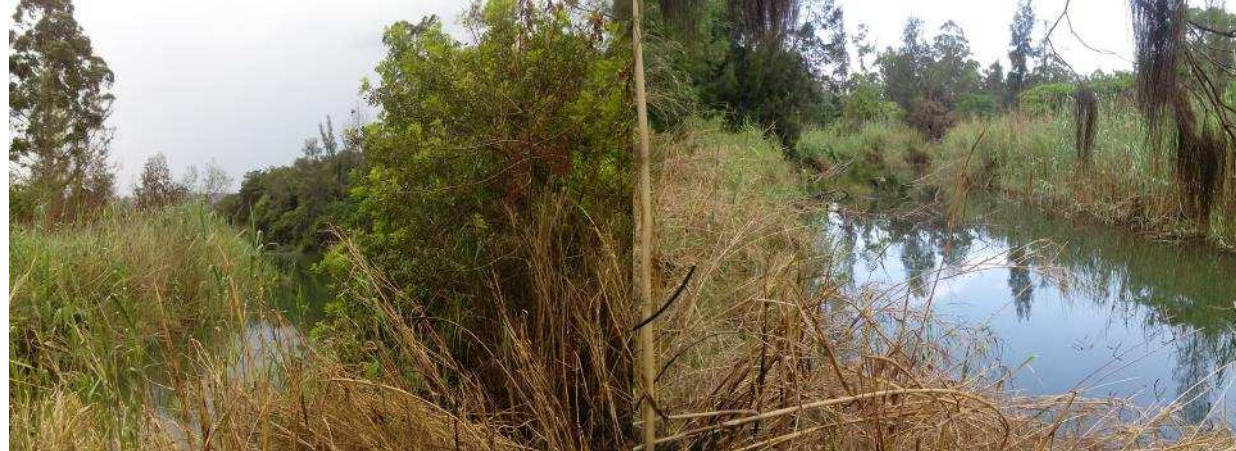
View of the sample site			View downstream of the sample site

Date	Index of Habitat Integrity		Diatoms		Status
	Instream	Riparian	SPI	%PTV	
9/12/2015	89	88	13.6	61	Good

The Mdloti upstream of Canelands East was assessed below the impacts from the Hazelmere water treatment plant. Due to habitat limitations SASS5 macroinvertebrate assessments were not included at this site. The biological health was determined using diatoms.

The diatom results indicate that the biological water quality was in a good condition at the time of the assessment. The percentage Pollution Tolerant Values (%PTV) indicated that there is organic pollution impacting the system.

The IHI assessments showed the integrity of both the instream and riparian habitats to be good. The main impacts at the site were related to construction/sand mining activities immediately upstream of the site and alien vegetation.

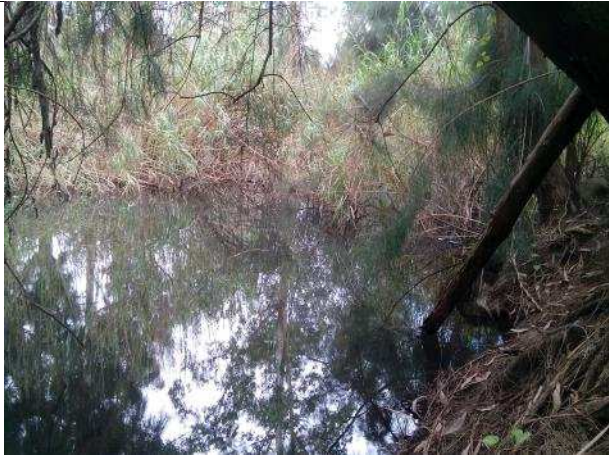
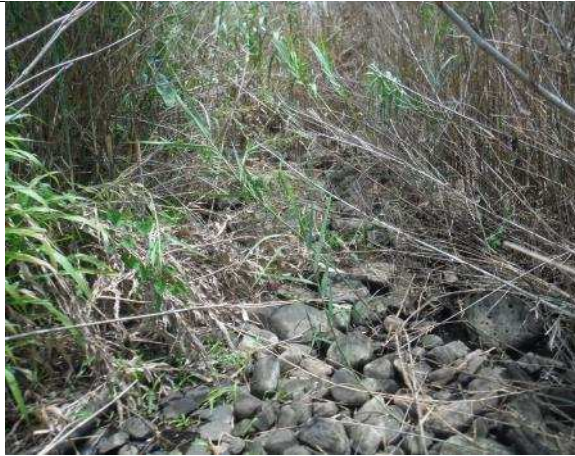
View upstream of sample site			View downstream of sample site

Date	Index of Habitat Integrity		Macro-invertebrates		Diatoms		Status
	Instream	Riparian	SASS Score	ASPT	SPI	%PTV	
9/12/2015	93	89	106	5	16.2	52	Good

The site was located downstream of Canelands East but upstream of the sand mining concession. The SASS5 assessment indicated the biological water quality was in a fair condition; however, habitat was limited at the site which in turn negatively impacted the SASS score. Diatoms which are not habitat dependent possibly provide a better indication of the condition of the site. The diatoms showed the site to be in a good condition with the score improving compared to the upstream site: this would suggest a lack of additional impacts emanating from the Canelands East property.

The instream habitat integrity was near to natural with only minor impacts at the site. The riparian habitat was in a good condition, with alien plants being the main impact.

The baseline assessment identified that the affects from Canelands East were leading to an improved water quality of the Mdloti River. It is recommended that future activities on site should not allow the water quality of the downstream site to decline below that of the upstream site.
