## **Appendix E: Wetland Verification Exercise**

**RE: VERIFICATION OF THE PRESENCE OR ABSENCE OF WETLANDS AS PART OF THE ENVIRONMENTAL ASSESSMENT AND AUTHORISATION PROCESS FOR THE PROPOSED SASOL CHARLIE POLLUTION CONTROL DAM IN SECUNDA, MPUMALANGA PROVINCE**

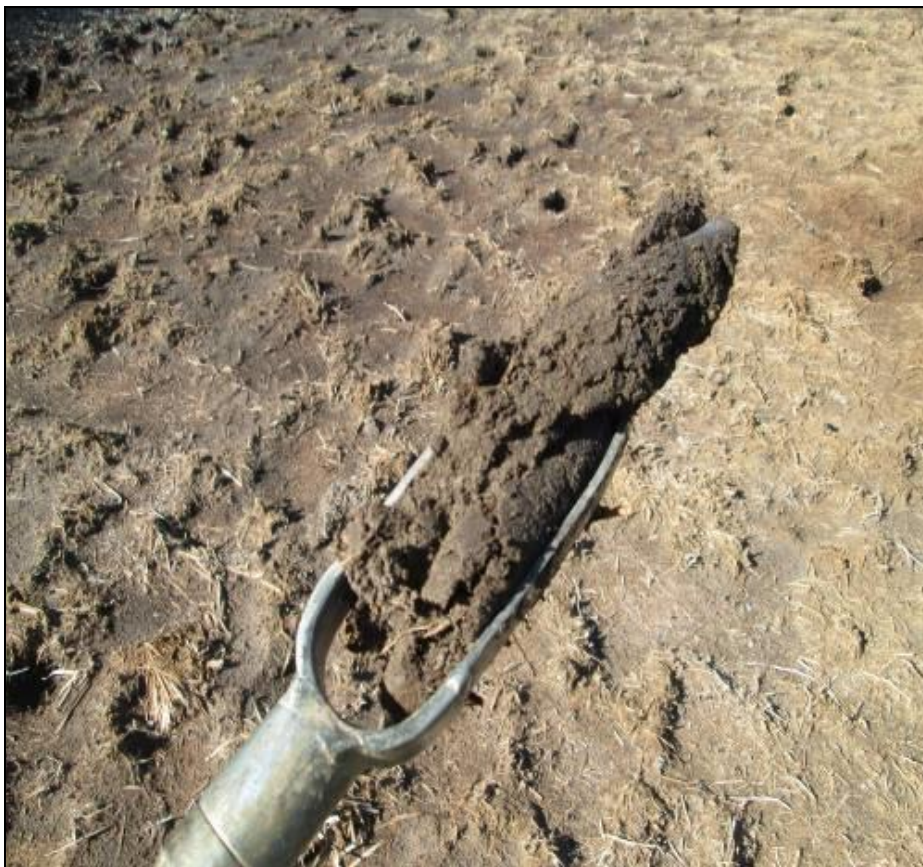
3. Soil auguring took place at several points within the study area to determine whether soils that are associated with prolonged and frequent saturation and a fluctuating water table which leads to soil mottling were present. However no signs of mottling was observed in the soil samples taken within the site or within 32m thereof as depicted in Figure 5;

**Figure 5: Representative photograph of a soil sample taken within the study area.**

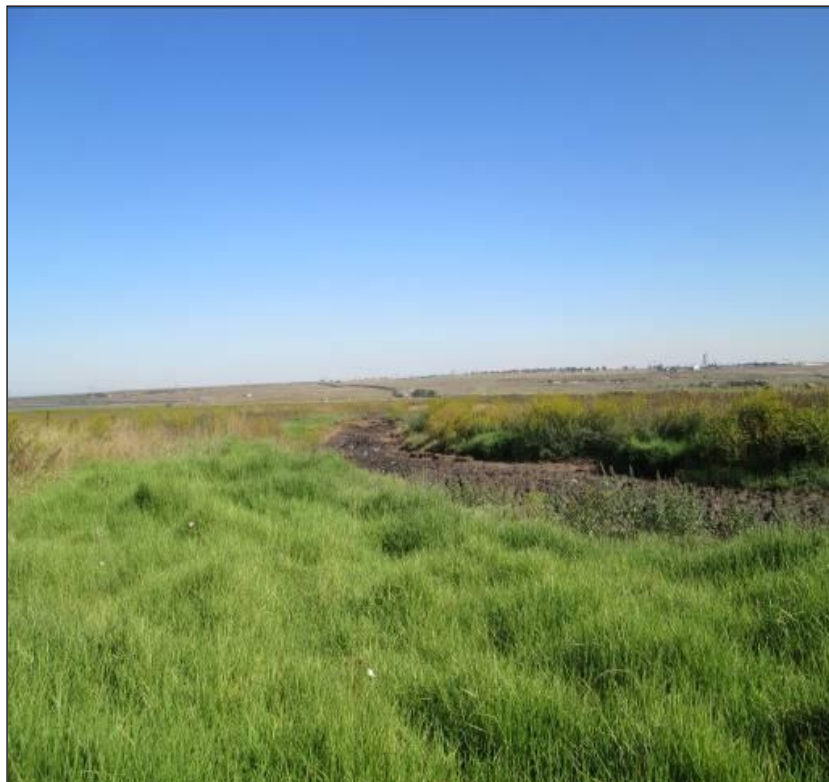
6. The channel-like feature identified to the south of the study area was found to be unvegetated, and soil samples taken within this area did not display gleying or mottling which would be indicative of wetland conditions. The channel-like formation is deemed likely to have been formed as a result of seepage originating from the Charlie 1 landfill site located on the eastern boundary of the study area. It is also possible that the area has been cleared of vegetation for agricultural purposes. Representative photographs of this channel-like formation are presented in Figure 6;

**Figure 6: Representative photograph of an area resembling a constructed channel, situated approximately 200m south of the study area**

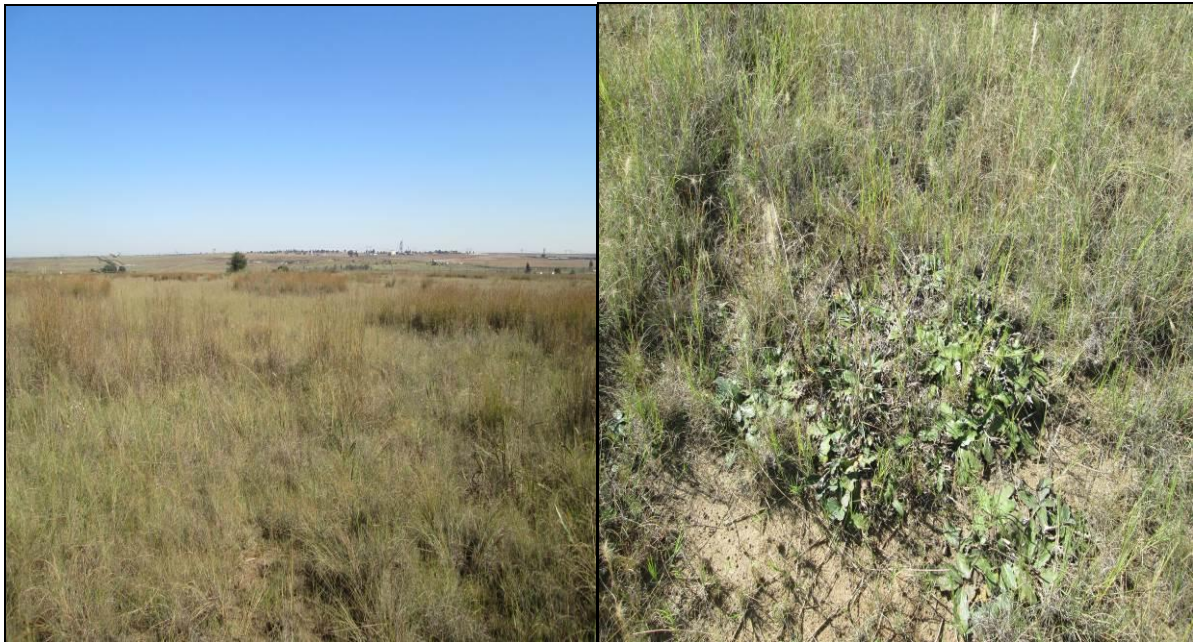
- 
7. Wetlands within 500m of the study area were investigated, and approximately 100m northeast of the study area, a poorly defined mosaic patch of temporary wetland and moist grassland was identified. This area showed minimal wetland characteristics and the boundary was not clearly discernible and difficult to delineate (Figure 7). Vegetation indicators were also minimal and vegetation such as *Helichrysum kraussii* and *Haplocarpha scaposa* were observed;

**Figure 7: A mosaic of temporary wetland and moist grassland located northeast of the study area.**

8. The development of the PCD is unlikely to pose a threat to this feature as well as the conservation of wetlands on a local or regional scale; and
  9. Based on the findings of the assessment it is the opinion of the ecologists that from an ecological viewpoint, the proposed project be considered favorably. However, it is recommended that as part of mitigatory measures, the proposed PCD be properly lined to prevent seepage, which may affect the surface and groundwater environment over time.
