Wetland Assessment Study:
In support of the
Basic Assessment Study
for the proposed Upgrade to the Eastbury Trunk Sewer
Line Project, eThekweni Metropolitan Municipality,
KwaZulu-Natal

June 2014

Wetland Assessment Study in support of the Basic Assessment Study for the Proposed Upgrade to the Eastbury Trunk Sewer Line Project, eThekwini Metropolitan Municipality, KwaZulu-Natal

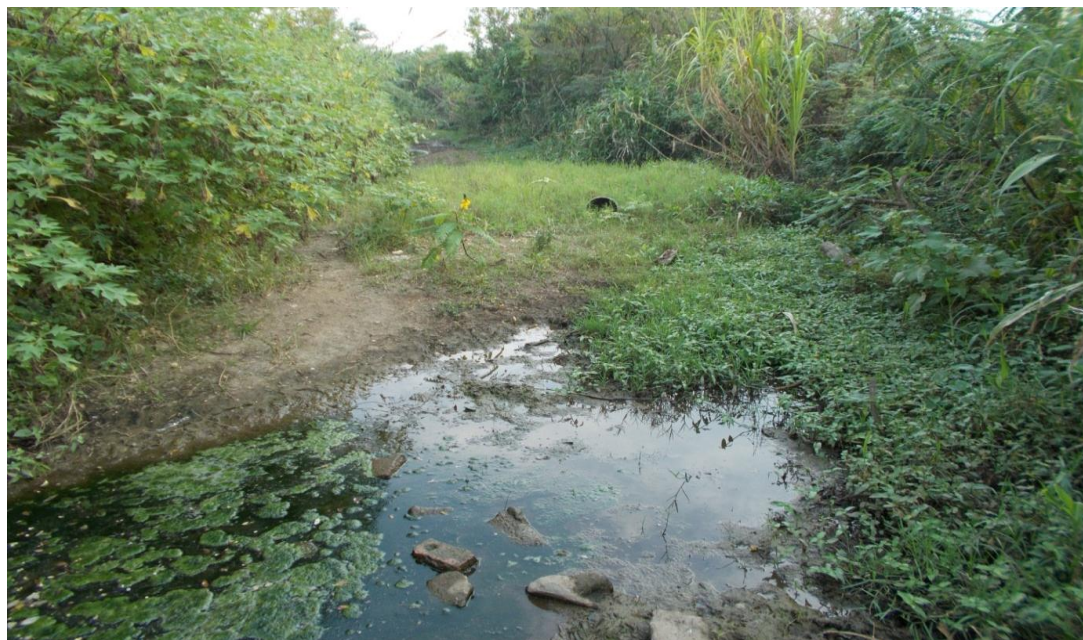
Figure 2 – Ditch located between the road and rail servitudes, extensively invaded-colonised by alien invasive vegetation.

To the south of the infilled area and lower-lying southern vacant strip of land ~~to the south~~, a drain / ditch runs parallel to the road for a distance of approximately 300_m (Fig. 2). This ditch, which appears to be fed by stormwater from the rail servitude and the adjacent road, has been colonised by a mix of alien invasive vegetation species forming a band of dense thicket-like vegetation. Theis ditch contains areas of standing water and has an outlet under the road, extending west of the road to the stream to the south-west.

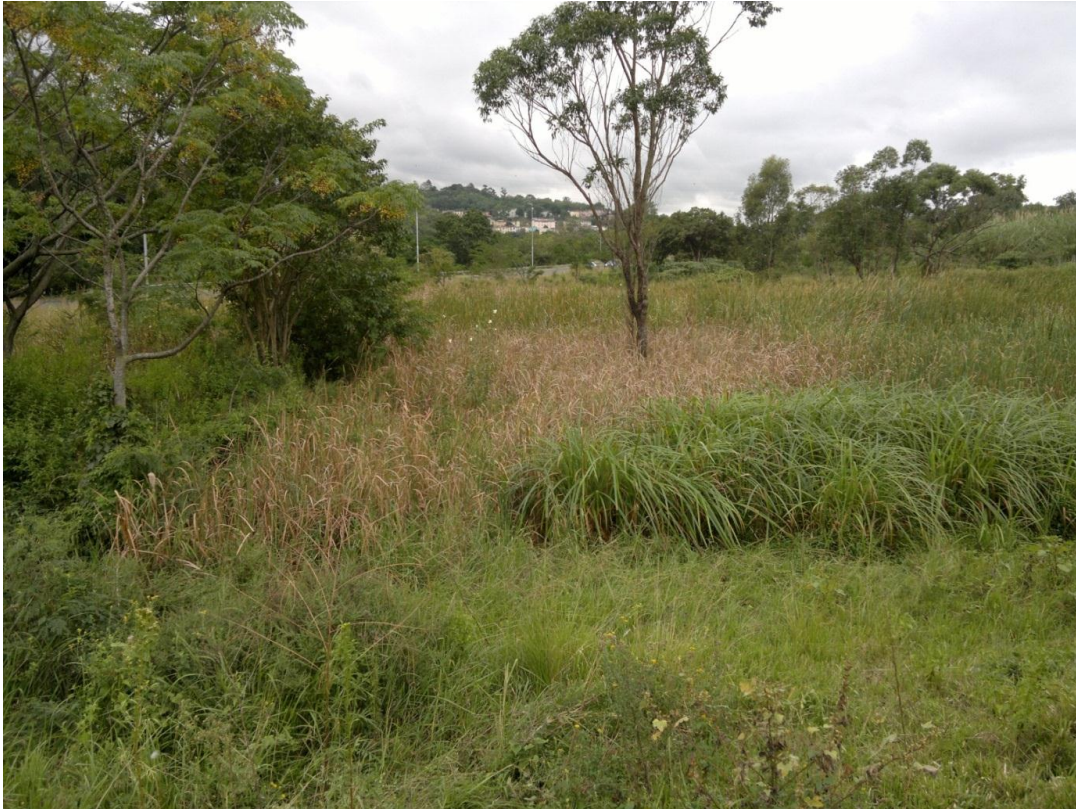
Figure 3 – Southern edge of the wetland area to the north-east of the northern end of the sewer route, as viewed from the 'impounding' embankment 'impounding' it.

Soils investigated at the edge of the wetland revealed the presence of hydromorphy, primarily in the form of soft plinthic soil characteristics very close to the surface, as well as iron and manganese mottling and redox depletions within a grey (gleyed) matrix at a slightly greater depth below the surface (Fig. 4, Fig. ?). These soils along with the vegetation assemblage in this area were clear indicators of the presence of wetland habitat (Fig. 3?). The wetter part of the wetland consisted of *Typha capensis* reedbeds, along with a few specimens of the species *Cyperus dives* (Figs. ? & ?). Both these plant species are *Typha capensis* is an obligate hydrophytes, which are that is often almost always associated with wetland soils (Marnewecke & Kotze, 1999). The periphery of the rushbeds and reedbeds graded to grassy vegetation on the edge of the road servitude. In this transitional area on the edge of the wetland, the predominant species noted was *Imperata cylindrica* (facultative species in wet climate conditions), with other grass species noted including *Hyparrhenia filipendula* (wide range of habitat), *Paspalum urvillei* (facultative wetland species), *Bothriochloa bladhii* (grows on riverbanks, in vleis, other wet places & often in road reserves where water collects) and *Sporobolus pyramidalis*. A number of sedge species were also encountered in including *Cyperus (Mariscus) congestus*, *Cyperus rotundus*, *Pycreus polystachyos* *Imperata cylindrica*, *Paspalum urvillei* and *Cyperus congestus* are hydrophyte species typically associated with wetland habitat, in particular the margins of wetland habitat. This vegetation assemblage and transition is typical of wetland margins and is generally reflective of an increasing degree of inundation of the soils from the area outside of the wetland into the wetland itself.

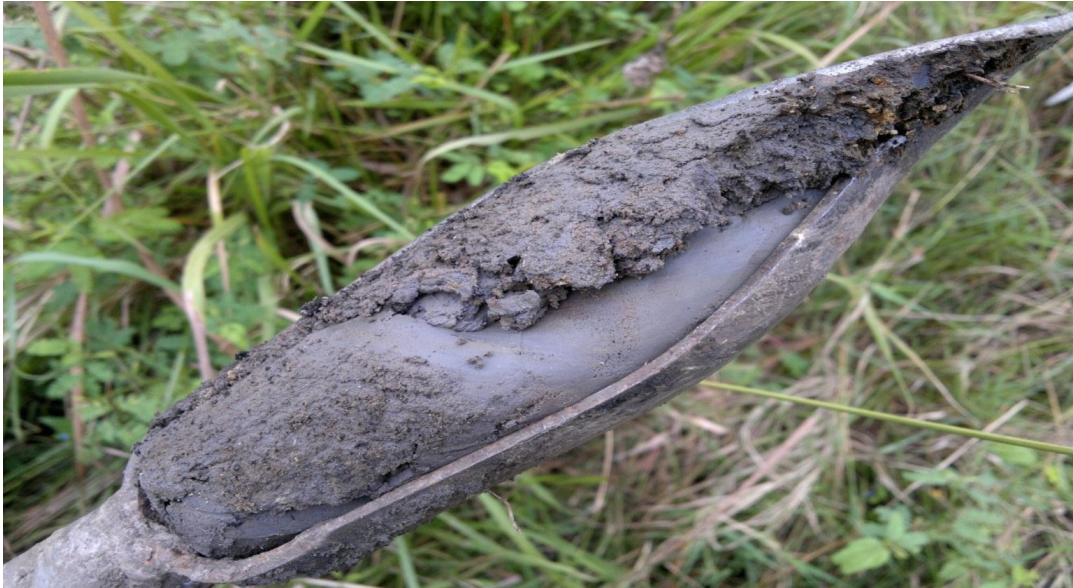
Figure 4 – Gleyed soils and iron mottling from the periphery of the wetland area to the north-east of the alignment

As discussed above, no outlet or culvert for this wetland was noted at this point, and the wetland appears to rather be obstructed by the raised servitude and a raised embankment that runs between the road and the rail servitude. It should be reiterated that this wetland area is not located close to the section of sewer pipeline being upgraded and will thus be unlikely to be affected by the proposed development.

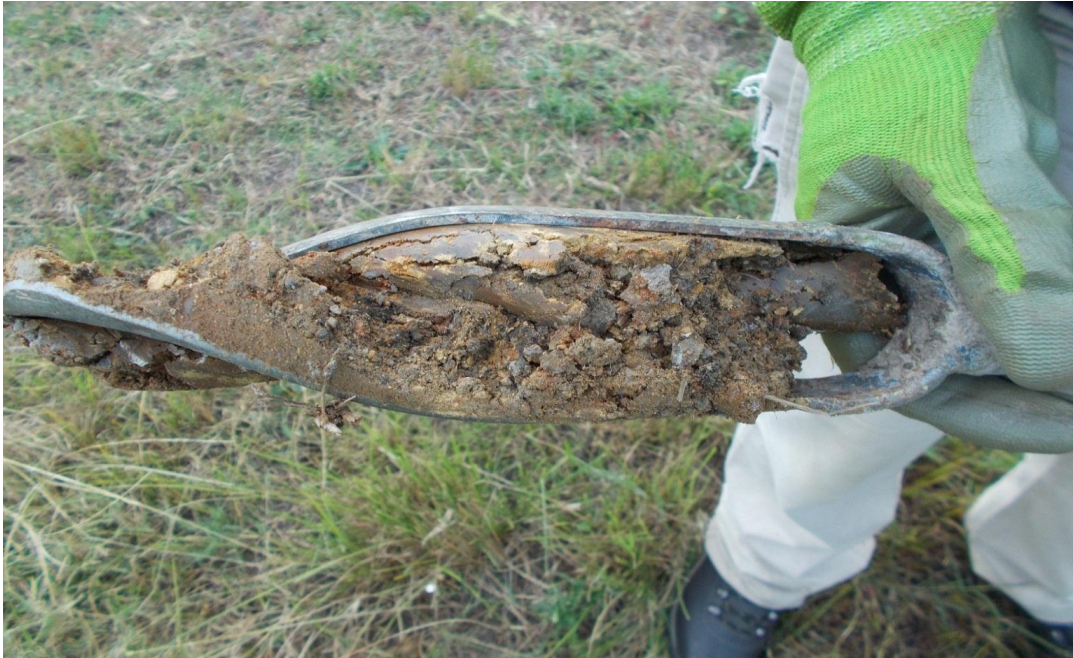
Figure 5 – Soft plinthic soils from a sample point

Soils in this area were noted to be highly clayey in character, showing expansive (swelling and shrinking) properties in certain locations (as indicated by surface cracking). Certain soil samples along this stretch of the intervening area between the two servitudes along this part of the alignment showed no signs of hydromorphy, however in a number other sample locations along this stretch, hydric soils were located. Redoximorphism was noted primarily in the form of soft plinthic characteristics. Soils with plinthic characteristics are characterised by localisation and accumulation of iron and manganese oxides under conditions of a fluctuating water table, with soft plinthic soils being non-indurated and hard plinthic being indurated. Hard plinthic horizons are also known as ferricrete or hardpan. The Westleigh (Orthic A→Soft plinthic B) wetland soil form was encountered within certain sample points in this area. The presence of soft plinthic soils in a number of the samples indicated that under natural conditions a degree of soil saturation sufficient for the development of anaerobic conditions and thus hydric soils would have been present in this area, but no evidence of a current perched water table was noted on the site. Within the soft plinthic matrix a number of redoximorphic characteristics were present, in particular large iron (bright orange and red) and manganese (black) oxides (mottles), as well as adjacent areas of clay and redox depletions (greyer areas within the matrix). The location of oxides and depletions in an alternating pattern within the matrix in certain of the soils sampled is representative of processes of the reduction of translocation of Fe ions and subsequent re-oxidisation of ions, a process that typically occurs within a root canal.

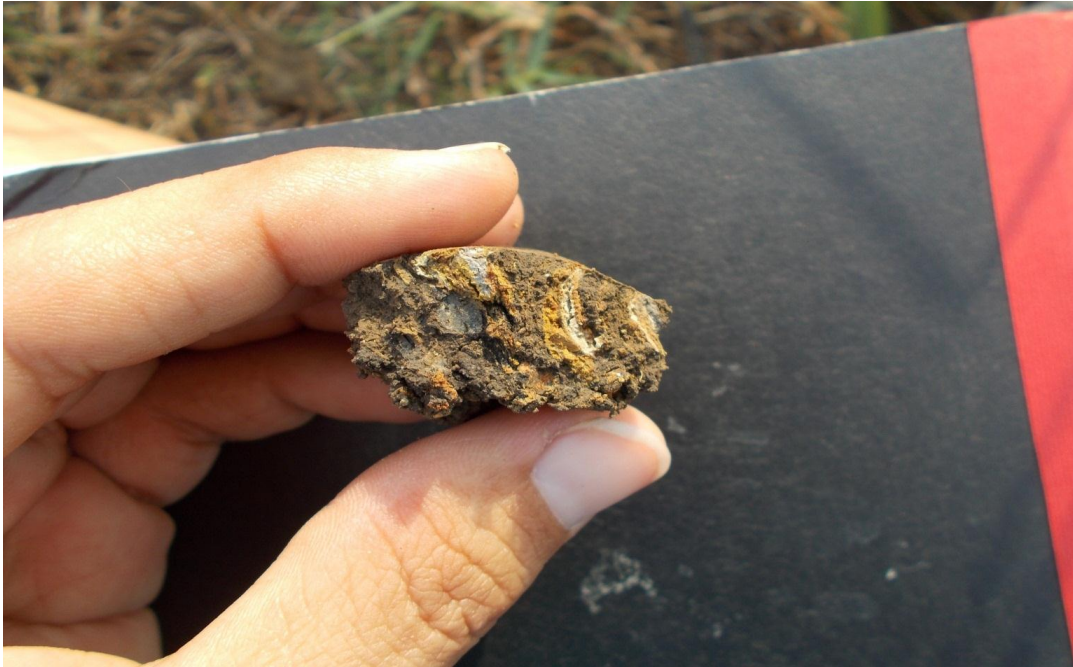
Figure 6 – Alternating pattern of redox concentrations and redox depletions

From a terrain perspective, such hydromorphic soils were not only found in the lowest point (shallow depression) in this intervening area between the two servitudes, but on sloping ground of slightly higher elevation closer to the railway servitude. In addition these plinthic soils were found at the surface of the ground in certain of the sample locations, which is unusual in that under natural conditions, soft plinthic soil horizons are only encountered as secondary or sub-soil horizons. These two observations suggest that the substrate in this area between the road and rail servitudes has historically been subject to physical disturbance, with the alteration of both soils and hydrology. Due to the presence of the road and rail servitudes, topsoil may have been removed and gradients may have been altered to ensure drainage off the road and rail servitudes. In addition a fuel pipeline appears to run through this area, running adjacent to the road, as indicated by the presence of white pipeline markers in this area. These activities have clearly resulted in the alteration of the natural ground level in these servitude areas and the alteration of the natural hydrology of the area. The location of hydromorphic soils on a slightly higher gradient could possibly suggest the historical (natural) presence of a seepage wetland in this location, but may also reflect a natural extension of the valley bottom wetland with an associated degree of inundation. However due to the physical transformation of this area, the origin of these areas of hydric soils is very difficult to determine. The presence of hydric soils in this area, but with no visible indications of vegetative wetland habitat indicate that these soils are residual hydric soils.

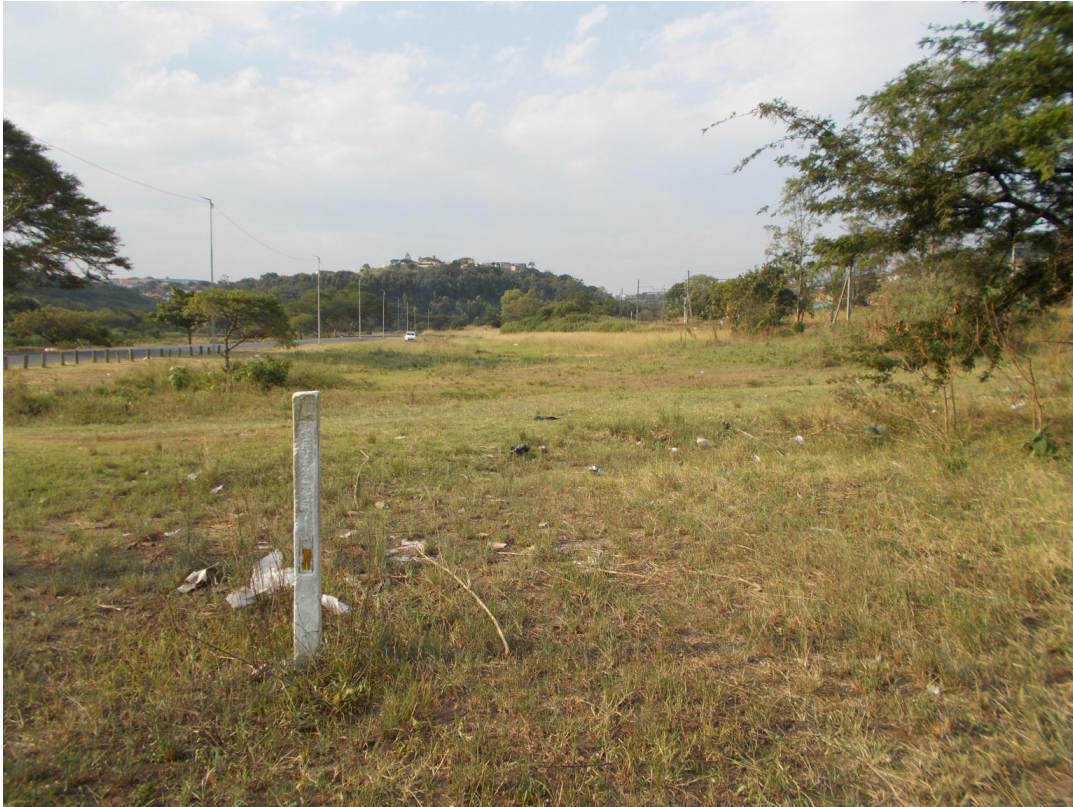
Figure 7 – Open grassy area between the Eastbury Drive and the railway servitude in which residual areas of hydromorphic soils are located. Note the white fuel pipeline marker in the foreground

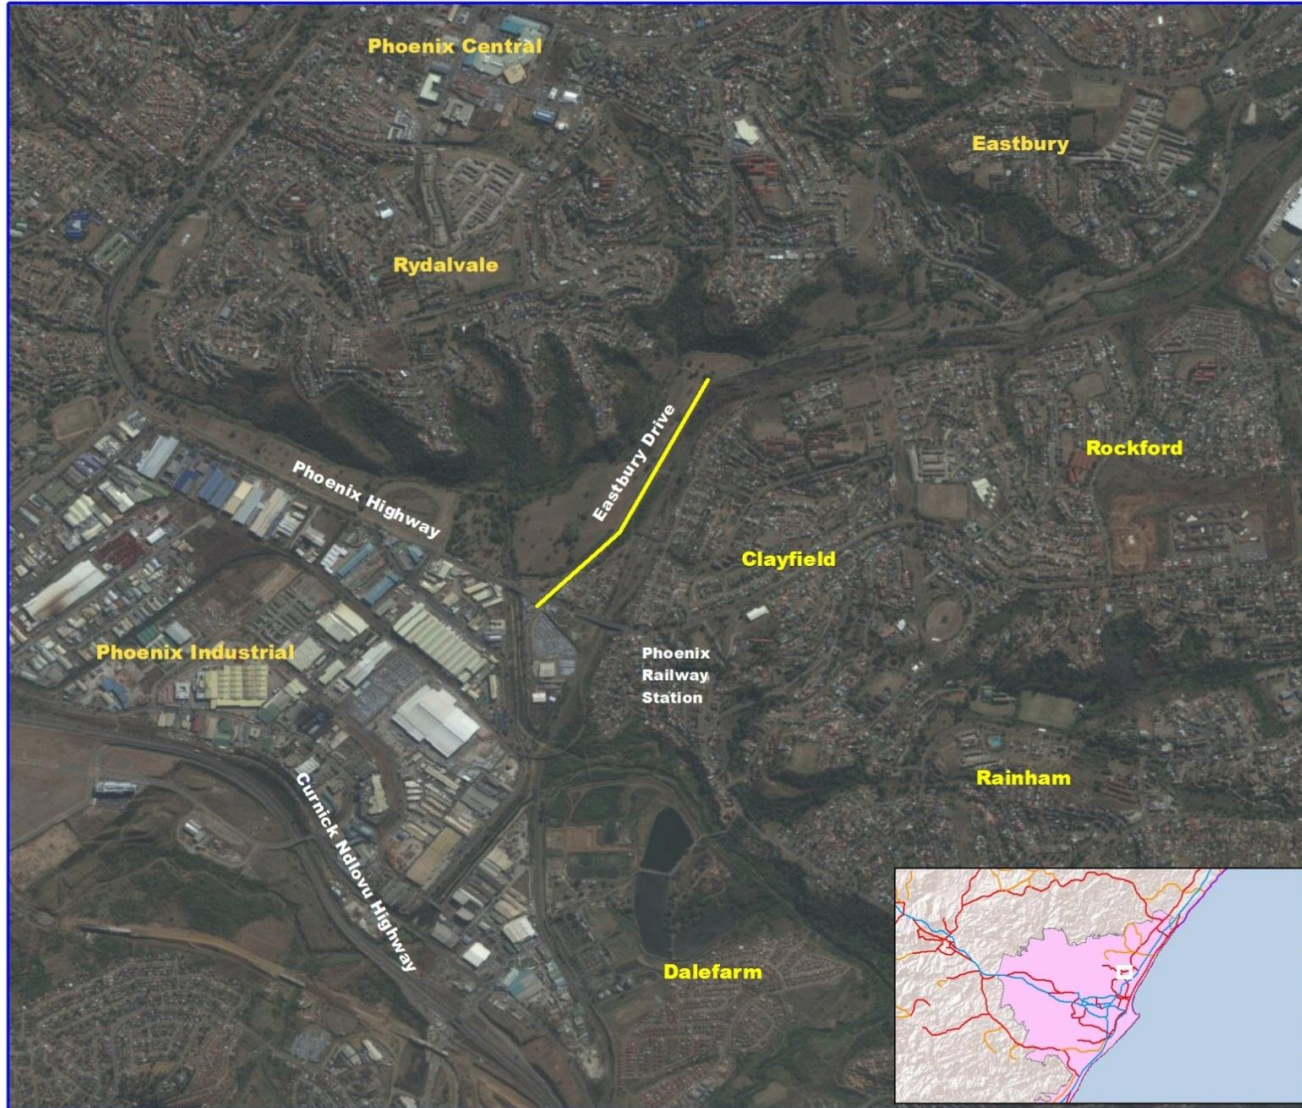
PROPOSED UPGRADE TO
THE EASTBURY TRUNK
SEWER LINE

**WETLAND
DELINEATION
ASSESSMENT**
