Environmental Impact Assessment for the proposed Concentrated Solar Thermal Power Plant on the farm Sanddraai 391, Northern Cape – Surface Water Study

Solafrica Thermal Energy (Pty) Ltd

April 2016

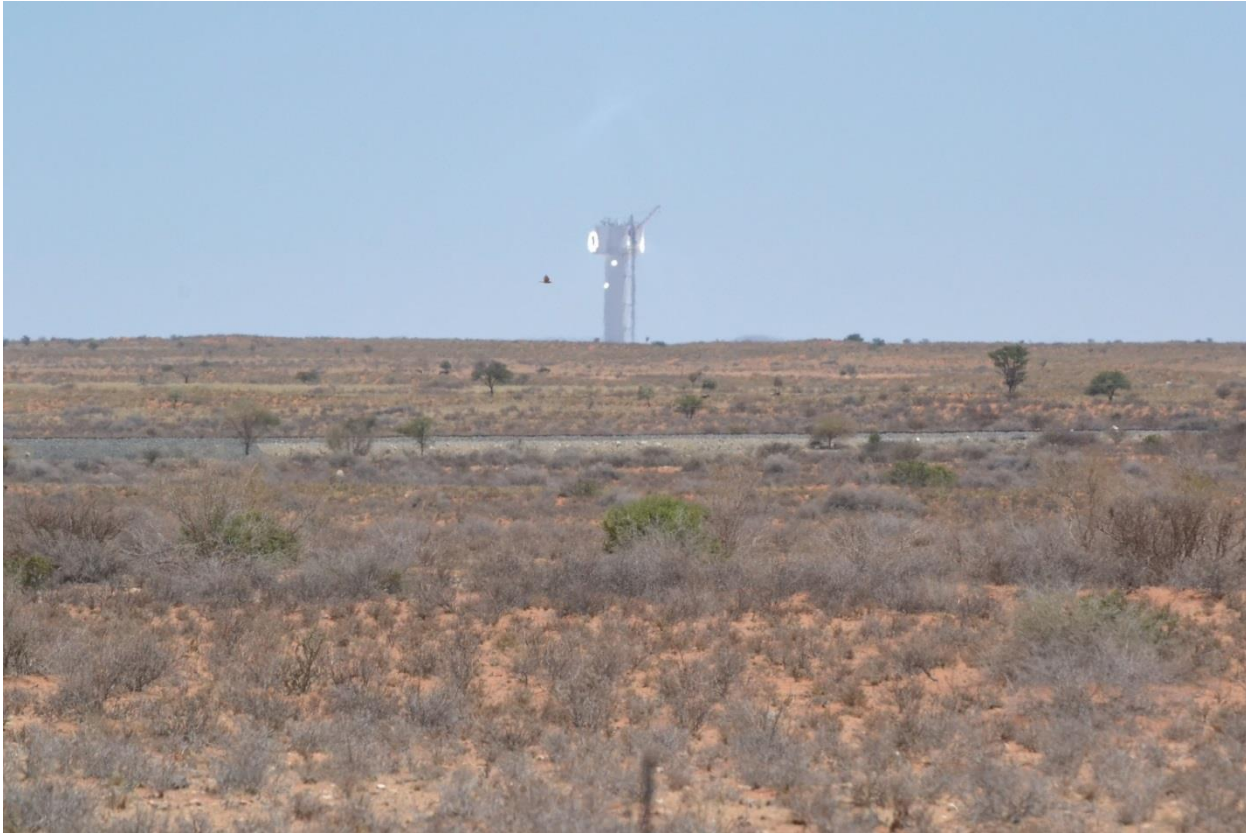
Figure 6 – An example of a central receiver CSP Plant as viewed from the N10 Highway near the Upington Airport

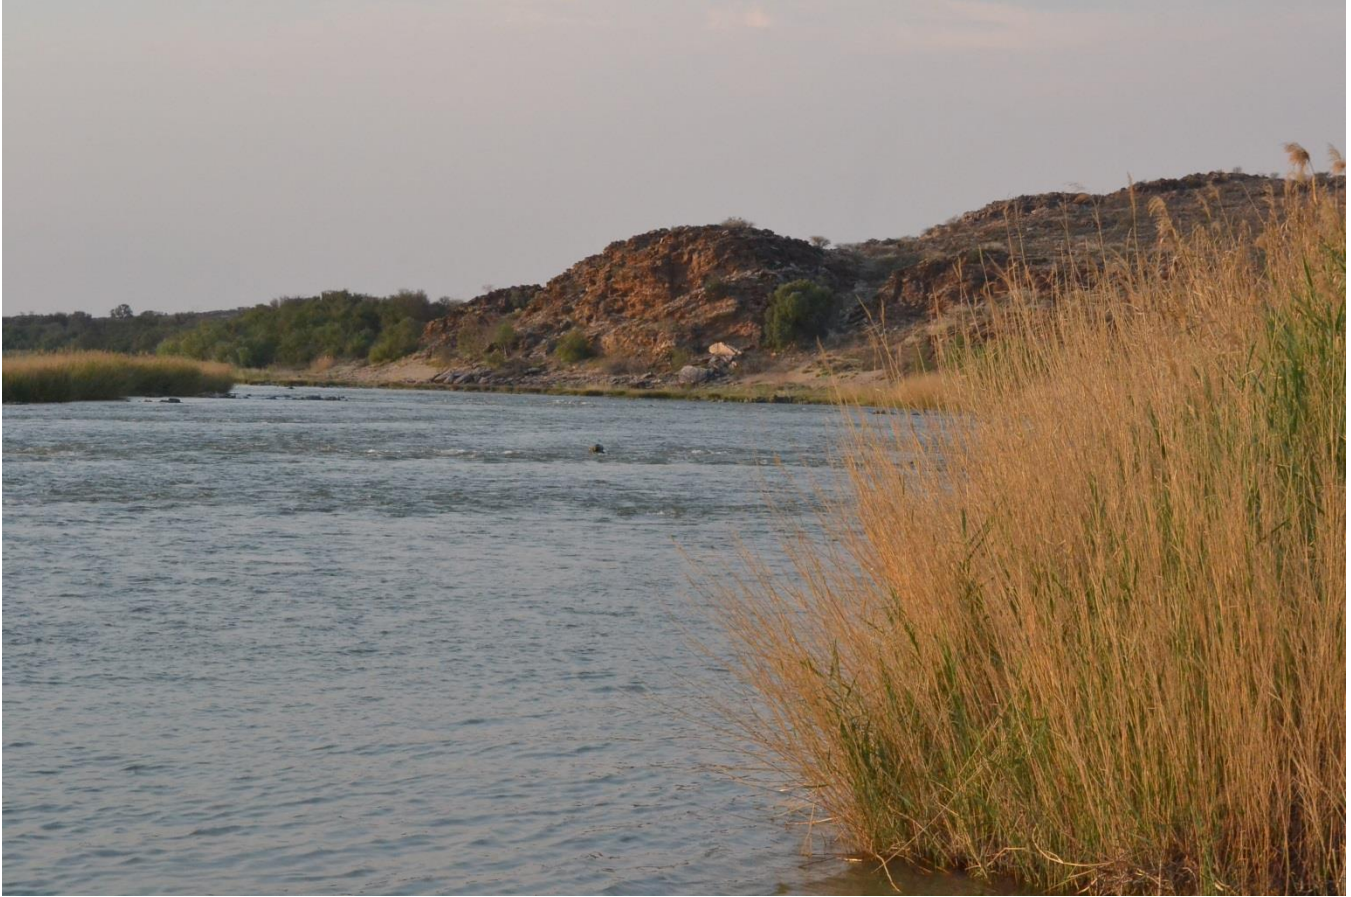
Figure 11 – Low cliffs along the eastern bank of the Orange River formed by outcropping strata of the Brulpan Group on the Ebenhaeser Property

The eastern bank of the Orange River in the vicinity of the study area is characterised by the presence of rocky terrain that rises from an alluvial terrace within the Orange River valley bottom that abuts the channel of the river (this terrace has been subject to intense cultivation). The Orange River corridor is underlain by alluvial sediments of recent geological origin. These sediments are only located in a narrow band along the river. Located immediately adjacent to the Orange River corridor and occupying the most south-westerly part of the development site is a wider band of basement rocks (Quart-muscovite schists, quartzites, quart-amphibole schists and greenstones) of the Brulpan Group of the Groblershoop Formation. Areas underlain by the relatively more resistant quartzites form the low ridges (interfluves) in this area. The terrain in this part of the site is rugged, with widespread outcropping of bedrock rising away from the river, forming a number of low ridges and accompanying shallow small valleyheads. In the southern part of the site the terrain rises to form a local highpoint, with this high ground extending right down to the Orange River on the farm Ebenhaeser 394 to the north where an outer bend of the Orange River has cut into these strata to form low cliffs on the river's eastern bank. The presence of the rocky strata in the south-western part of the site has an important bearing on surface water drainage, as discussed below.

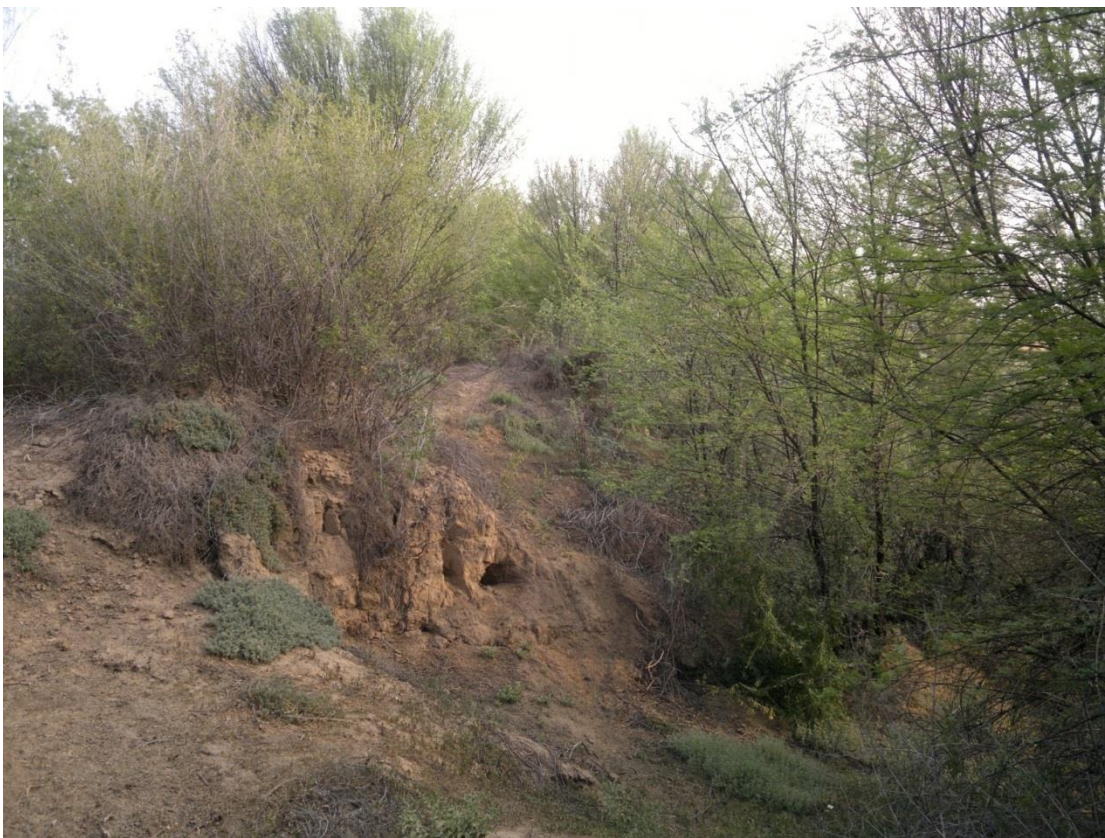
Figure 12 – Typical structure of the upper part of the riparian zone close to the current Ebenhaeser abstraction point where the riparian zone is narrow and more sloping, characterised by riparian thickets on alluvially-deposited material

The riparian zone of the river is located beyond the active channel. The cross-sectional profile of the riparian zone of the river varies, depending on whether the point along the reach is located on an inner or outer bed. In the part of the reach near the Sanddraai Farmstead, the riparian zone is characterised by a wide, flat flood bench (sand flats referred to above) located just beyond the active channel. This flood bench consists of alluvially-deposited silt, with little mature riparian thicket vegetation, rather open areas and silt banks or areas of dense *Phragmites australis* reedbeds. Where the river bends back in an eastward direction to the north of the Sanddraai Farmstead, the riparian zone becomes much narrower and more steeply sloping from the edge of the active channel, rising up from a much narrower flood bench characterised by reedbeds (that is even absent in certain places) through a series of steeper slopes and terraces to the top (outer edge) of the macro-channel bank. Beyond this macro-channel bank a wide alluvial terrace is located on which cultivation and orchards have been established. The current edge of the riparian zone ends at the start of this terrace (where the orchards and fields start), but under natural conditions the riparian zone is likely to have extended onto the floodplain terrace, which has now been completely transformed.

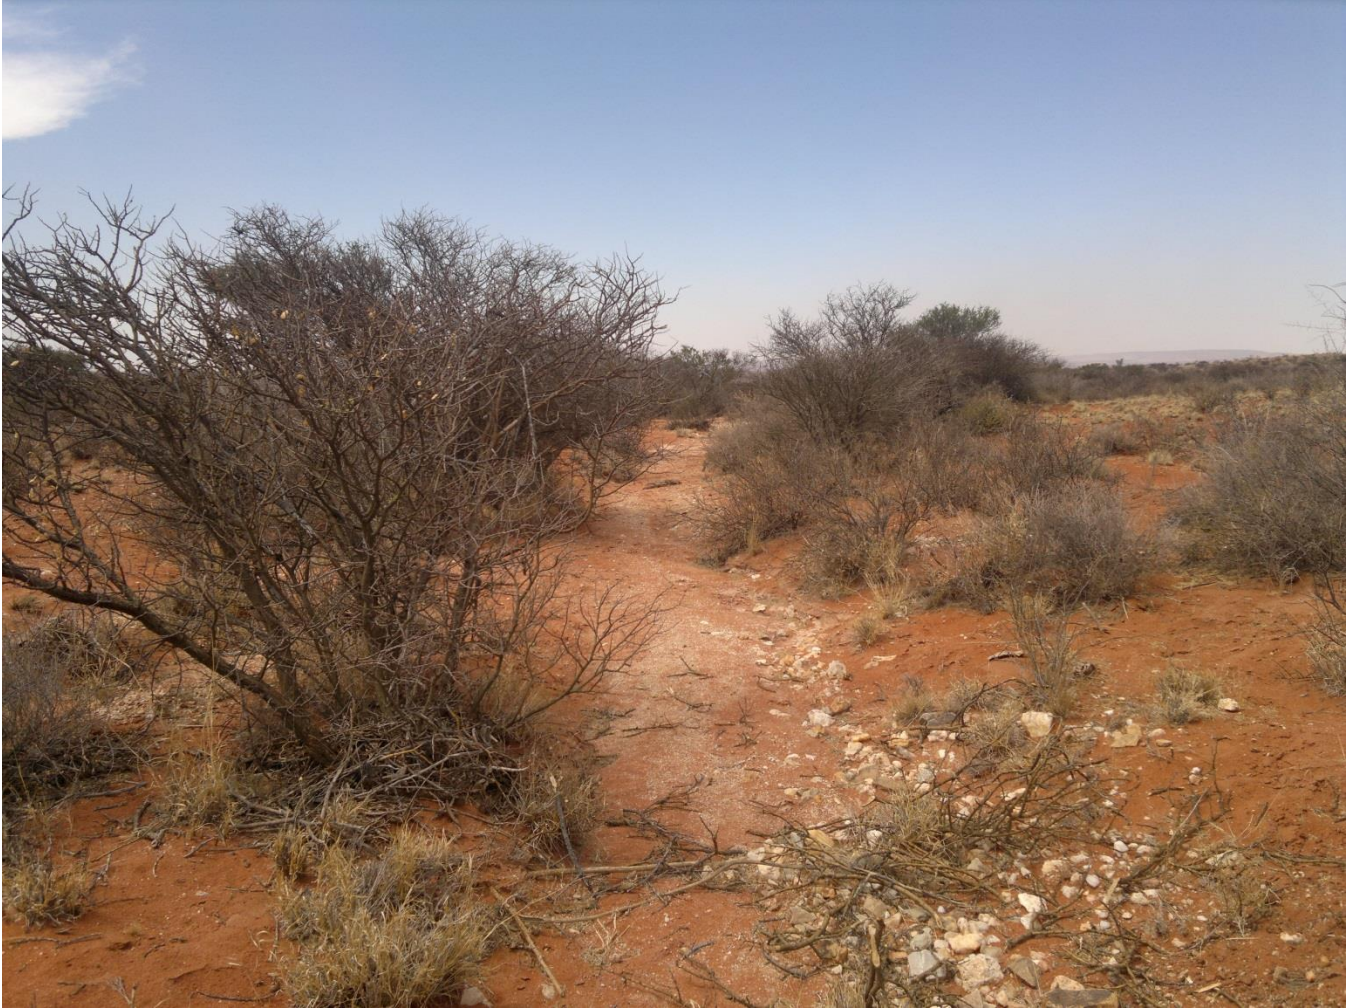
Figure 13 – Example of a watercourse along Alternative 1 (Crossing Alt1_15) with a very poorly defined channel and riparian vegetation

No evidence of active surface water flow was noted along any of the watercourses assessed in the field away from the Orange River, and all are likely to be strictly episodic, flowing only in response to rainfall events of sufficient duration and intensity. Evidence of periodic flow along these watercourses is provided primarily by the presence of wrack that is deposited on the upstream side of obstacles in the path of the watercourse, in particular the fence lines along which most of both pipeline alternative route run. In this context wrack is the (primarily vegetative) material washed down river courses during flood / spate flow events, and which is trapped behind branches and other obstacles, remaining in situ after the flood has passed. The evidence of wrack beyond the active channel indicates that these areas were inundated by flood waters and gives a good indication of the extent of higher / spate flows along the rivers in the study area. Although the presence of wrack does not provide an indication of the frequency of flooding, it does give an indication that a spate flow did occur along the water course, and the position of the wrack horizontally away from the channel, and vertically above the channel bed indicates the extent of the flooding and the volume of water that passed along the system, and is a reliable indicator of the extent of maximum hydrological activation and as such is a good indicator of the lateral extent of the riparian zone.

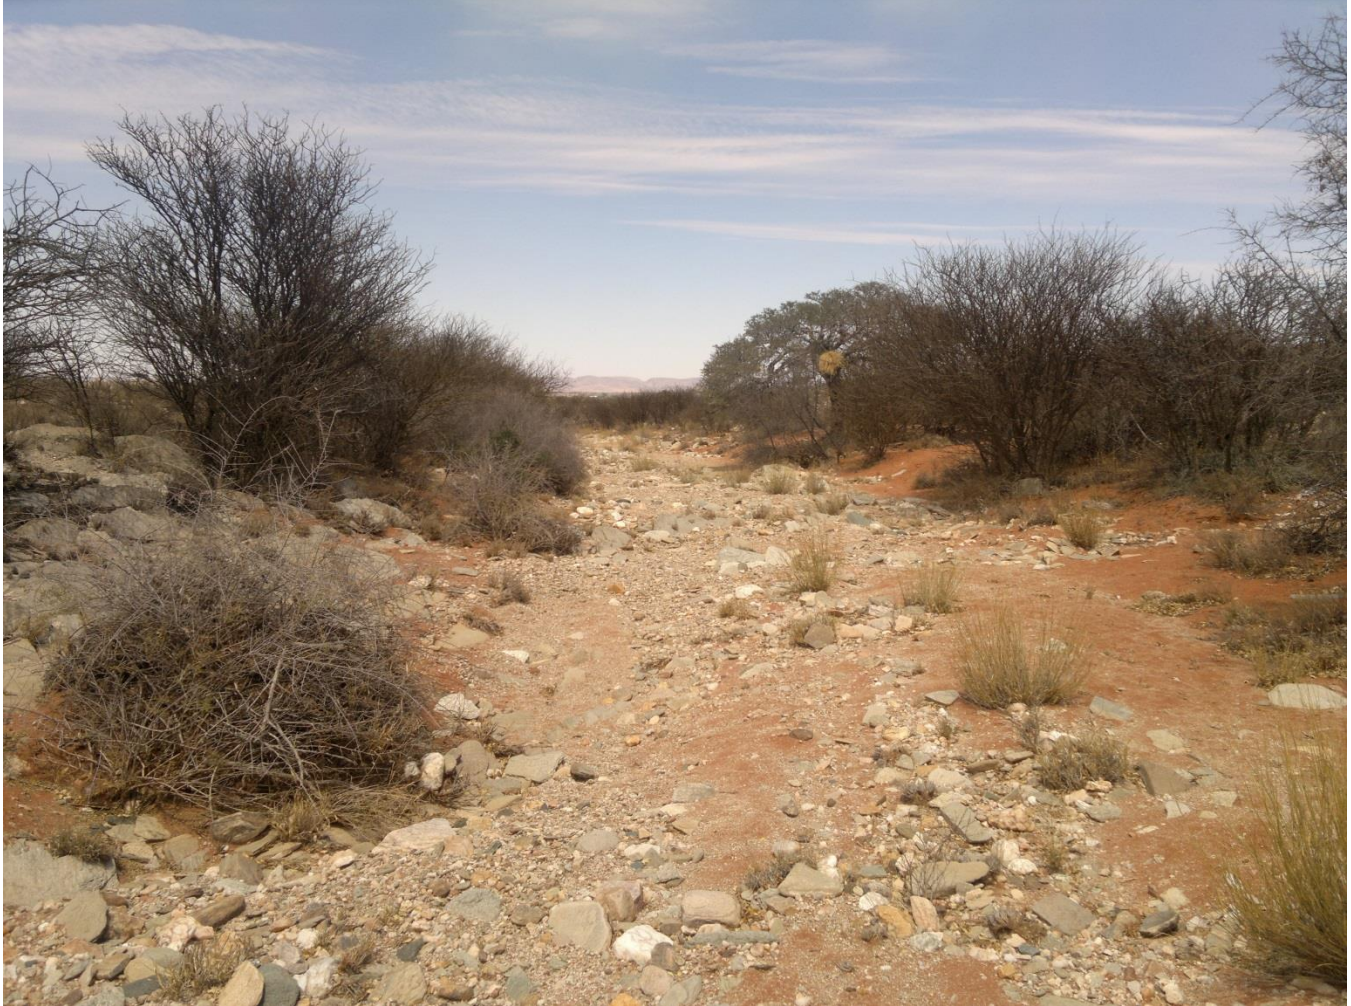
Figure 14 – The largest of the ephemeral watercourses (Crossing Alt2_22), displaying a more defined channel and more developed riparian vegetation

In a hydromorphological context most of the watercourses assessed in the field contained a main (active) channel, a feature of most fluvial systems. The high stream order of certain of the watercourses crossed by the pipeline alternatives is indicated by the relatively lack of incision and lateral extent of most of the channels of the watercourses crossed. The largest watercourse crossed (Crossing Alt2_22) was characterised by a relatively unincised central channel. Fluvial channels were not noted to be subject to significant degrees of channel bank

erosion. Active channels were characterised by a sandy, alluvial substrate with little vegetative cover, or alternatively areas of bedrock outcropping. This alluvial substrate is likely to shorten the period of flow within the system following a rainfall event, as it would enhance the ability of overland flow entering and flowing down the system to permeate into the substrate.
