# The Tinley Manor Southbanks Coastal Development: Updated Estuarine Impact Assessment and Specialist Input for the Umhlali Estuary

Specialist Report for: Tongaat Hulett Developments

Royal HaskoningDHV Reference Number: E02.DUR.000493 Client Reference: DC29/0019/2011

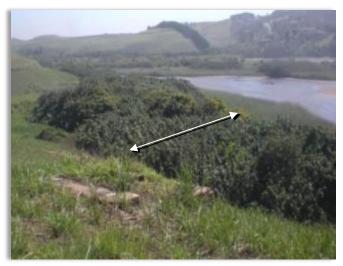
Figure 8. *H. tiliaceous* and *B. racemosa* fringe on the southern bank of the Umhlali Estuary – facing west

There appears to be significant reed encroachment from the southern bank, where extensive reed beds have developed, possibly as a result of silting of the southern channel (Figure 11). *Echinocloa* grass is well established in the upper reaches of the estuary. At the mouth, the sand bar is stabilised by dune pioneer species and grasses, as well coastal dune forest species, such as *Strelizia nicolai, Brachylaena discolour*, and *Mimusops caffra*.

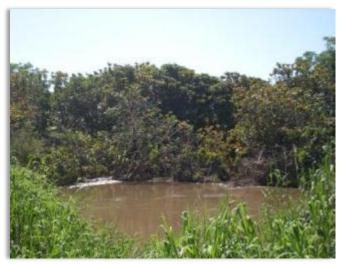
Figure 9. Dense *B. racemosa* swamp forest on the northern channel – facing north west

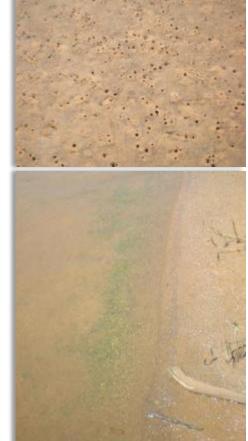
Figure 12. High density occurrence of *C. kraussi* (top) and *T. granifera* (bottom) as green band, in the Umhlali Estuary

Soft-sediment sampling by Forbes & Demetriades (2009) produced a total of 23 taxa dominated by polychaete worms and amphipod crustaceans. The densities of the amphipods increased significantly in the spring season from 3 027 to 40 672 individuals/m<sup>2</sup>. The presence of the polychaete species, *Capitella capitata*, a well-known indicator species of organic pollution, was negligible. The most conspicuous feature of the benthos was the wide distribution of the burrowing prawn, *Callianassa kraussi*, where burrows were visible mainly in the lower and middle reaches. However, the abundance of this species

was not assessed as the burrows extend deeper than that of the surface sampling technique that was used. In addition, the presence of the alien invasive snail, *Tarebia granifera*, was particularly noteworthy. This species reached a maximum density of 10 848 individuals/m<sup>2</sup> in the southern channel (Forbes & Demetriades, 2009). While *T. granifera* is present in numerous estuaries across KwaZulu-Natal (Forbes & Demetriades, 2010; (Meyer, 2011), the exceedingly high abundance in the Umhlali Estuary is cause for concern, as invasive species typically outcompete native species for critical resources, which results in a loss of diversity.

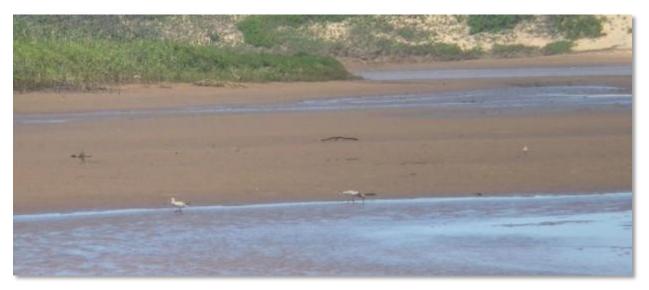
During the 2012 field inspection when the estuary mouth was open, large numbers of birds were also not observed. However, wading bird species including Common Greenshank, Little Egret, and White Fronted Plovers were seen foraging on the exposed sandbanks and in the shallows (Figure 13). Other bird species noted were Spurwing Goose, White breasted Cormorant, Reed Cormorant, Pied Kingfisher, Fish Eagle, and Woolly necked storks.

Figure 13. Common Greenshank seen foraging on the exposed sand banks in the lower reaches of the Umhlali Estuary

The sand/mud banks and swamp forest constitute 8 ha and 7 ha, respectively, however the extent of the sand/mud banks varies depending on the open/closed state of the mouth, river flow and tides during open periods. During exposure, sand/ mud banks become important feeding areas for birds (Figure 13 above). The relative extent of reed and sedge coverage in the Umhlali is noteworthy and arguable attributed to significant sedimentation of the southern

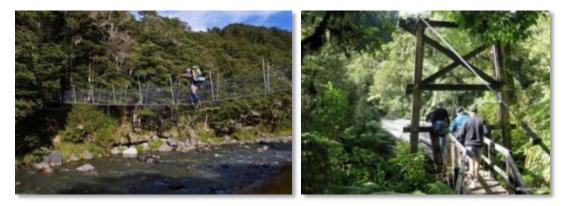
Figure 15. Examples of low impact footbridge options

Further disruption to the flow of the Umhlali Estuary and natural drainage lines should be avoided as much as possible, by limiting new road crossings, infrastructure, boardwalks, bridges or any other structures, which may be required to cross wetlands, streams, tributaries or parts of the estuary itself. If these are deemed necessary, the design must ensure unobstructed/unimpeded flow of water, the least disturbance to sensitive habitats, the shortest span, and that the least harmful materials and methods are used, to ensure minimal impact on the aquatic environment. Limited elevated boardwalks are the preferred design options as they are known to have low environmental impacts (Figure 15).
