**AQUATIC AND WETLAND ECOLOGICAL ASSESSMENT AS
PART OF THE ENVIRONMENTAL AUTHORISATION AND
WATER USE AUTHORISATION PROCESS FOR THE
PROPOSED PONGOLA (MBOZA) RIVER BRIDGE,
KWAZULU-NATAL**

November 2015

Prepared by: Scientific Aquatic Services
Report authors: S. van Staden (Pr. Sci. Nat.)
D. Crafford (Pr. Sci. Nat.)
Report Reference: SAS 215288

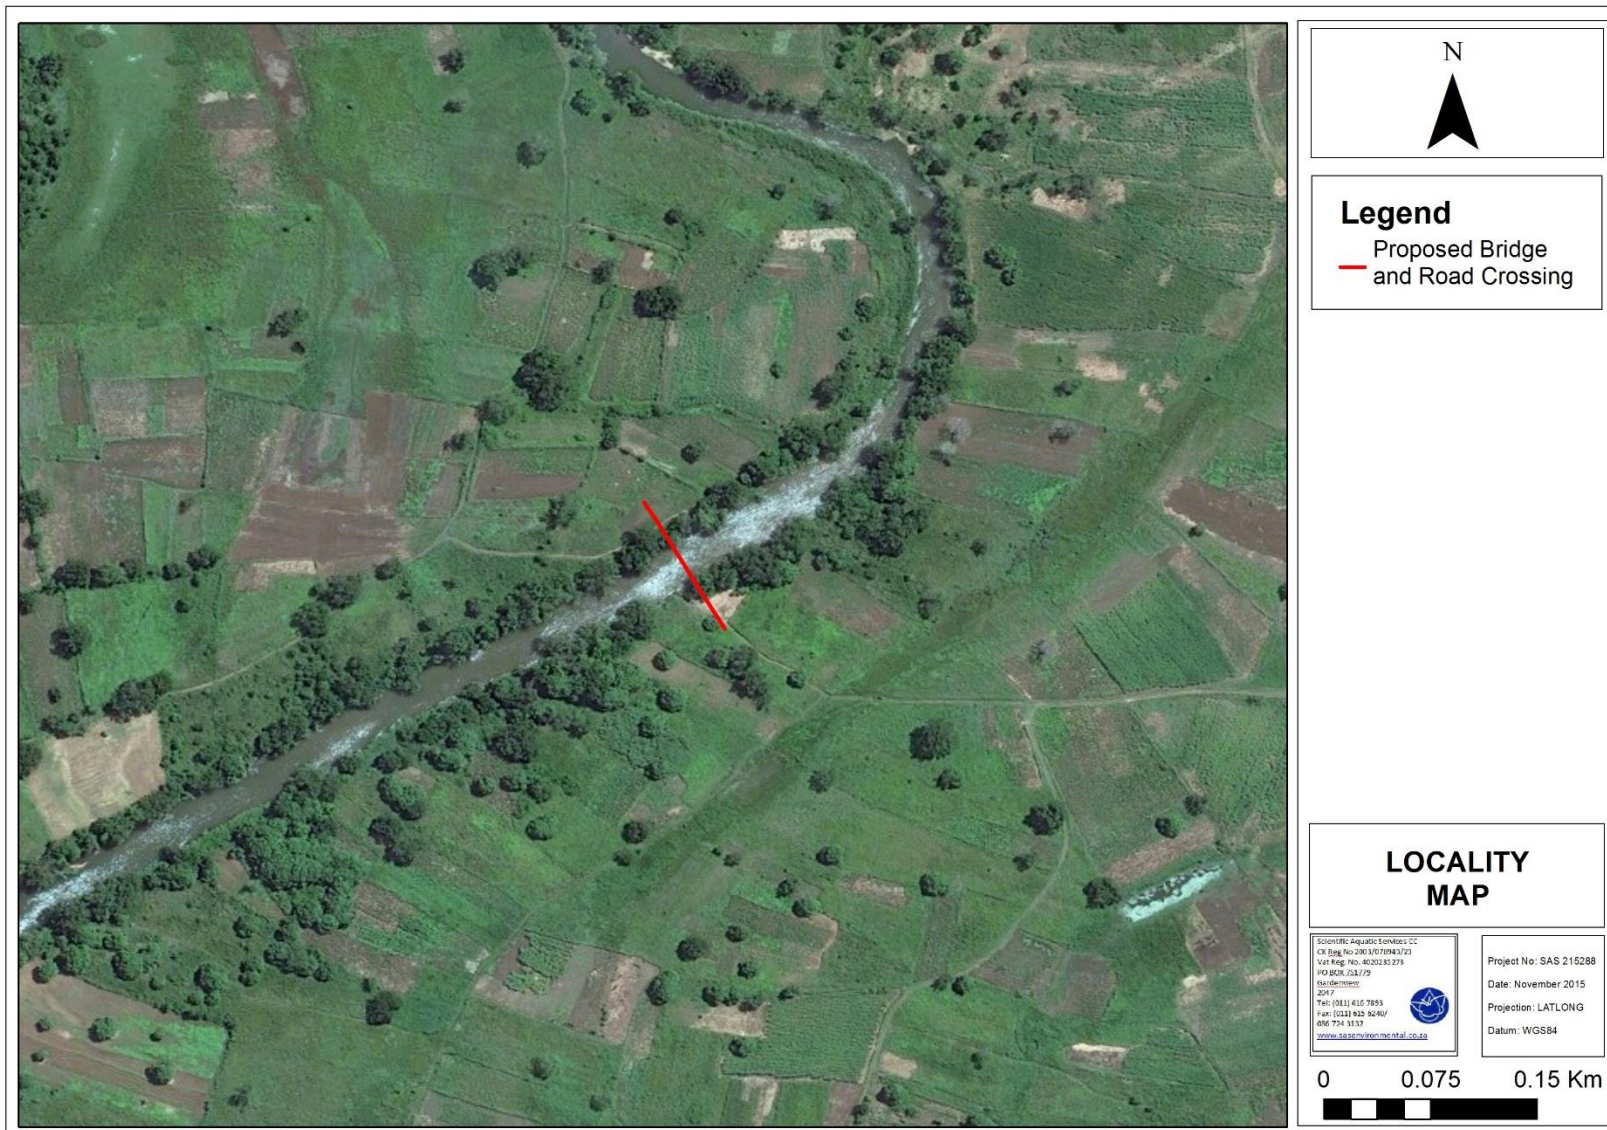
Figure 1: Digital satellite image depicting the location of the proposed bridge and road construction area to the surrounding areas.

Scientific Aquatic Services (SAS) was appointed to conduct a wetland and aquatic assessment as part of the Environmental assessment and authorisation process for the proposed Mboza Bridge Project; hereafter referred to as the “proposed bridge and road crossing” (Figures 1 and 2) A summer (October 2015) assessment was performed.

In order to define the EIS, PEMC and DEMC, a study undertaken by Kleynhans (1999) helped define the quaternary catchment of concern (W45A, refer to Figure 1). The findings by Kleynhans (1999) formed part of a project entitled “A procedure for the determination of the ecological reserve for the purpose of the national water balance model for South African rivers”.

The sections below describe the results obtained for the aquatic ecological integrity of the site based on water quality, instream and riparian habitat condition and biological impacts and integrity. Consideration was given to the position of the aquatic site during selection in order to assist in defining the PES and any impacts in this area. The aquatic assessment results are presented below and cover the aquatic resources in the vicinity of the proposed bridge construction area (refer to Figures 1 and 2).

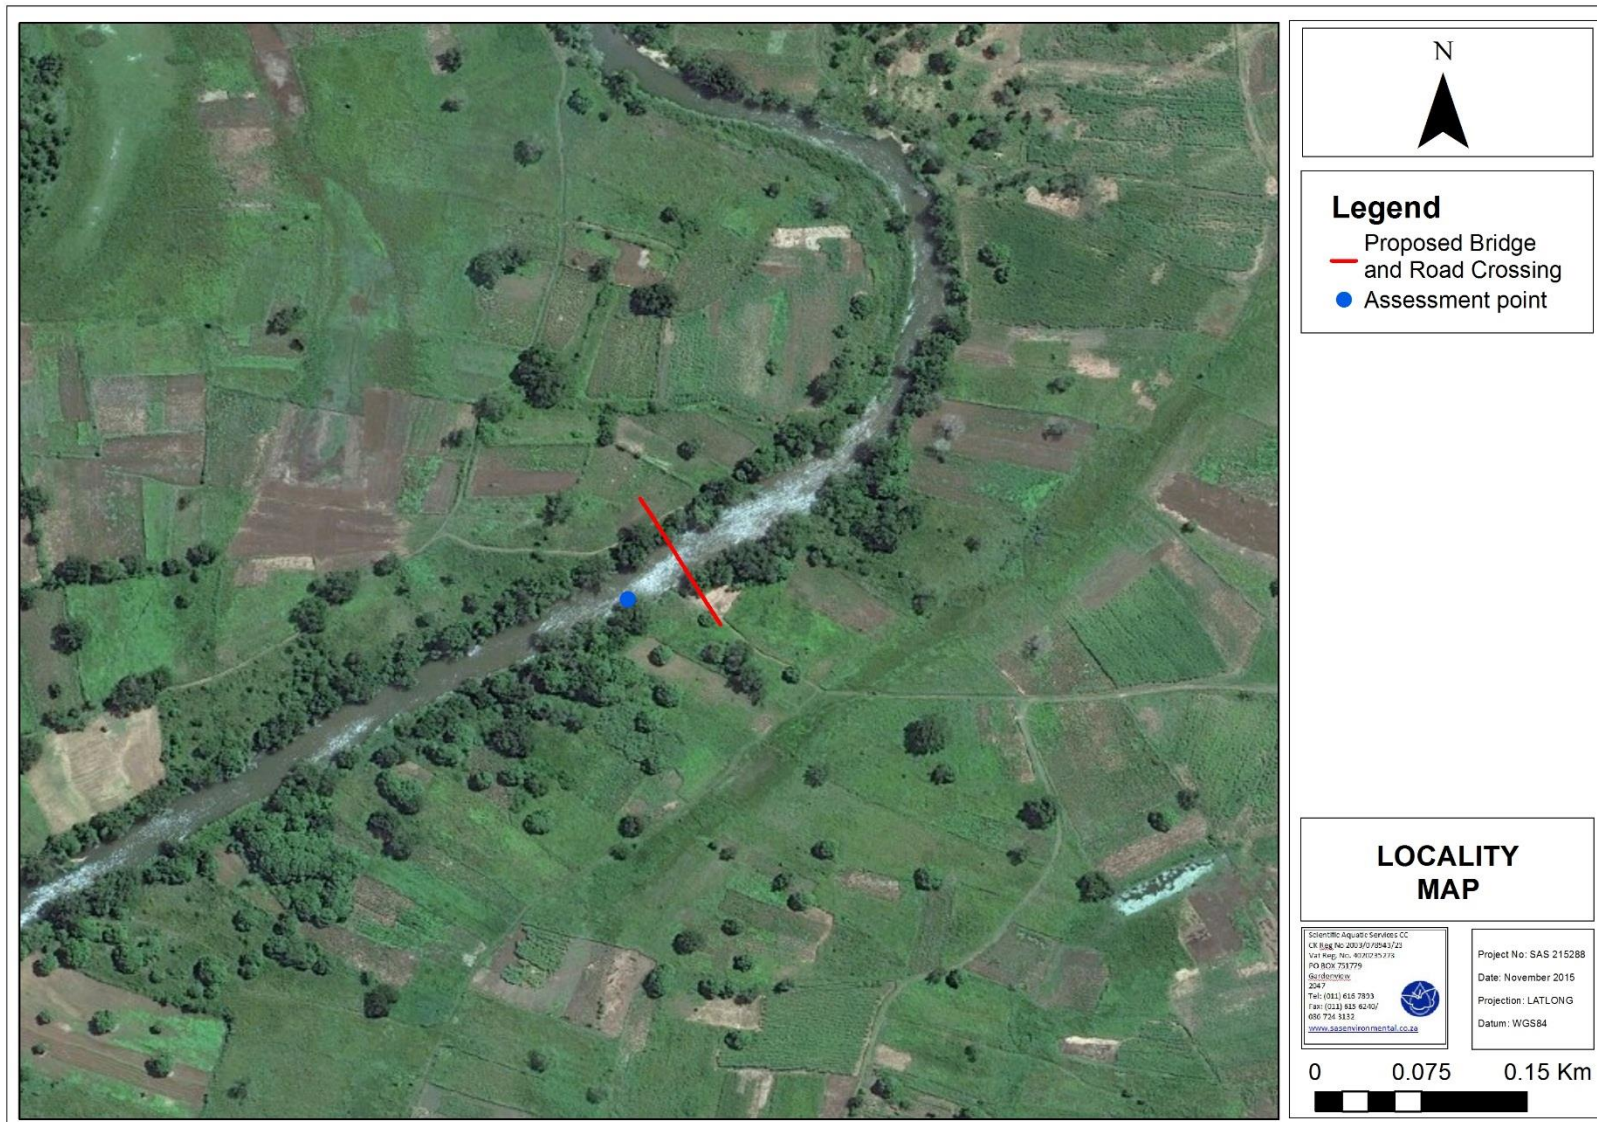
Site	Description	GPS co-ordinates	
		South	East
Mboza 1	Site on the Pongola River at the proposed river crossing (bridge construction site).	27°11'16.67"S	32°14'21.52"E

Figure 3: Aquatic ecological assessment point presented on a digital satellite image

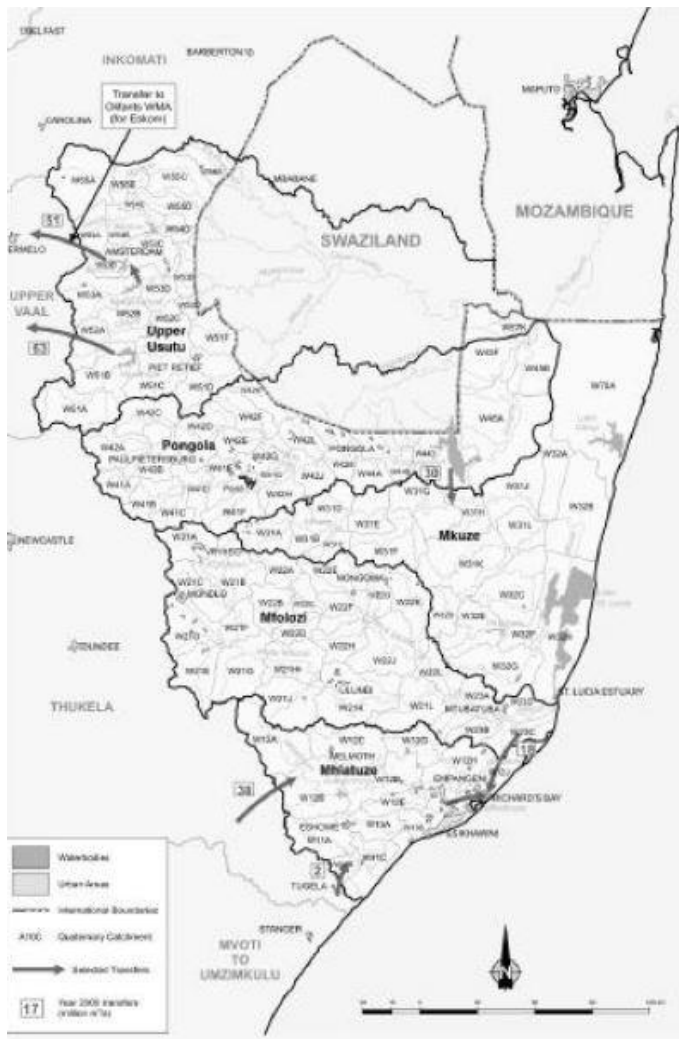
Figure 6: Base map of the Usutu to Mhlathuze Water Management Area (WMA). Source: Department of Water and Sanitation, previously Department of Water Affairs and Forestry (2004) National water resource strategy, Appendix D.

Water resources have been well developed in the Upper Usutu, Mkuze and Mhlatuze catchments. However, undeveloped potential exists in the Pongola and Mfolozi catchments. Ground water utilisation in most parts of the water management area is relatively limited and can be developed further. Strong interdependencies between surface and groundwater occur in many areas, with groundwater levels, together with surface flows, being particularly important to water balances in the ecologically sensitive coastal lakes and wetlands, some of which are internationally recognised conservation areas.

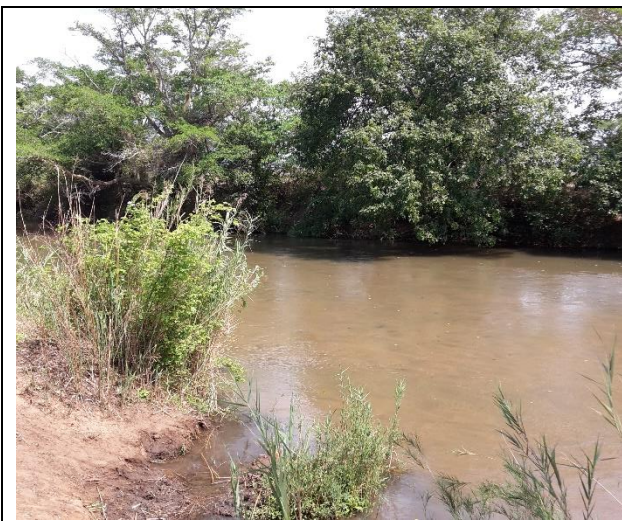
Figure 15: Upstream view of the Mboza 1 site indicating low flows at the time of assessment (October 2015)

SITE	Mboza 1 (Pongola River)
Braiding of the system	At this point the system mostly consists of one moderately flowing channel, which under low flows consists of largely laminar flow. Under higher flows an increase in turbulence can be expected.
Riparian zone characteristics	The riparian zone is narrow and the adjacent floodplain has been severely disturbed through tillage and agricultural activities. Some impact on the understorey from alien vegetation encroachment has occurred while the woody component is more intact. The riparian vegetation is in a fair condition.
Algal presence	No excessive algal proliferation was evident.
Visual indication of an impact on aquatic fauna	No visual evidence of significant impacts on the aquatic ecology of the system is deemed likely, beyond impacts on the understorey of the riparian zone.
Depth characteristics	The river at this point consists of shallow glides with depth varying, on average, between 10cm to 50cm deep under low flow conditions. In the area below the proposed crossing point the river consists of slightly deeper pools.

Flow condition	The river at this point is generally moderately flowing with faster flowing sections on bends and slower flow in the deeper pools.
Water clarity	Water was clear at the time of assessment
Water odour	None
Erosion potential	Under high flow conditions the system will erode rapidly due to the fast flow of the water and the fairly unstable sandy nature of the riparian zone. However deposition of sediments from further upstream ensures a dynamic equilibrium in the system. Some impacts on the hydrology of the system due to impacts of the upstream Jozini impoundment are deemed likely.

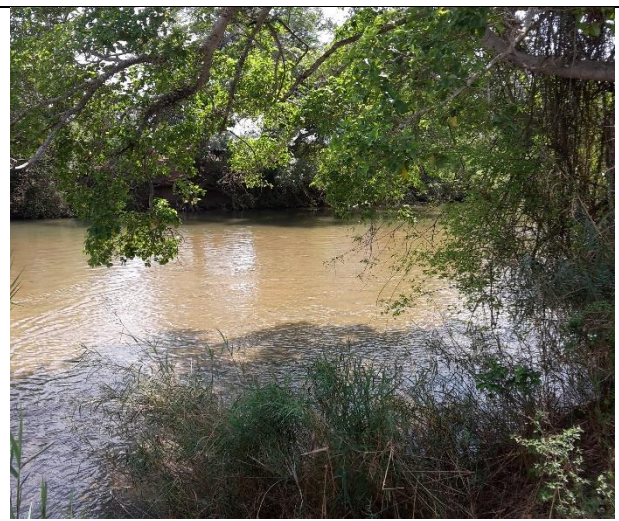
Figure 16: Downstream view of the Mboza 1 site (October 2015)

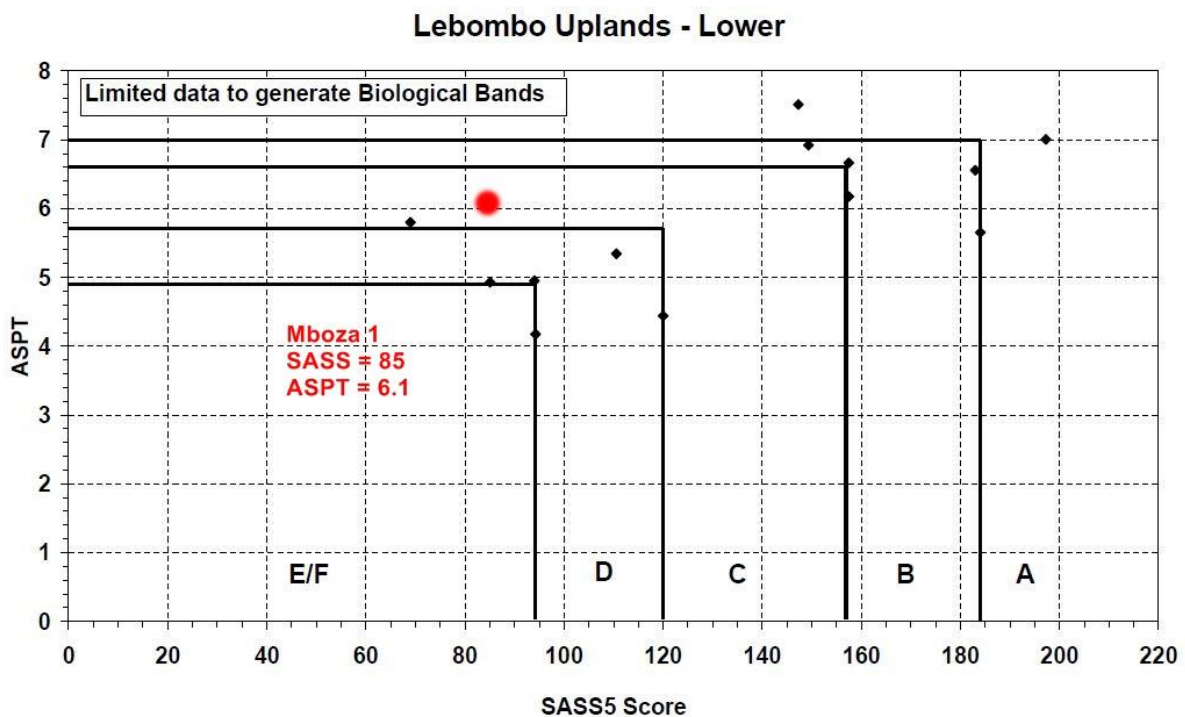
Figure 17: Scatterplot of historical SASS data (black) and data from the summer (October 2015) assessment (Dallas 2007)

- SASS scores indicated Category D (largely impaired) conditions at site Mboza 1 according to the Dickens and Graham (2001) classification system;
- According to the Dallas (2007) classification system, a Category C (moderately impaired) classification was obtained for site Mboza 1;

- The apparent discrepancy in results obtained for site Mboza 1 is due to the Dallas (2007) classification system being more sensitive to changes in ASPT compared to the Dickens and Graham (2001) classification system. It must also be noted that no data for the local aquatic region was available for the Dallas (2007) system and the adjacent most applicable ecoregion data was used for interpretation. For the purpose of this assessment both classification systems are deemed relevant.

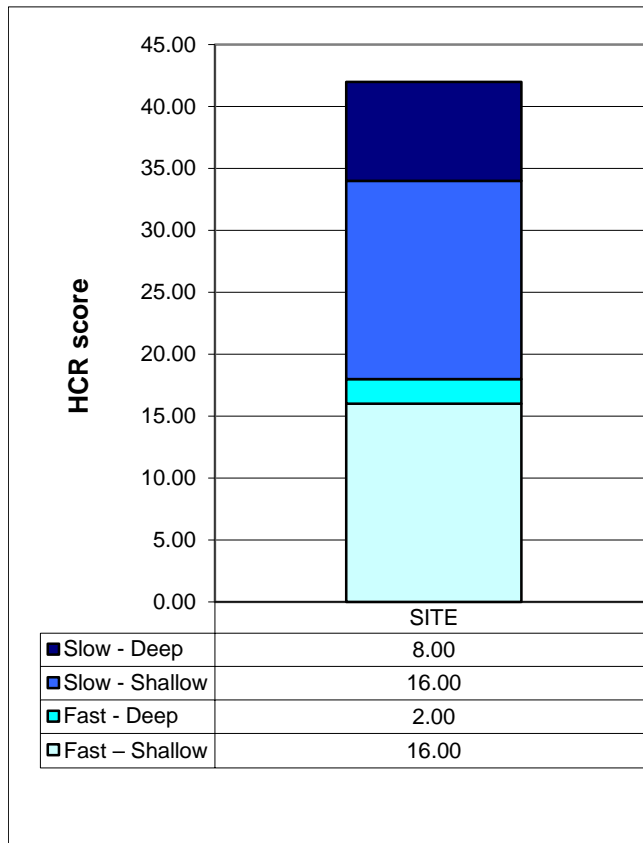
Figure 18: HCR scores for the Pongola River at site Mboza 1

It is clear that under low flows resulting in shallow conditions, a combination of slow and fast flows dominate the system. Cover feature availability is limited, with fish demonstrating a preference for deep conditions, rocky substrate or dense vegetation cover expected not to occur at the proposed crossing point.

The **HCR (Habitat Cover Rating)** results indicate that, under low flows resulting in shallow conditions, a combination of slow and fast flows dominate the system.

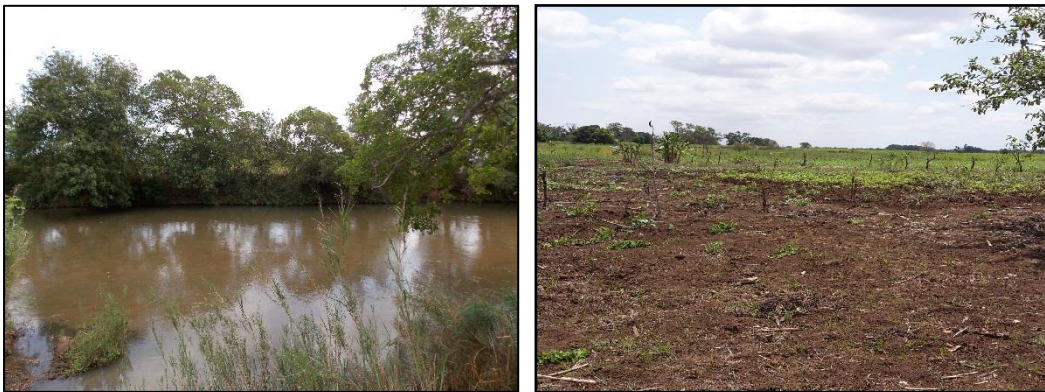
cocklebur). Although transformation of the wetland vegetation has occurred, the Pongola River is still considered to be of importance in terms of the provision of an ecological corridor through a largely transformed area. Furthermore, the system is likely to provide important ecosystem services and function and may provide the habitat to support an increased abundance of fish species. Being classified by the NFEPA database (2011) as a RAMSAR wetland as well as a WETFEPAs with particular importance in being located within 500m of a threatened waterbird point locality, the wetland plays an important role in delivering ecosystem services, despite being in a moderately degraded condition.

Figure 19: The Pongola River (left) and the cultivated crop lands associated with the floodplain wetland (right).

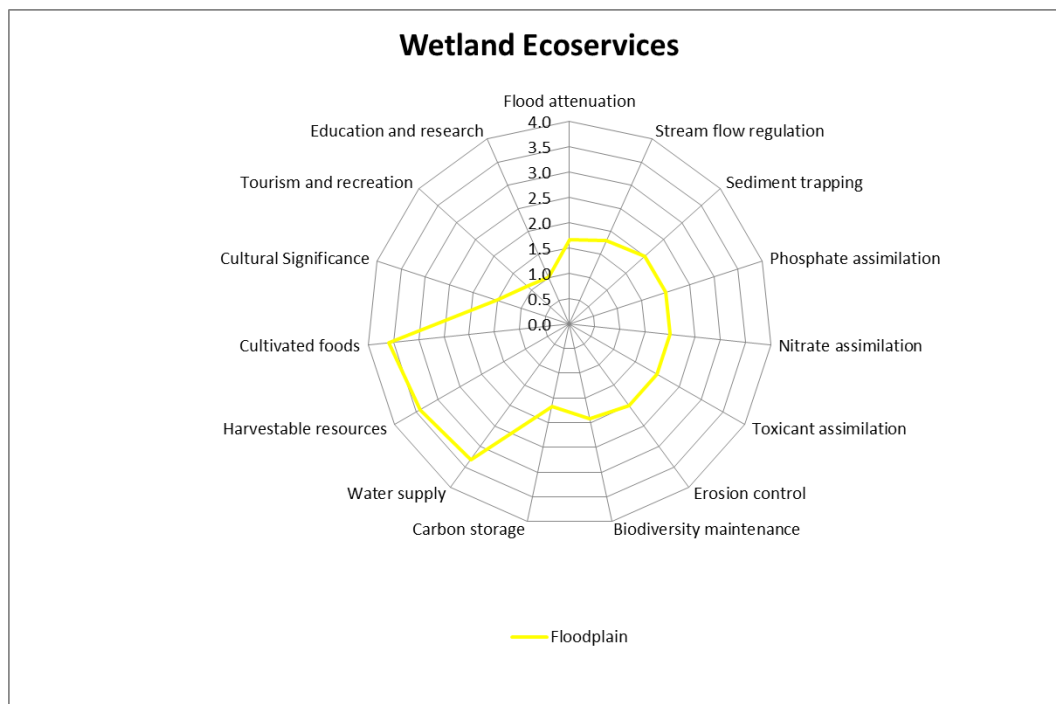
Ecosystem service	Floodplain wetland
Flood attenuation	1.7
Streamflow regulation	1.8
Sediment trapping	2.4
Phosphate assimilation	2.0
Nitrate assimilation	2.0
Toxicant assimilation	2.0
Erosion control	2.1
Biodiversity maintenance	1.9
Carbon Storage	1.7
Water Supply	3.3
Harvestable resources	3.4
Cultivated foods	3.6
Cultural significance	1.5
Tourism and recreation	1.1
Education and research	1.0
SUM	31.5
Average score	2.1

Figure 20: Radar plot of wetland services provided by the features associated with the proposed bridge infrastructure.

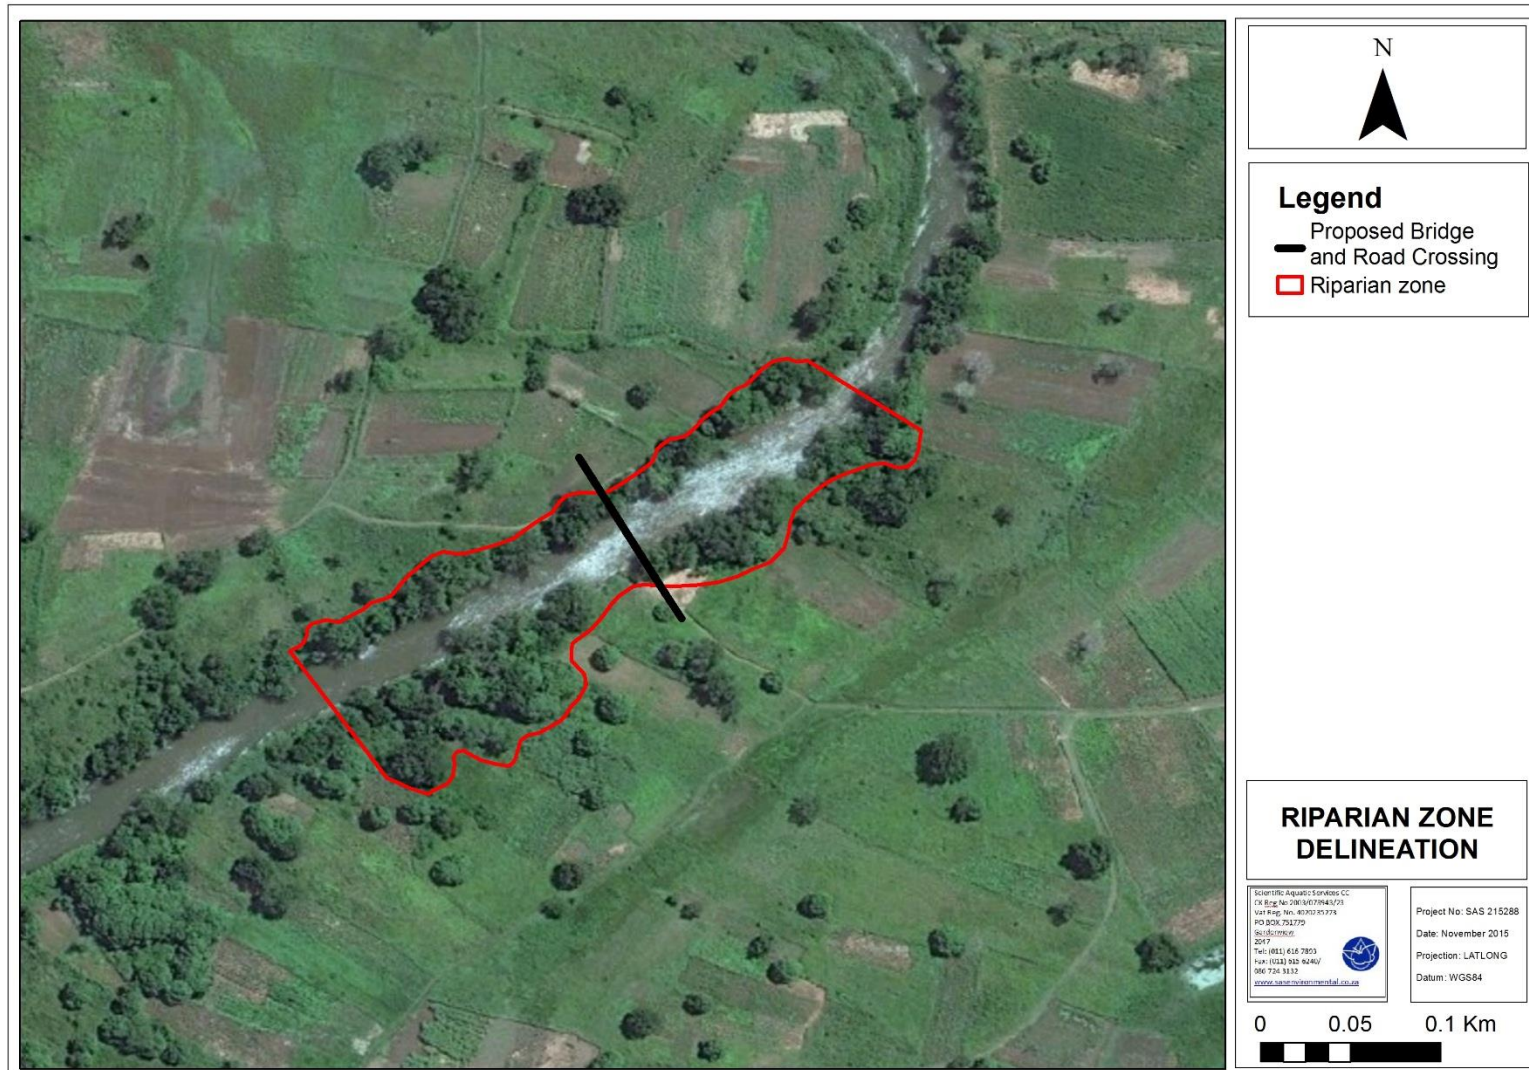
Figure 21: Riparian zone delineation of the area immediately surrounding the proposed bridge infrastructure site.

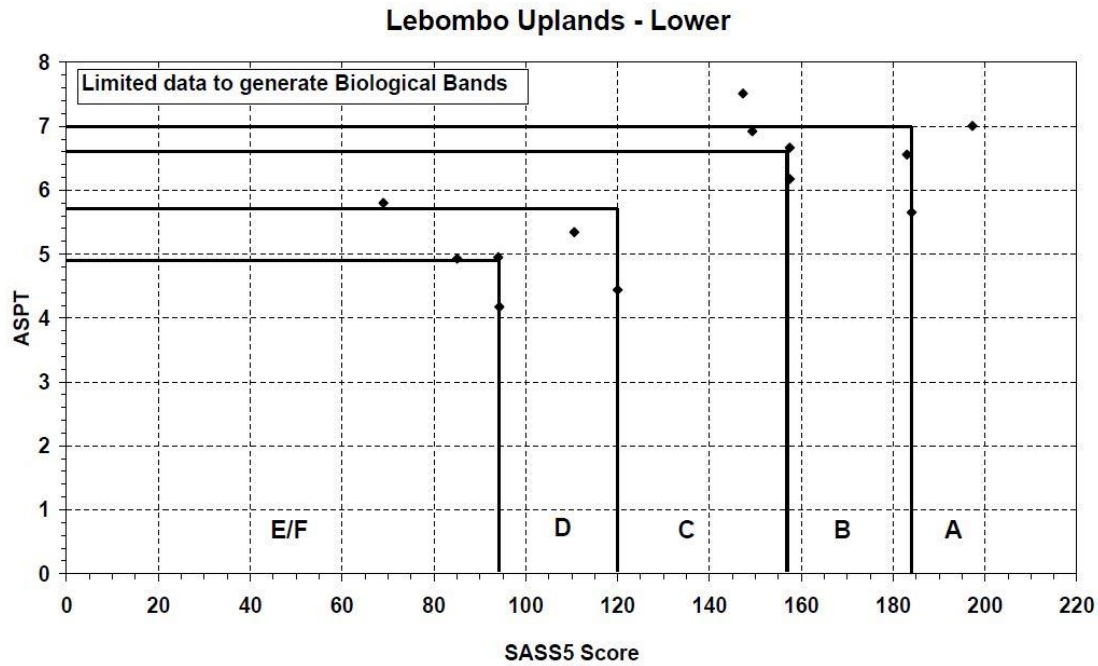
reference conditions were obtained from Dallas (2007), as presented in the figure below. Reference conditions are stated as a SASS score of 185 and an ASPT score of 7.0. Sites were classified according to the classification system for the Lebombo Uplands Lower aquatic ecoregion according to Dallas (2007) since no information for the Lowveld uplands is available, as well as the classification system of Dickens & Graham 2001.

Figure 23: SASS5 Classification using biological bands calculated form percentiles for the Lowveld Lower Ecoregion, Dallas, 2007
