Appendix J: Surface Water (Wetlands)

ENVIRONMENTAL IMPACT ASSESSMENT FOR THE PROPOSED CONTINUOUS ASH DISPOSAL FACILITY FOR THE MATIMBAPOWER STATION IN LEPHALALE, LIMPOPO PROVINCE

Proposed Continuous Ash Disposal Facility for the Matimba Power Station, Limpopo Province EIR Phase Surface Water Impact Assessment Study

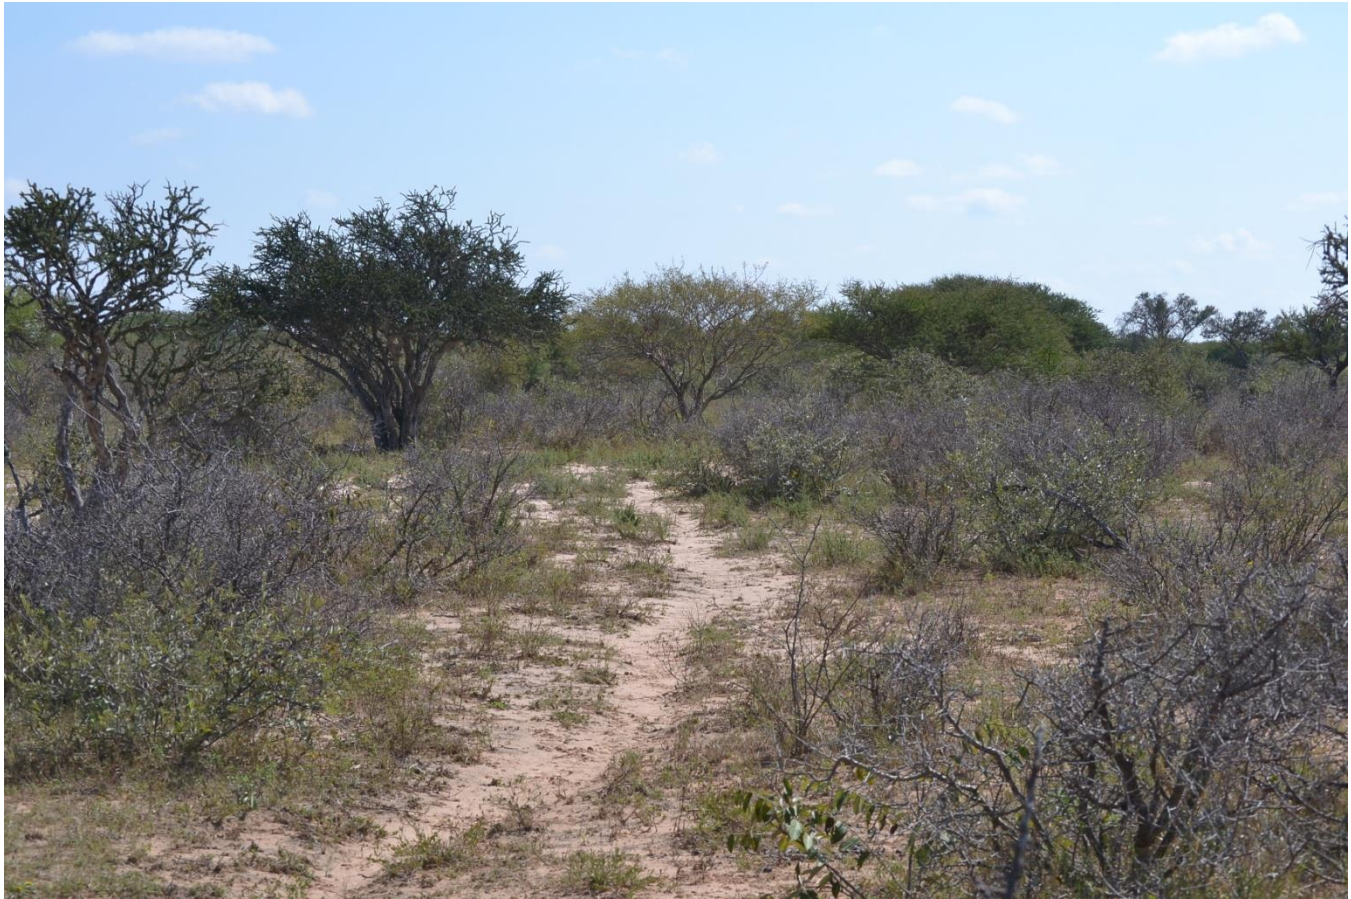
Figure 4 – Very shallow flow depression within the northern riparian corridor of the Alternative 2 Site

A number of small pan-like depressions were encountered along these ephemeral drainage lines, particularly along the drainage line on the Alternative 2 site. These depressions occurred in the context of a very flat gradient, and are areas of collection of surface water flow along the drainage system. The flat gradient in which these drainage lines occur is believed to account for the indistinct hydromorphological definition of the drainage lines. The formation of these depressions may be related to the formative processes in pans discussed above, as these depressions typically consist of clayey substrate that becomes 'sticky' and muddy when wet.

In certain reaches of the drainage lines assessed a reach downstream of an upstream reach that displayed a channel became very indistinct, being difficult to distinguish from the surrounding woodland. Thus these drainage systems appear to vary between slightly more hydromorphologically defined reaches in areas of slightly increased slope to areas where there appears to be no defined channel, with only a change in vegetation structure indicating a surface water or drainage feature.

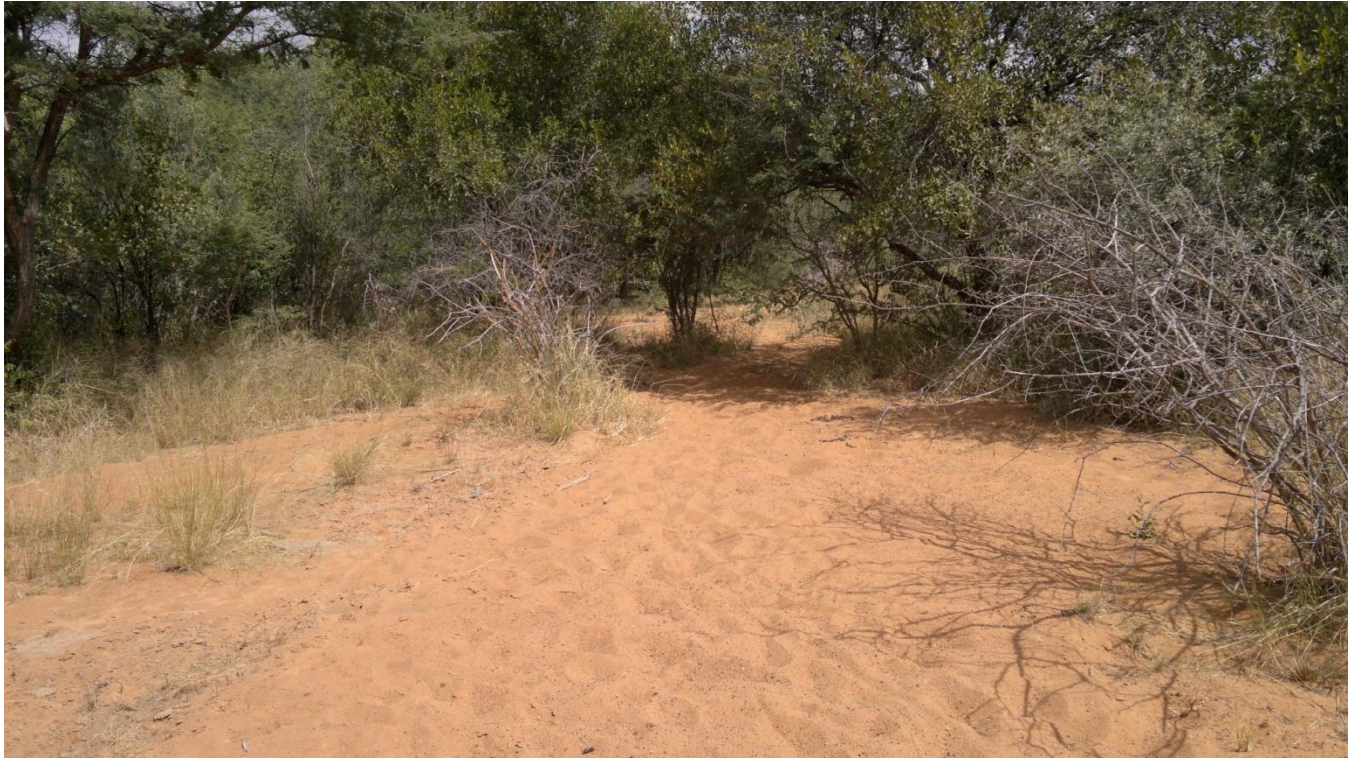
Figure 5 – Alluvial material with a very indistinct area of flow

The drainage line as indicated in the south-western corner of the site displayed more distinct hydromorphological characteristics that identified it as a watercourse, albeit without an incised channel or other very distinctive morphological features. The primary hydromorphological feature noted was a very shallow channel (more akin to a very shallow depression) or open area of sandy, alluvially transported sediment as is commonly encountered within ephemeral drainage systems. In one location along the reach a small depression or wallow was encountered. This area consisted of highly gleyed clayey soils that displayed hydromorphic characteristics in terms of the reduced matrix and the presence of small iron mottles. It is thus clear that this small localised area of clayey soils is seasonally inundated (it was dry at the time of the assessment), with sufficient periods of inundation to enable the development of hydromorphic soils, albeit in a very localised area. The 'channel bed' was typically 3-5m in width and was flanked by thick vegetation, comprising mainly of shrubs and some trees, forming a thicket-like cover. At a certain point just outside of the development site the drainage line had been dammed. The channel immediately downstream of the dam was most pronounced with the presence of cobbles in the channel bed and evidence of flow-deposited wrack on the margins of the channel.

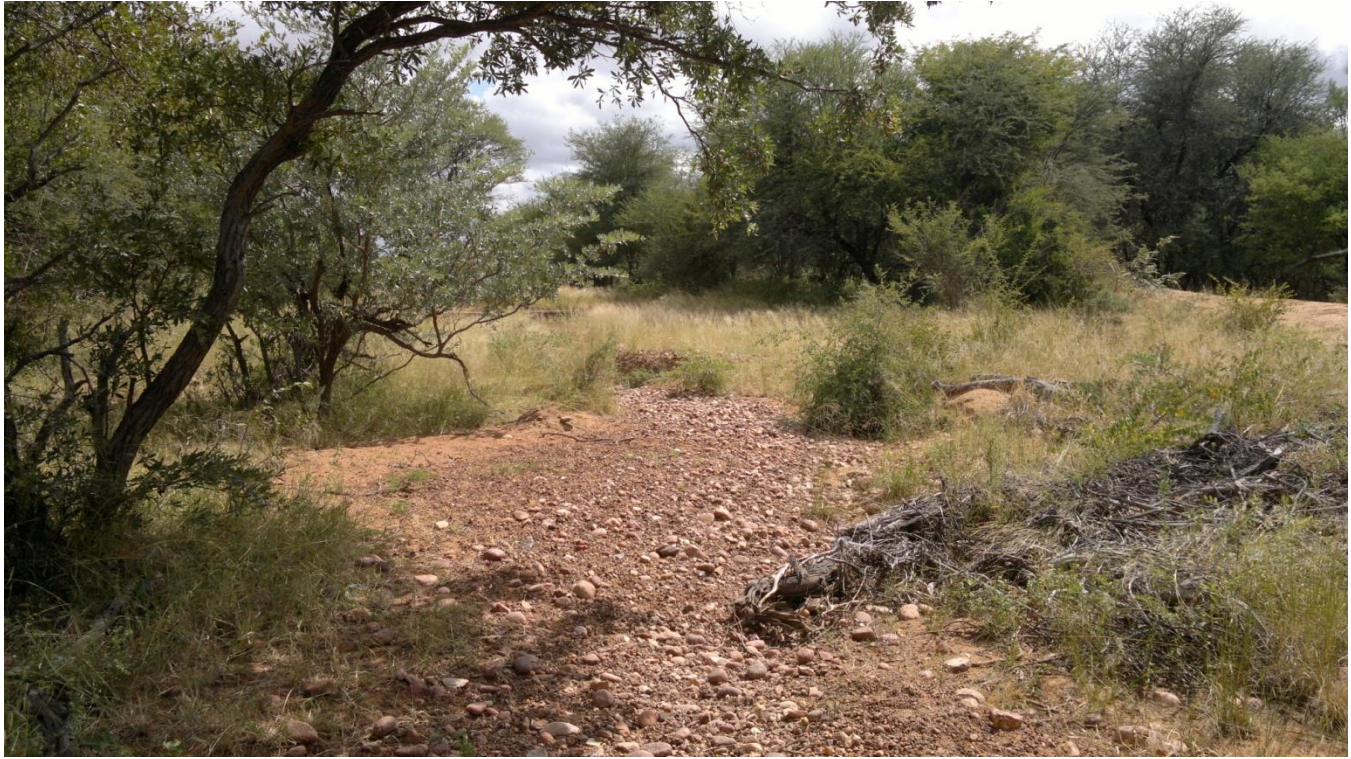
Figure 6 – Channel with alluvial material and flow wrack downstream of the dam

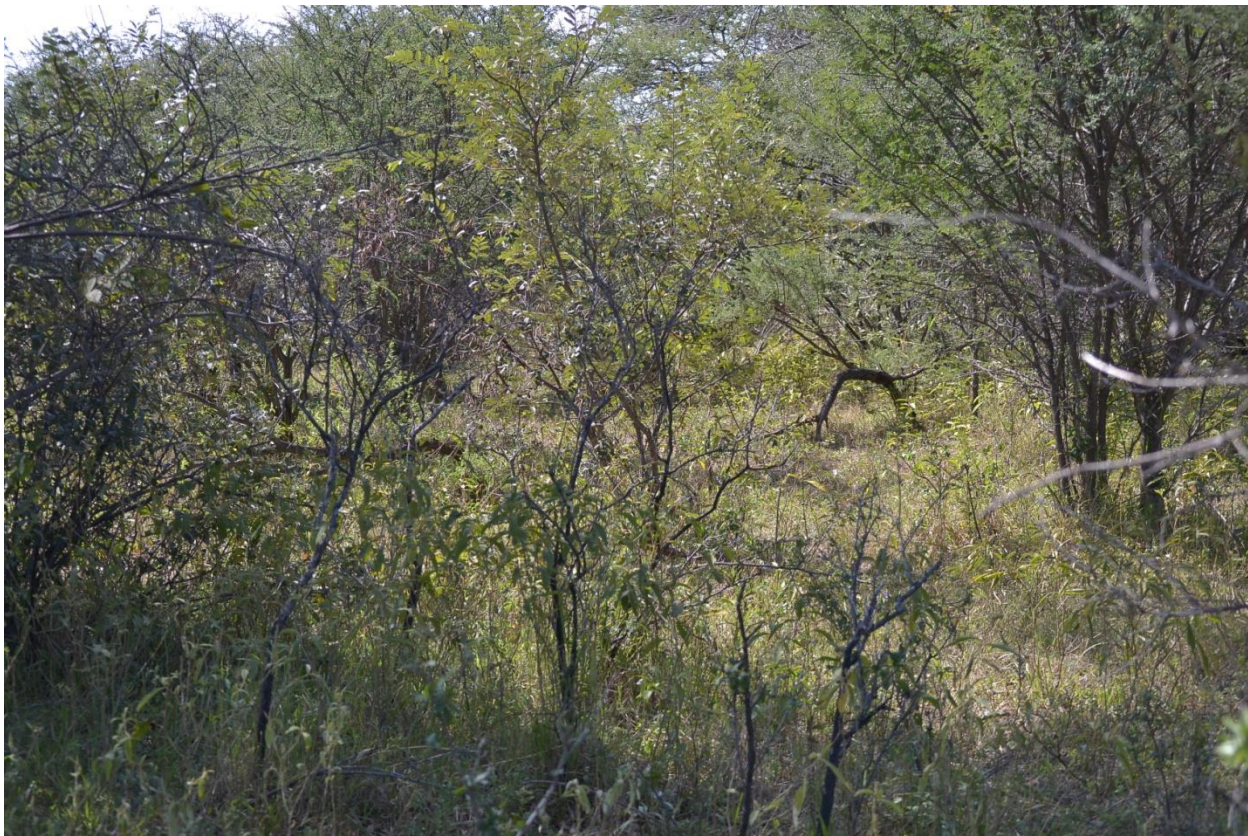
Figure 11 – Lush growth within the understory of the riparian corridor

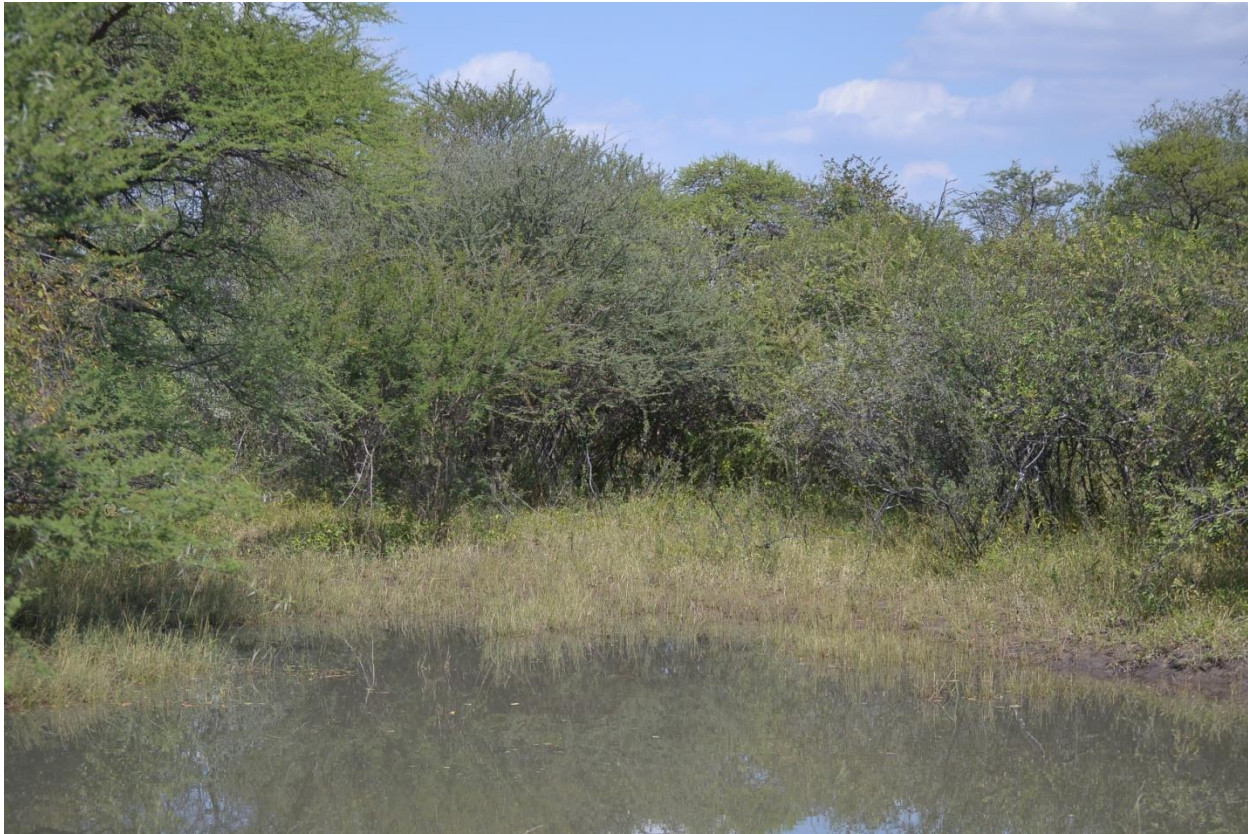
Figure 12 – Water-filled depression and flanking thicket vegetation along the western drainage line

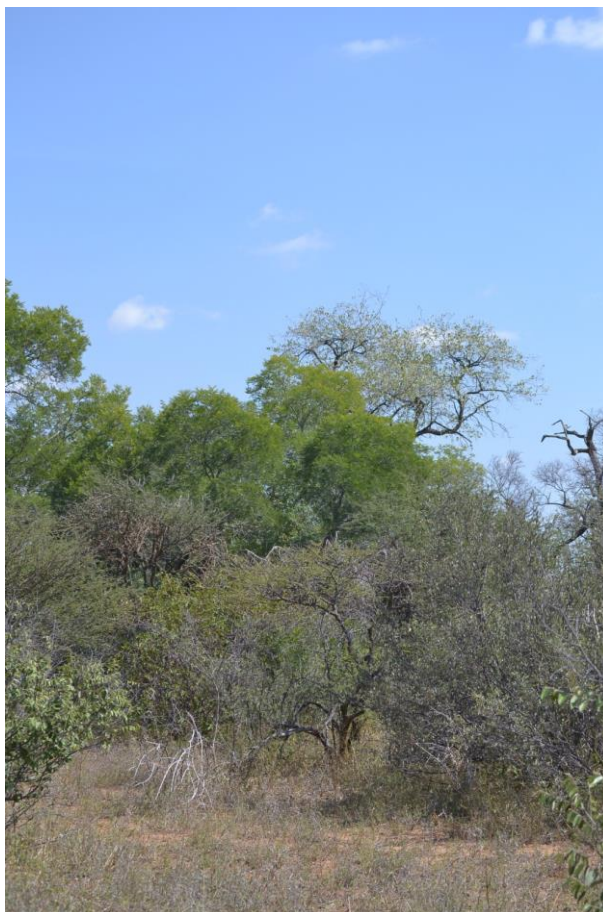
Figure 13 – Tall trees and shrubs within the riparian corridor along the western drainage line

Vegetatively the main difference between the two drainage lines was that tall trees were only encountered along a stretch of the western drainage line. In this part of the site, the riparian corridor was very distinct and differed markedly from the surrounding non-riparian woodland. Along the western drainage line close to the western boundary of the site, a linear arrangement of tall indigenous trees species was noted. These species included large specimens of *Combretum imberbe* as well as *Ziziphus mucronata*, *Combretum hereroense*, *Acacia erubescens* and *Peltophorum africanum*. The understorey of this area comprised of shrubs and a luxuriant grass cover (comprising mainly of the species *Panicum maximum*) indicating a high degree of moisture availability. A small water-filled depression was located within this stretch. The width of this riparian corridor is approximately 30-40m in width. Coverage by woody vegetation was not complete, being about 50% as viewed aerially. Interestingly the taller trees did not extend along the entire reach of the western drainage line assessed on the site, and this distinct riparian corridor 'dissipated' downstream (closer to the confluence within the northern drainage line). Analysis of the riparian aerial photography (see **Figure 15**) reveals a widened riparian zone (as characterised by the presence of larger trees) in the areas where the two drainage lines meet, reflecting a wider area of increased moisture availability.

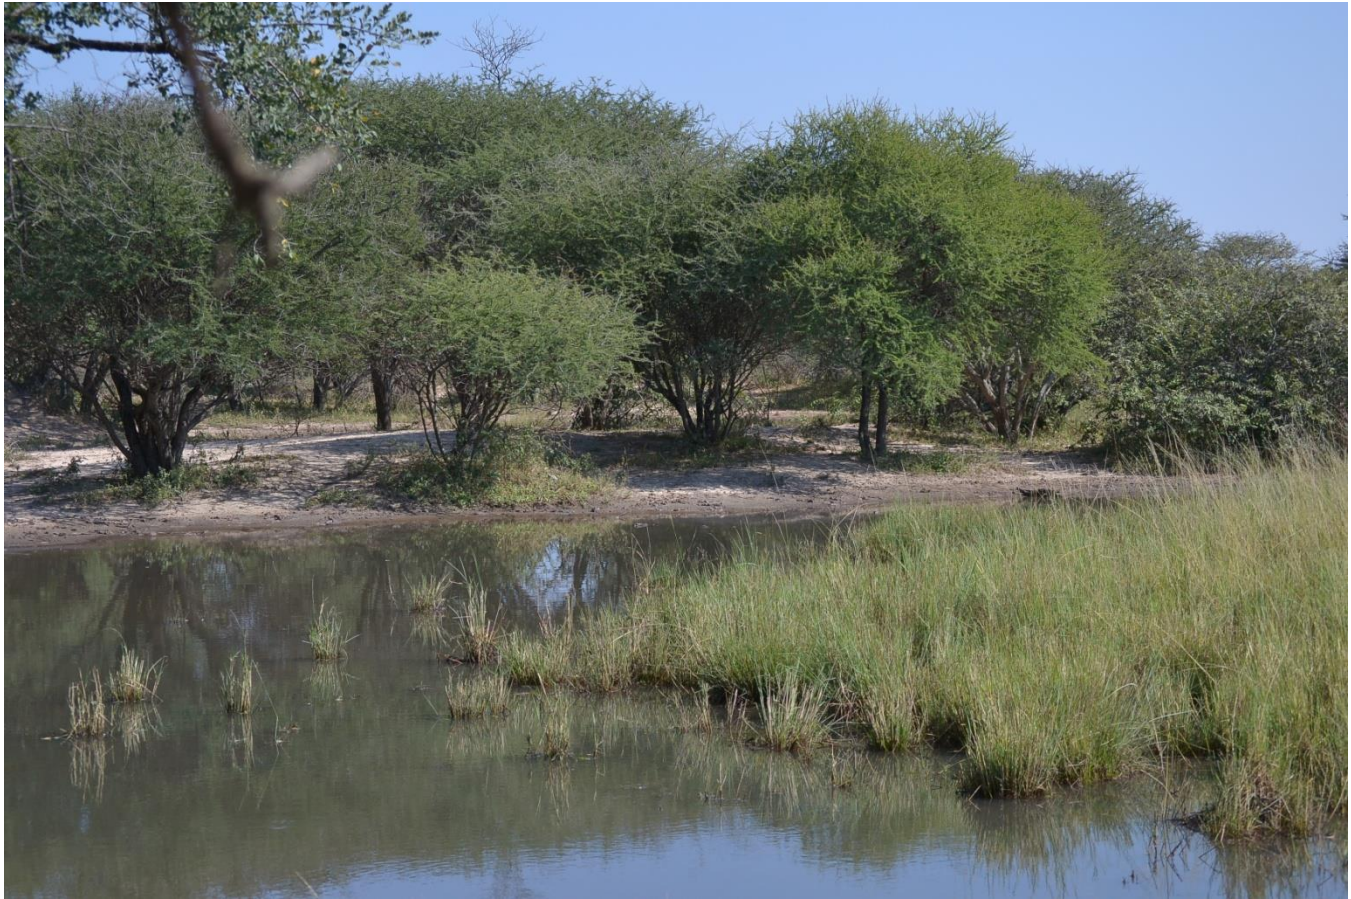
Figure 14 – Pan-like depression on the northern drainage line with *Arundinella nepalensis* marginal vegetation

As described above, 'typical' marginal vegetation only occurred in very limited parts of the riparian zone on the margins of the two pan-like depressions. This was comprised predominantly of the grass *Eragrostis inamoena* as well as the obligate wetland grass species *Arundinella nepalensis* in flooded areas. This species is listed as a facultative wetland species in the context of the eastern seaboard on South Africa (Kotze and Marneweck, 1999), but in this much more arid context is highly likely to be an obligate hydrophyte. The presence of this hydrophyte in these locations corresponds with the confirmed presence of hydric soils as discussed below.

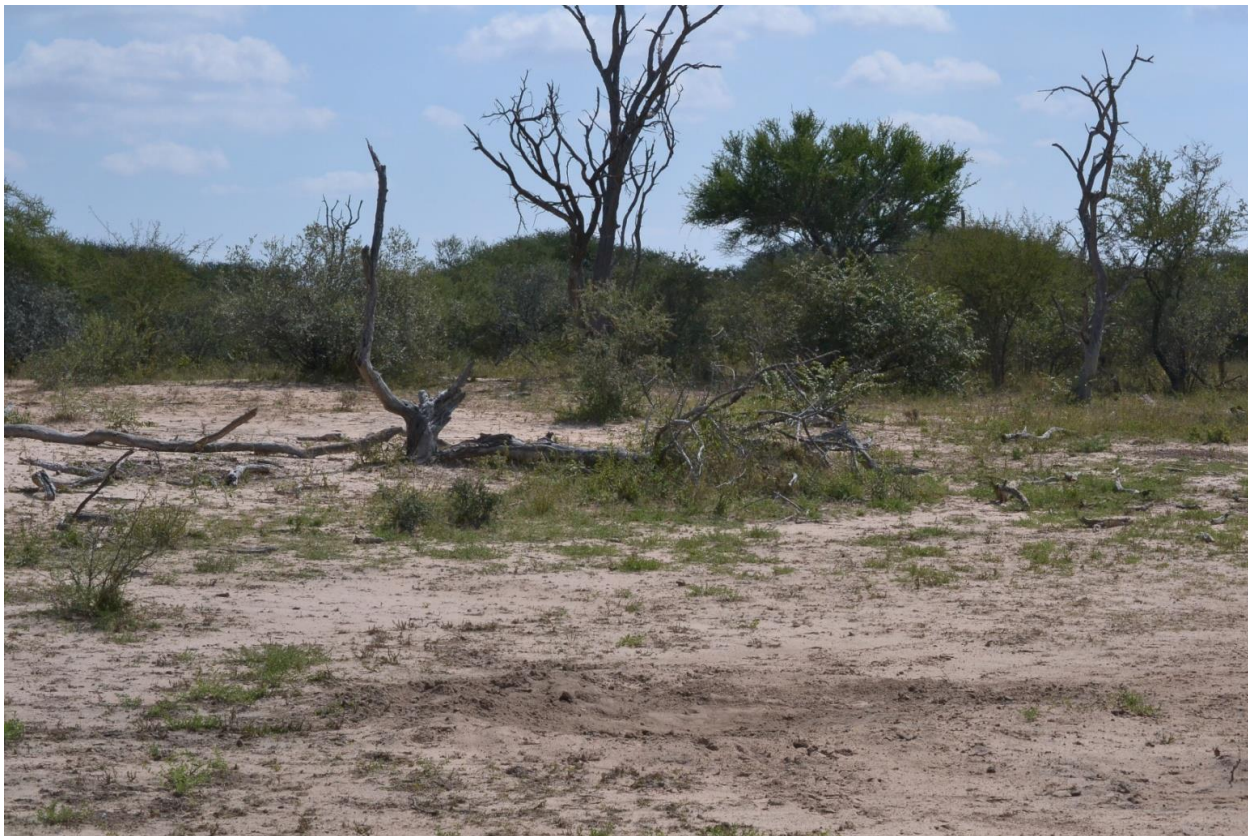
Figure 16 – Sodic area on the peripheries of the riparian corridor of the western drainage line

These areas of bleached white soils showed many affinities to classical sodic sites as commonly occur within the Lowveld of Limpopo and Mpumalanga, and were noted to have a structured (encrusted) upper layer. Sodic sites typically occur at the foot of the catena (the landscape setting in which they occur on the site), where colluvial processes ensure the accumulation of deflocculated clays as well as salts. Sodic areas typically occur at the interface of the footslopes with bottomlands in which riparian zones are located. The presence of sodium and the reaction between this sodium and clays in these areas accounts for the susceptibility of these areas to erosion and sodic site formation. Duplex soils typically occur in these areas; the distinctly layered profiles typically have highly impermeable B horizons that allow the formation of seasonally perched water tables at the A/B horizon interface (Chappell, 1992). Sodic sites are erosion features that represent the loss of the entire A horizon, thus exposing the underlying clayey B soils. Sodic areas take on a bleached white appearance, due to a thin veneer of coarse quartz clasts overlying the darker clays that represents the remnants of the now eroded topsoil (Chappell, 1992). These sodic areas typically occur roughly parallel to the course of drainage lines, with an intervening band of riparian vegetation. This pattern is present on the site, with a clear zone of bleached white soils occurring between the riparian zone of the western drainage line and the edge of the footslopes to the north. In conditions where no overgrazing has occurred, there is typically a dense grass cover, however the high level of accumulation of sodium within the leaves attracts certain grazing herbivores, to the extent to that they tend be highly overgrazed, destroying the grass cover and initiating sodic site formation. Shallow surface depressions over impervious clays tend to form wallows and attract many types of animals. Such depressions were found on the site, both in the form of shallow, dry depressions or the larger water-filled depressions.

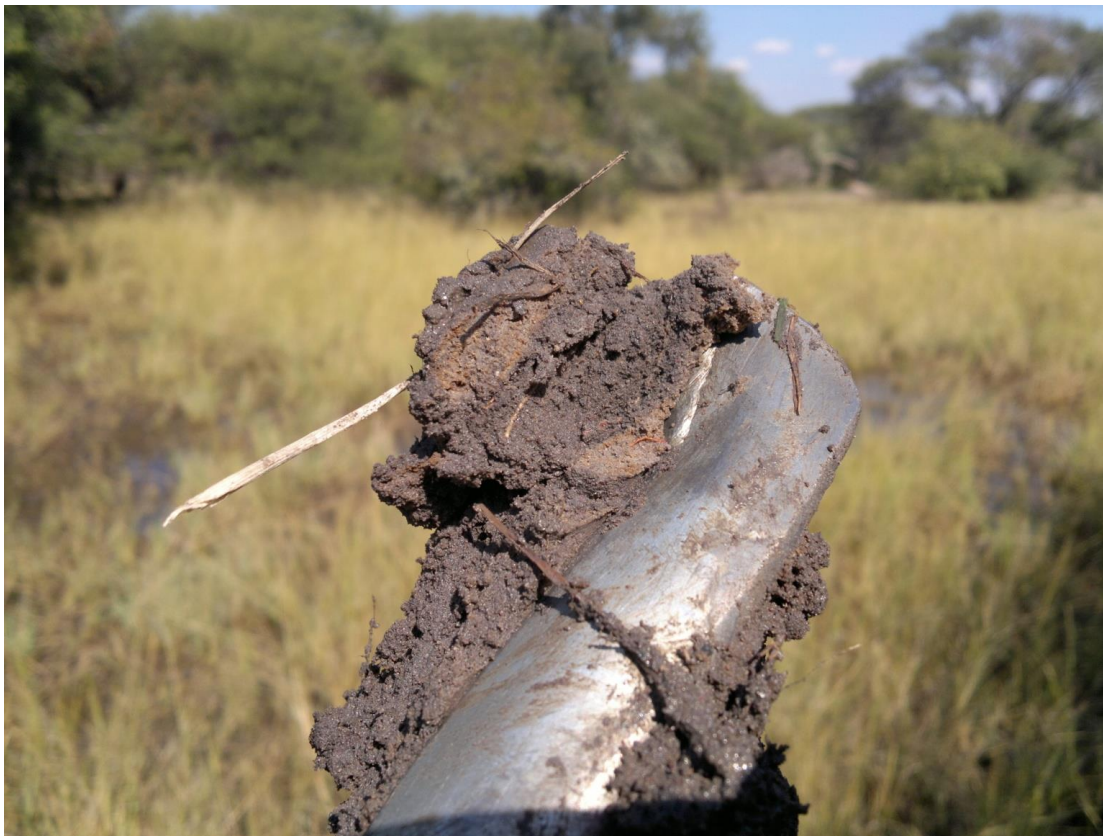
Figure 17 – Redox depletions within soils in the pan-like depression along the northern drainage line

Soils in the larger pan-like depression were sampled to determine the presence of hydromorphy. The upper-most profile consisted of an Orthic A horizon to c40-50cm, being grey-brown at the surface grading down to a more gleyed interface with the B. Redoximorphic features in the form of iron mottles along with alternating patterns of redox depletions alongside iron mottles - a typical indication of repeated wetting and drying and associated development of anaerobic soil conditions and subsequent re-oxidation of the soils were present. The redoximorphic features only extended to c50cm below ground level, thus the zone of seasonal wetting and drying appears to only be associated with the presence of inundation by surface water inflows in the A horizon. Brown clays comprised the underlying B horizon. This vertical pattern is typical of the foot of the catena in areas prone to sodic area development as described above.

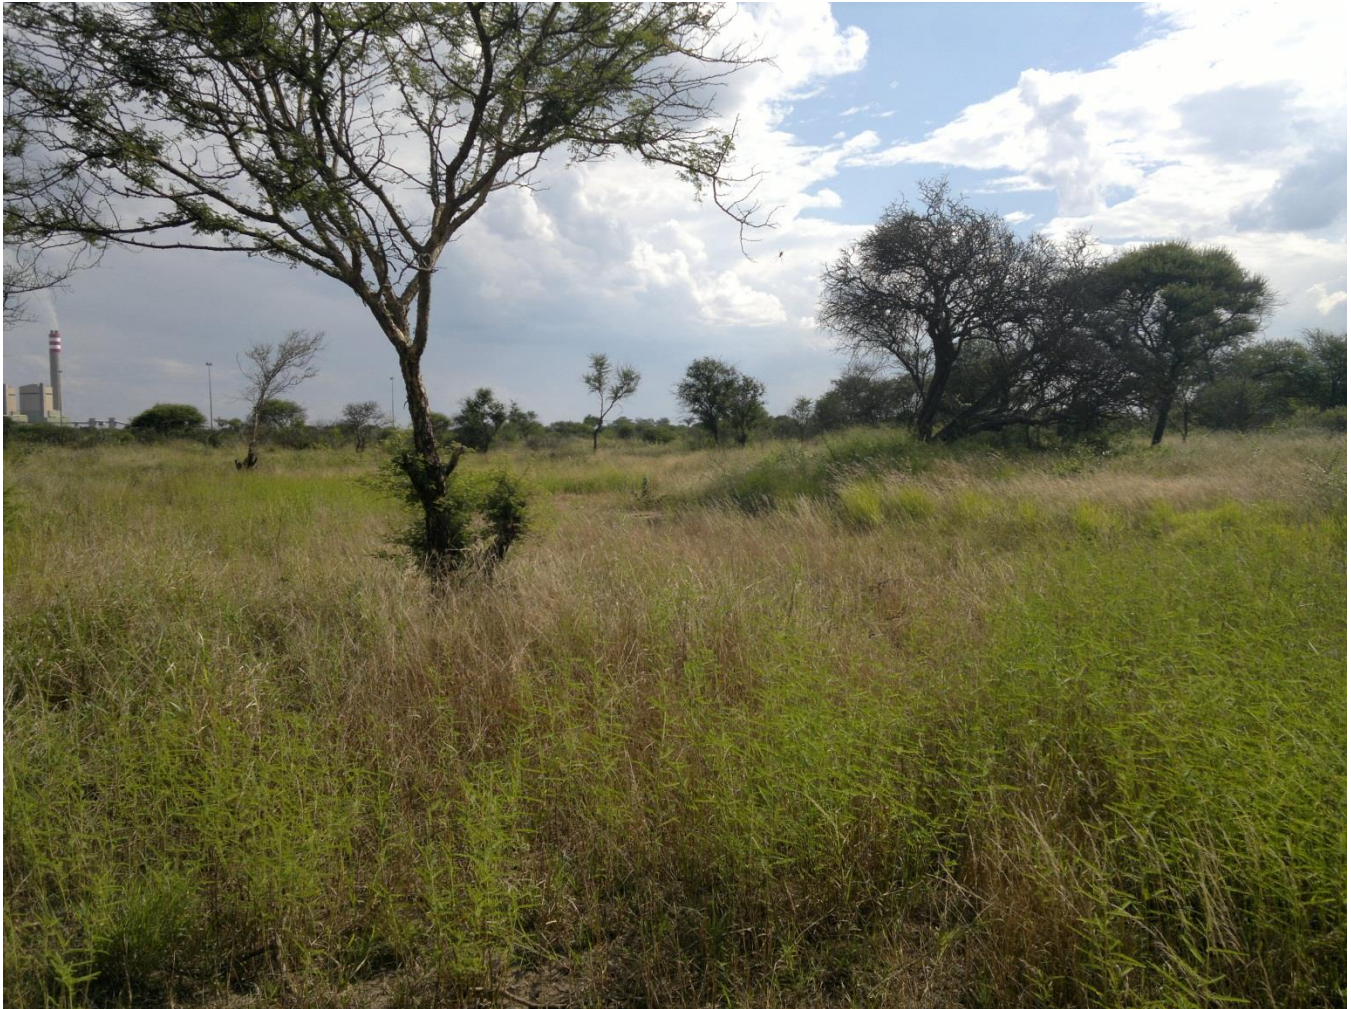
Figure 18 – The head of the watercourse north of Marapong

A tributary of the Sandloop rises to the north of the Marapong township relatively close to the proposed alignment of the conveyor belt to the Alternative 2 Site, and thus this watercourse was investigated to determine whether it extended to the alignment of the conveyor belt. The watercourse was noted to rise to the east of the conveyor belt alignment, and the surface water feature becomes visible at a low point in the otherwise flat or very gently sloping terrain. A small depression characterised by the presence of shallow standing water was located at the head of the watercourse. This depressional area was investigated for the presence of hydric soils, which were found to exist in the form of gleyed clays with the presence of extensive iron mottling. The vegetation in the depression consisted predominantly of the grass species *Echinochloa holubii* (a grass species typical of watercourses and naturally moist areas in the more arid parts of southern Africa) and a *Sesbania species* shrub within the depression. Downstream of this depression, the watercourse extended eastwards in the form of a poorly defined channel characterised by some bare patches of soil and stands of *Bothriochloa insculpta* grass (a species that can also occur in wet areas), and consisting of a series of similar downstream depressional areas. Upslope (west)

of the uppermost depression, no visible surface water characteristics were present; although the area was characterised by grassy as opposed to shrub-dominated vegetation, there was no evidence of hydric soils (soils sampled were sandy, well drained in character) or any physical drainage features.

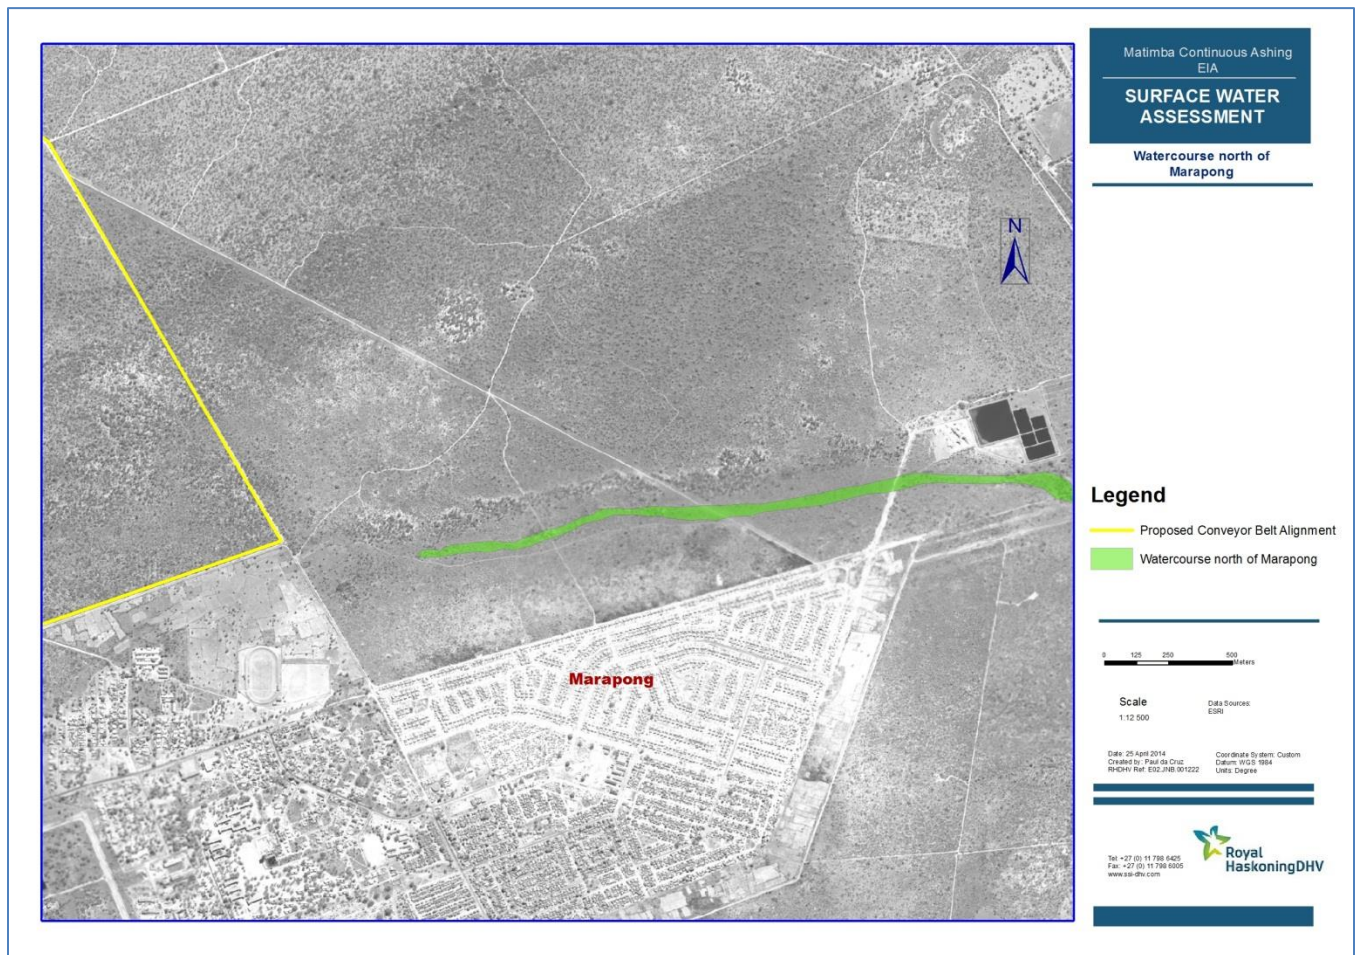
Figure 19 – Watercourse north of Marapong, in relation to the proposed conveyor belt alignment

Interestingly this watercourse did not display a wooded riparian corridor as displayed by the other watercourses on and around the nearby sites, rather being characterised by grassy vegetation with a different species composition in the watercourse to the immediately adjacent areas that were characterised by the presence of grasses and low shrubs. Analysis of the site and of satellite imagery for the site reveals that a strip of trees runs parallel to the northern side of the watercourse in this area, but at a distance (approx. 50m) away from it. The site assessment revealed that gently sloping area moving north of and away from the watercourse graded from grass-dominated vegetation in the uppermost depression and ensuing channel to an area of low shrubs (mainly *Dichrostachys cinerea*) and to a belt of taller trees with the tree species being mainly *Acacia erioloba*. This belt of trees was too far removed from the watercourse to be riparian in nature, and appeared to be related more to the presence of sandy soils as opposed to the clayey soils in the watercourse.

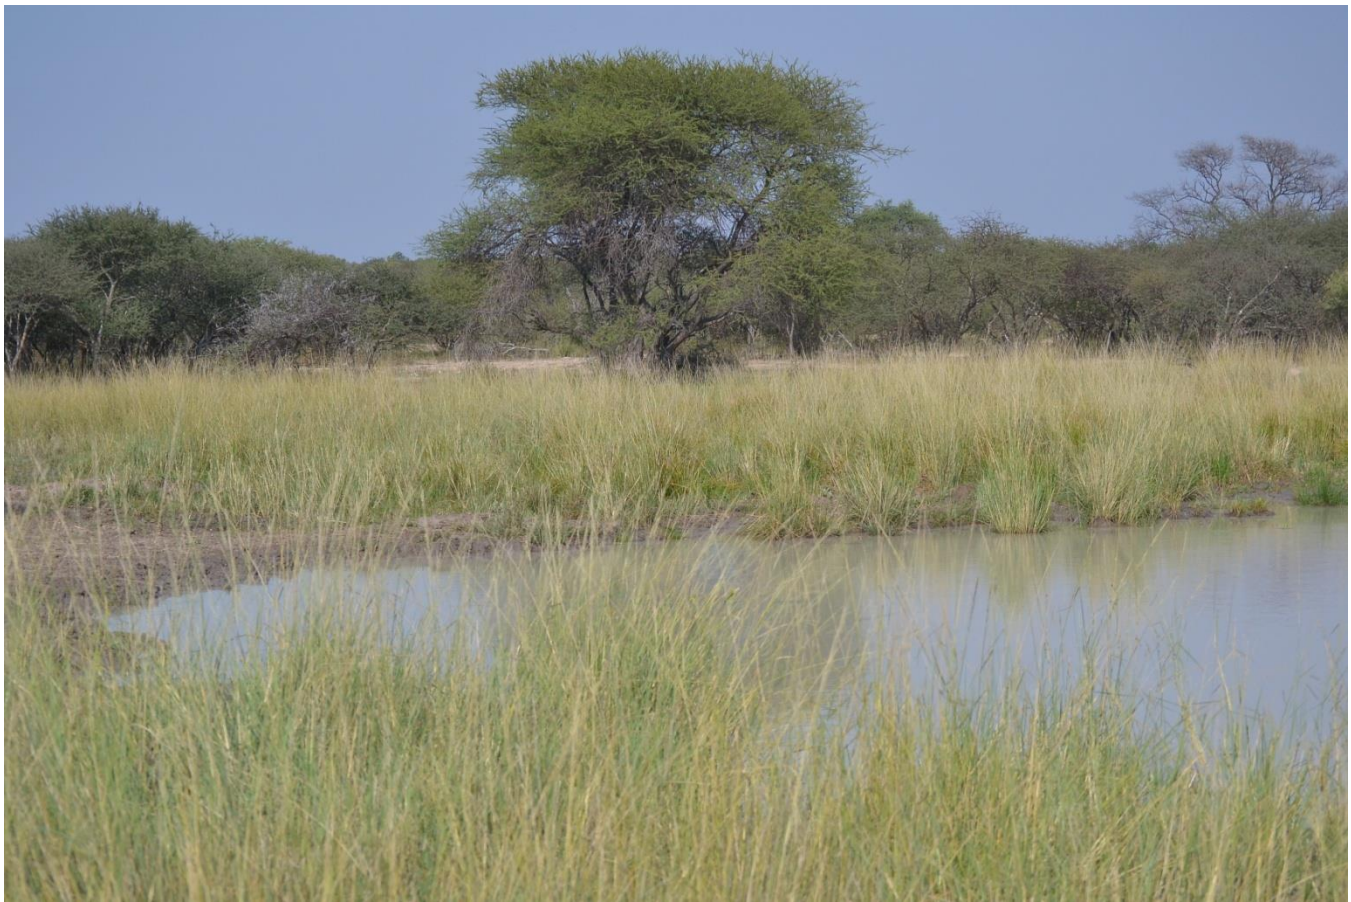
Figure 20 – Small pan-depression on the south-eastern part of the Alternative 2 Site
