Underground Coal Gasification Project and Associated Infrastructure in support of co-firing of gas at the Majuba Power Station, Amersfoort, Mpumalanga - Wetland Assessment Study – EIAR Phase

Eskom Holdings SOC Ltd

Revision 3
July 2014

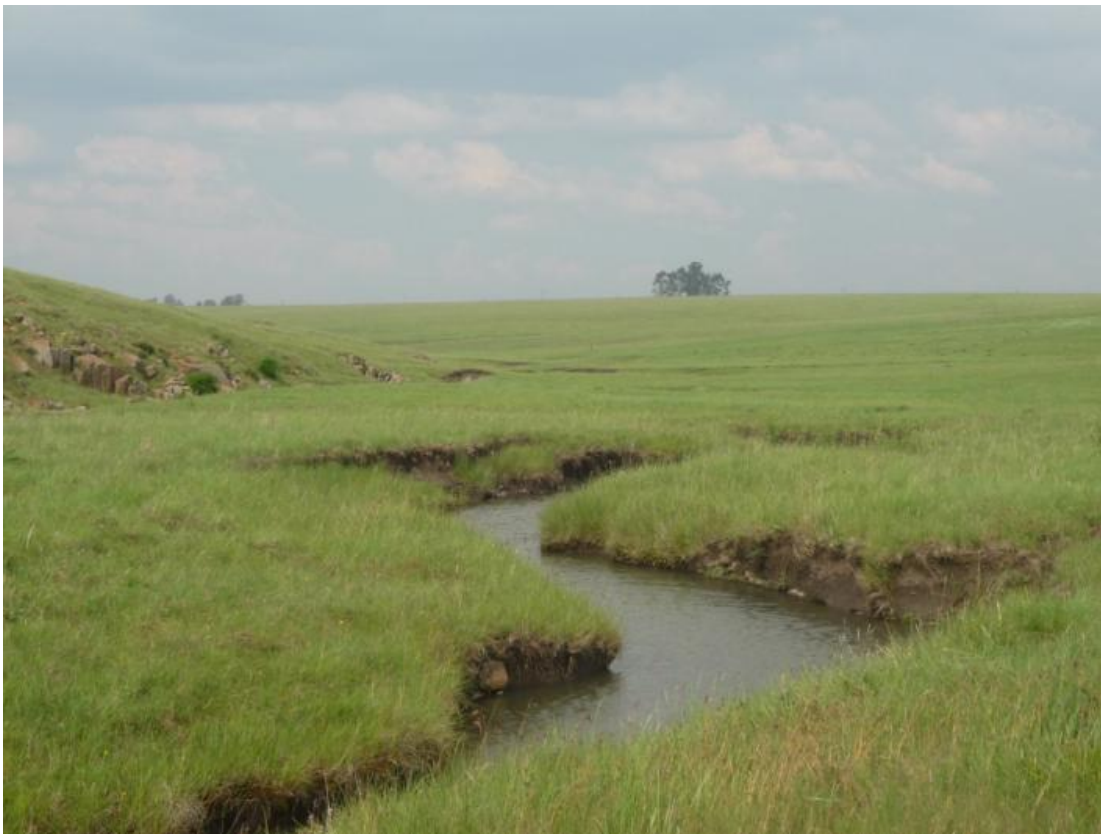
Figure 8 - Relatively narrow wetland and channel in dolerite geology in the downstream reach R_Riet_3

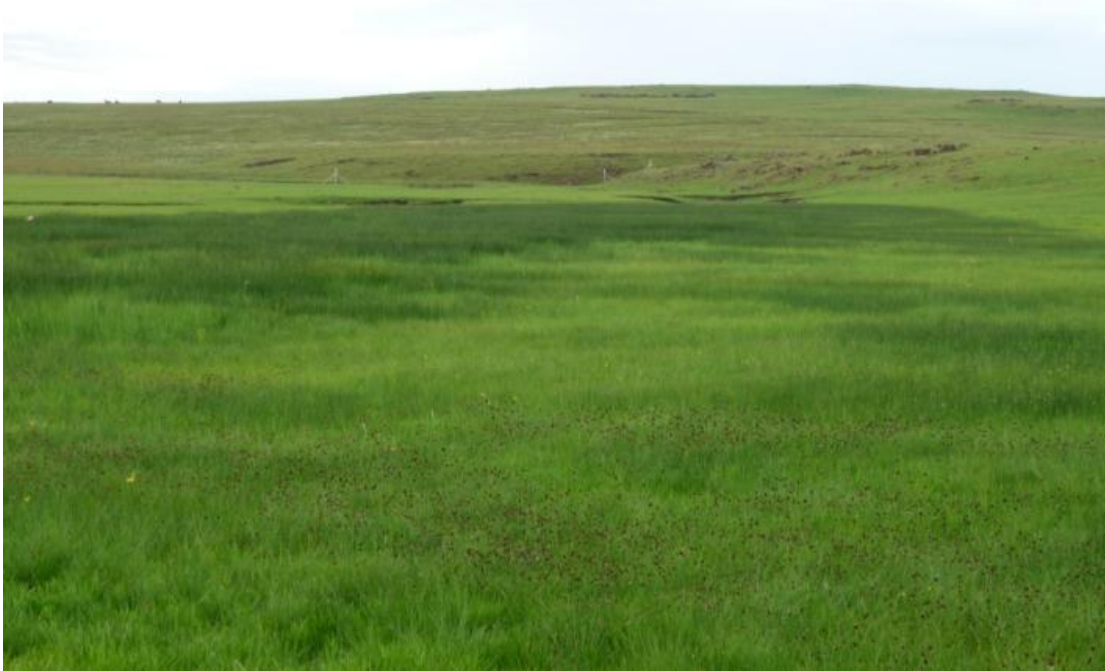
Figure 11 - view to the a low dolerite ridge (dyke) shown by the arrow which tapers the downstream end of the wetland reach R_Riet_6 resulting in extensive marshy areas upstream in the foreground of the picture

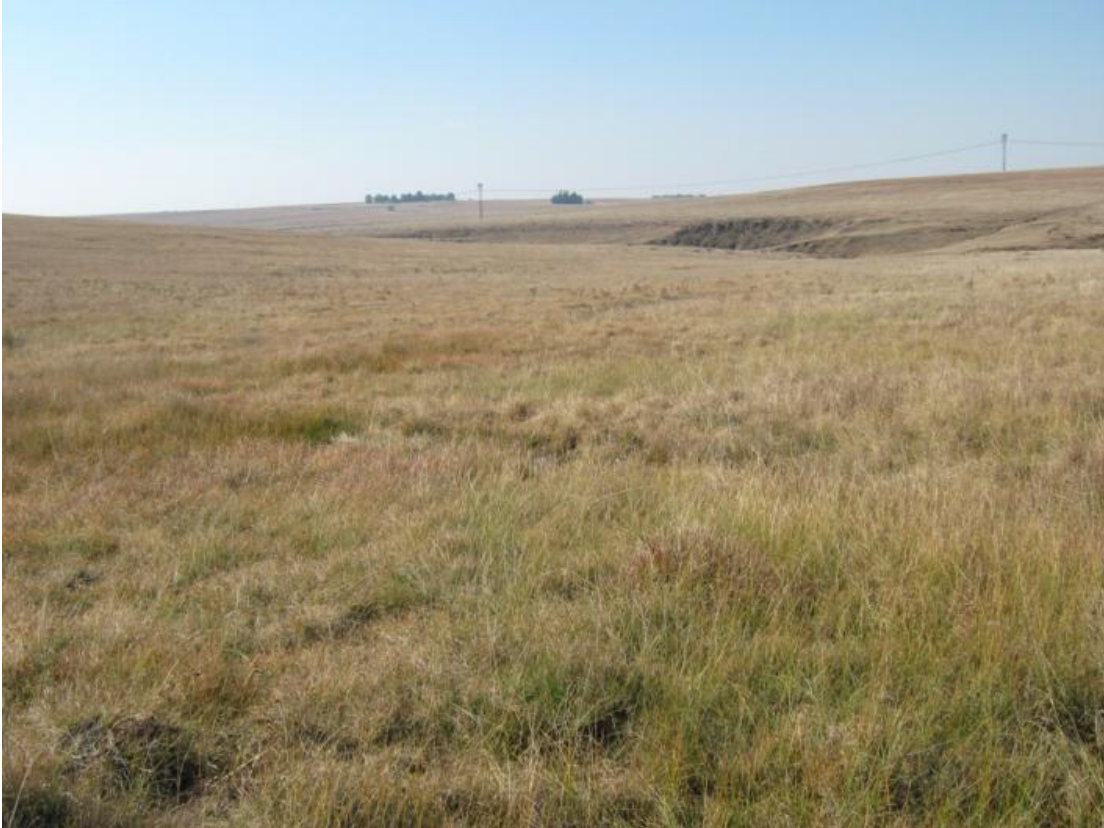
Figure 13 - Seepage areas (indicated by patches of darker vegetation) in a valleyhead seep) in the Palmietspruit catchment to west of the revised study area

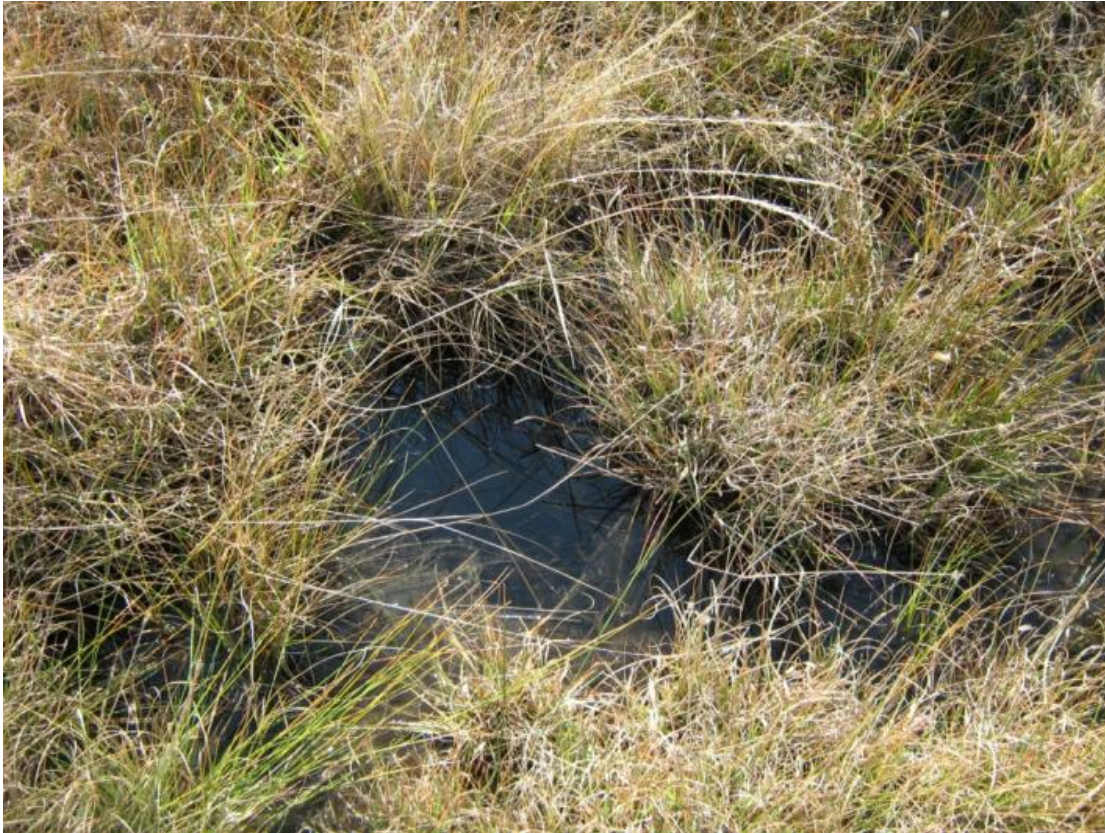
Figure 14 - Clear groundwater discharge in the valleyhead seep wetland reach R_Pal_10

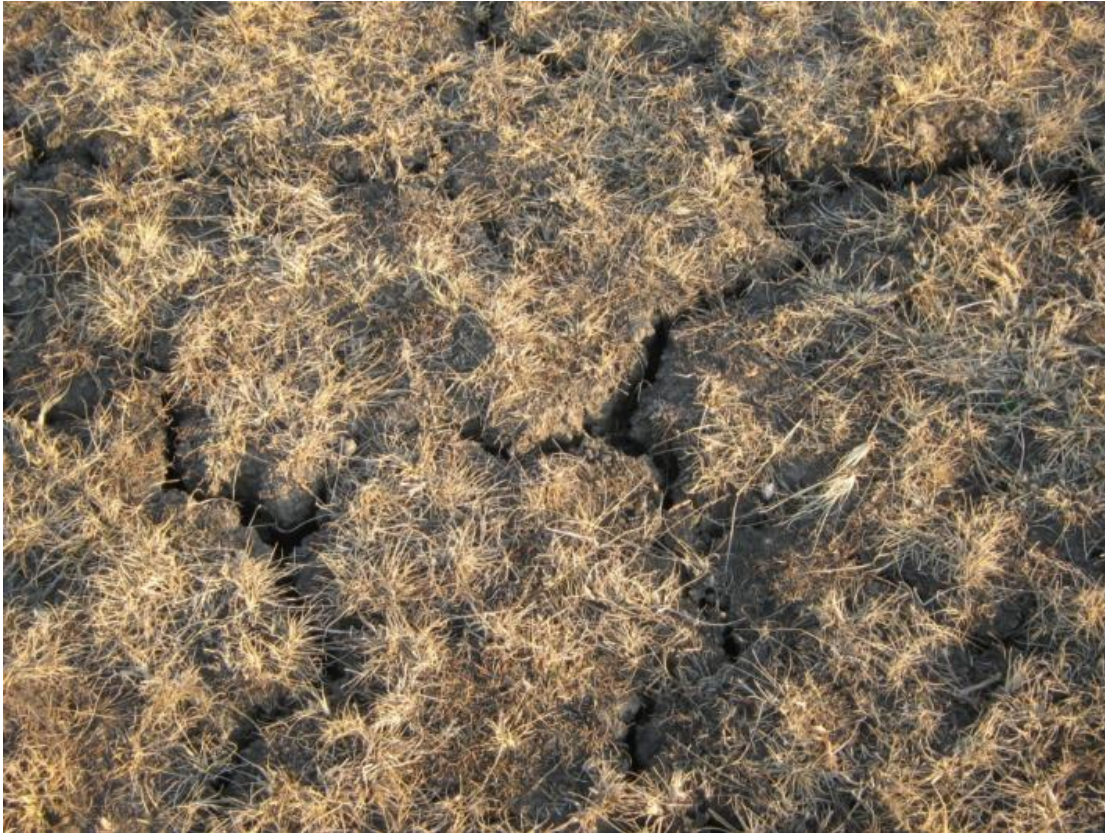
Figure 15 - Cracking on the surface of vertic soils

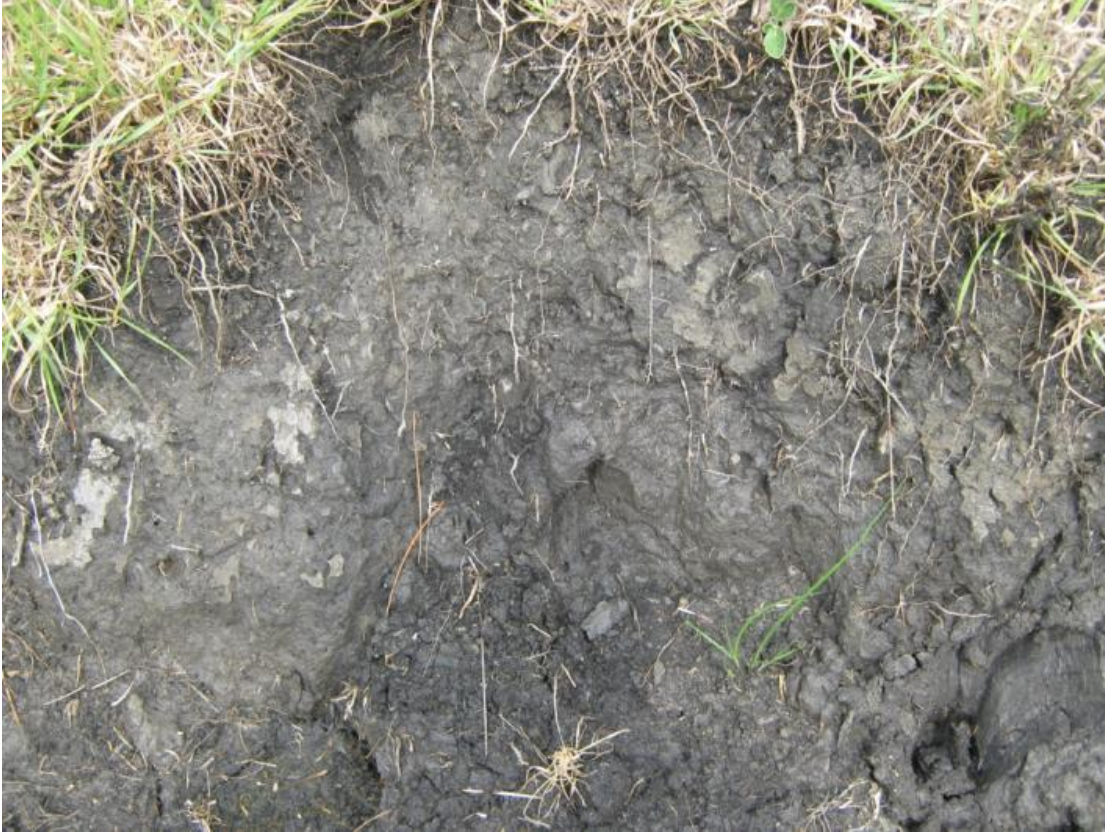
Vertic soils are characterised by the presence of swelling and shrinking clays. They typically form where there is a distinct wet and dry period that affects the soils. These soils swell when they become saturated, and shrink again when they dry out, leading to characteristic ‘cracking’ on the surface of the ground. There are two main formation processes for vertic soils: the first is in low lying positions where vertic soils form due to the accumulation of base rich weathering products, and requiring a distinct period of seasonal (winter in this case) drying to form the swelling clays. The second is on varying, but mainly flat, topography due to the weathering of basic igneous parent materials (Johan van der Waals, pers. comm.). The second formation process is thought to be the main reason for the predominance of vertic soils in the Study Area as these vertic soils are found from crest to valley bottom. These vertic soils are typically dark black in colour in the upper parts of the profile (the vertic A horizon), and are often associated with the presence of lime modules.

Figure 16 - An example of a Vertic A Horizon

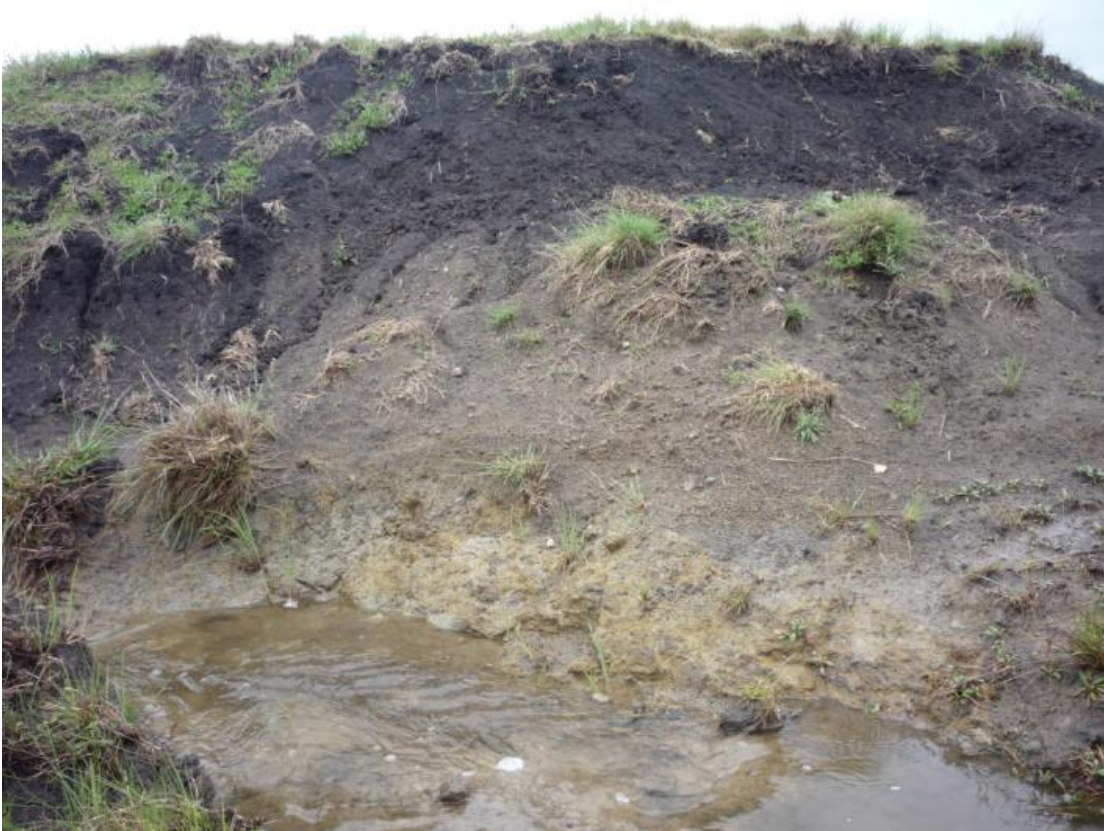
Figure 17 - An example of a Rensburg soil form on the Rietfontein Farm Property to the south of the proposed service road alignment. Note the depth of the G horizon (>0.5m bgl)

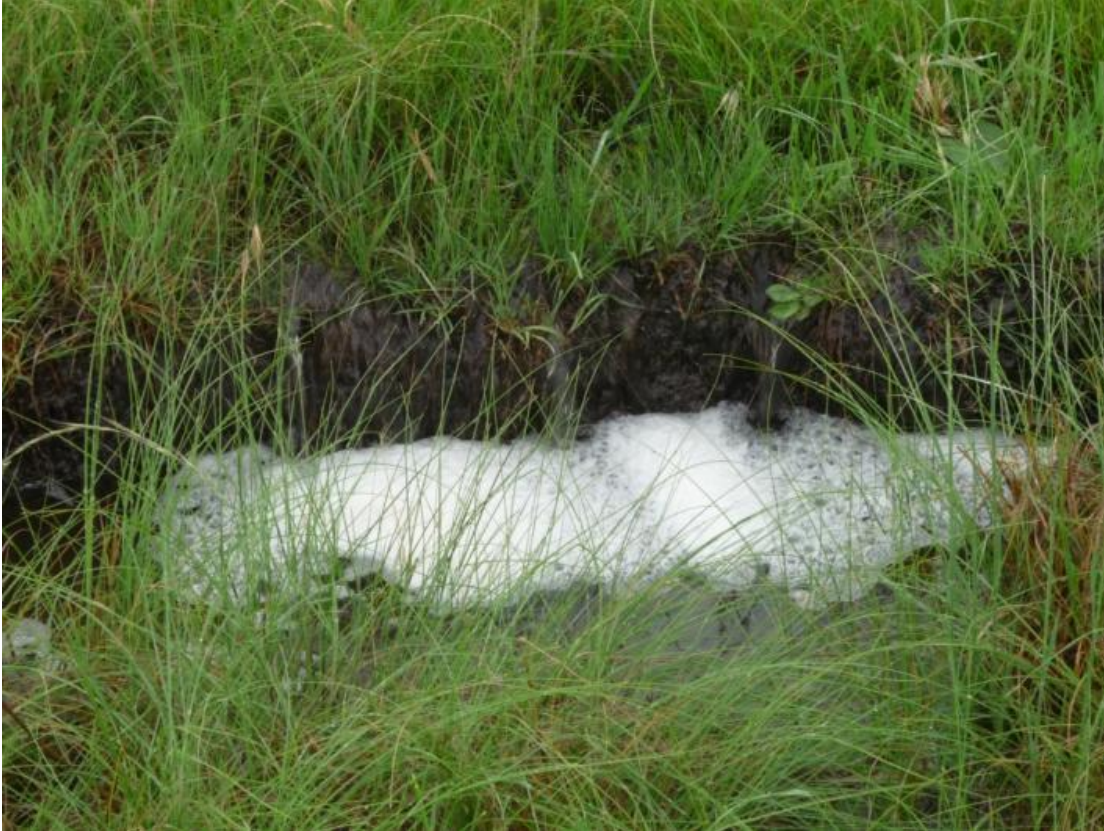
Figure 21 - Overland flow in the catchment of a wetland immediately after a prolonged period of rainfall

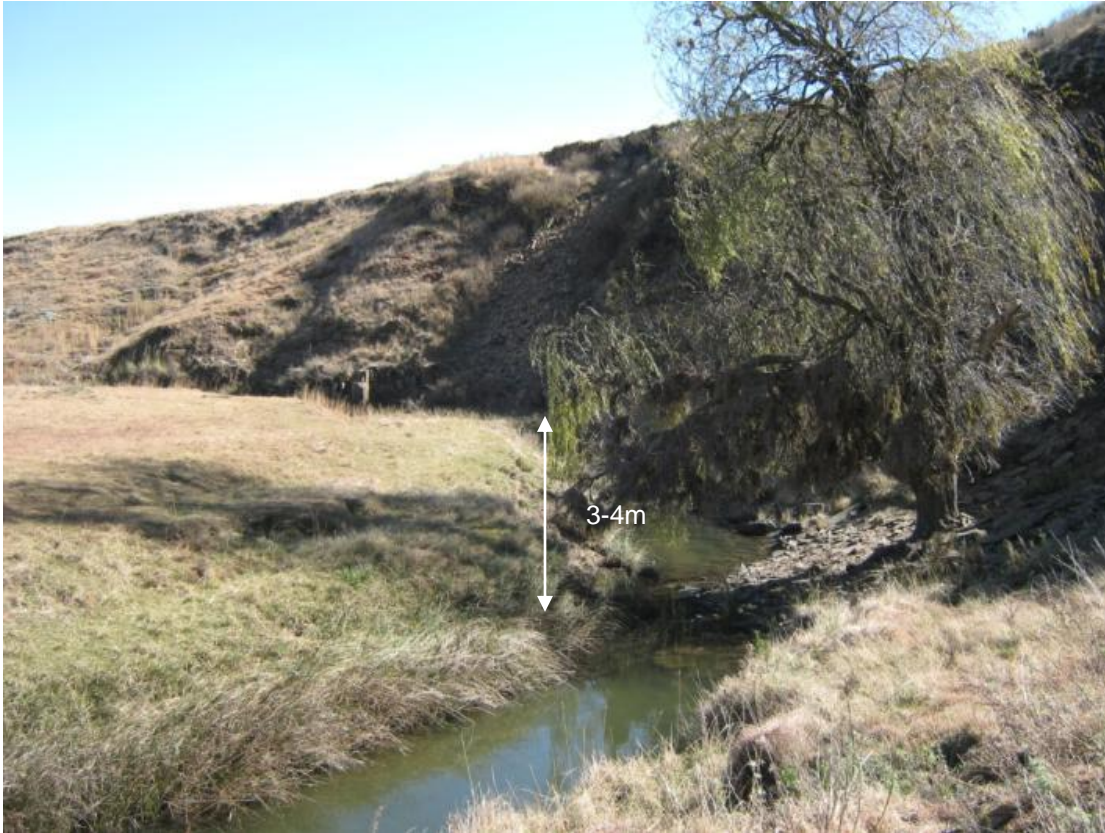
Figure 22 - Flood wrack in a willow tree along the Palmietspruit south of the Perdekop Road in the original study area

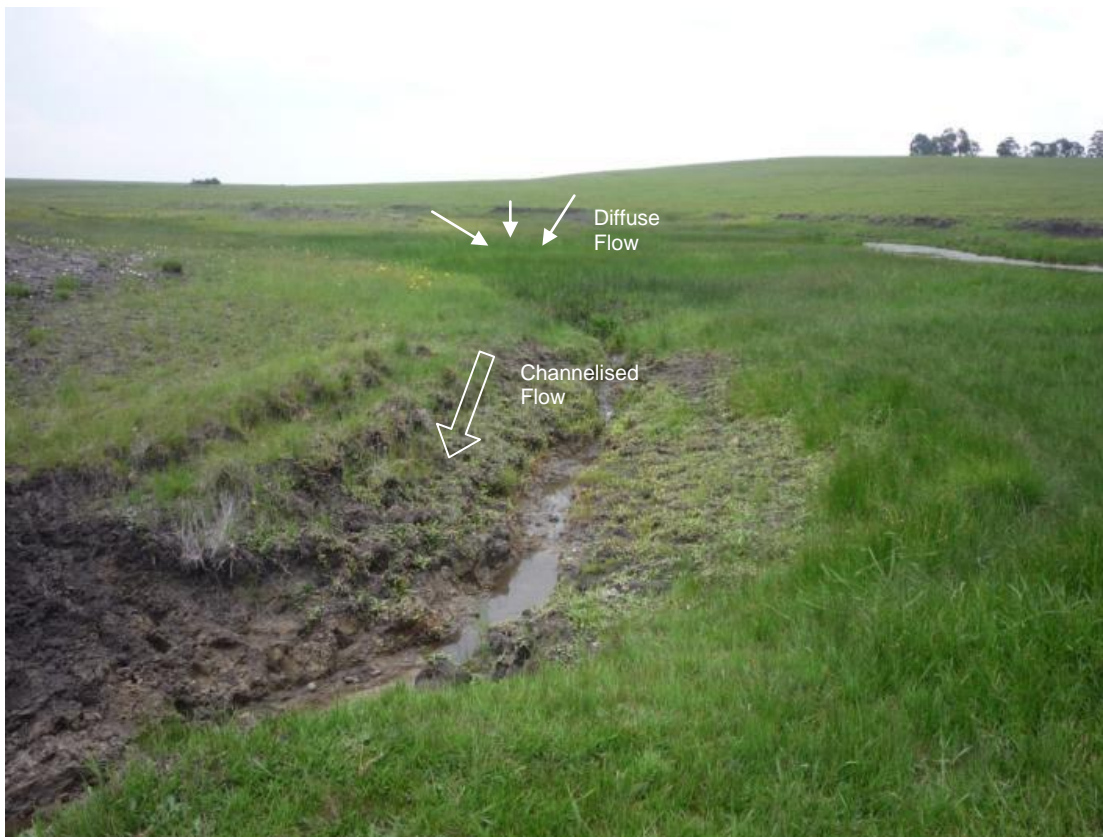
In the wider area there are many examples of headcuts that are eating back into parts of wetlands that have diffuse flow and thus healthy, moribund wetland vegetation. These headcuts have altered the state of the downstream portion by lowering the water table and channelising the flow, thus ultimately causing a change in vegetation composition (often associated with the replacement of wetland hydrophytes with terrestrial / non-wetland species). Left unchecked, these headcuts will result in the loss of the wetland habitat upstream and adversely affect the hydrological and ecological functioning of the wetland reach.

Figure 24 - Example of a headcut eating up into an area of diffuse flow in a wetland on the Rietfontein farm east of the Roodekopjes Property. Note the impact of the cattle trampling in the foreground

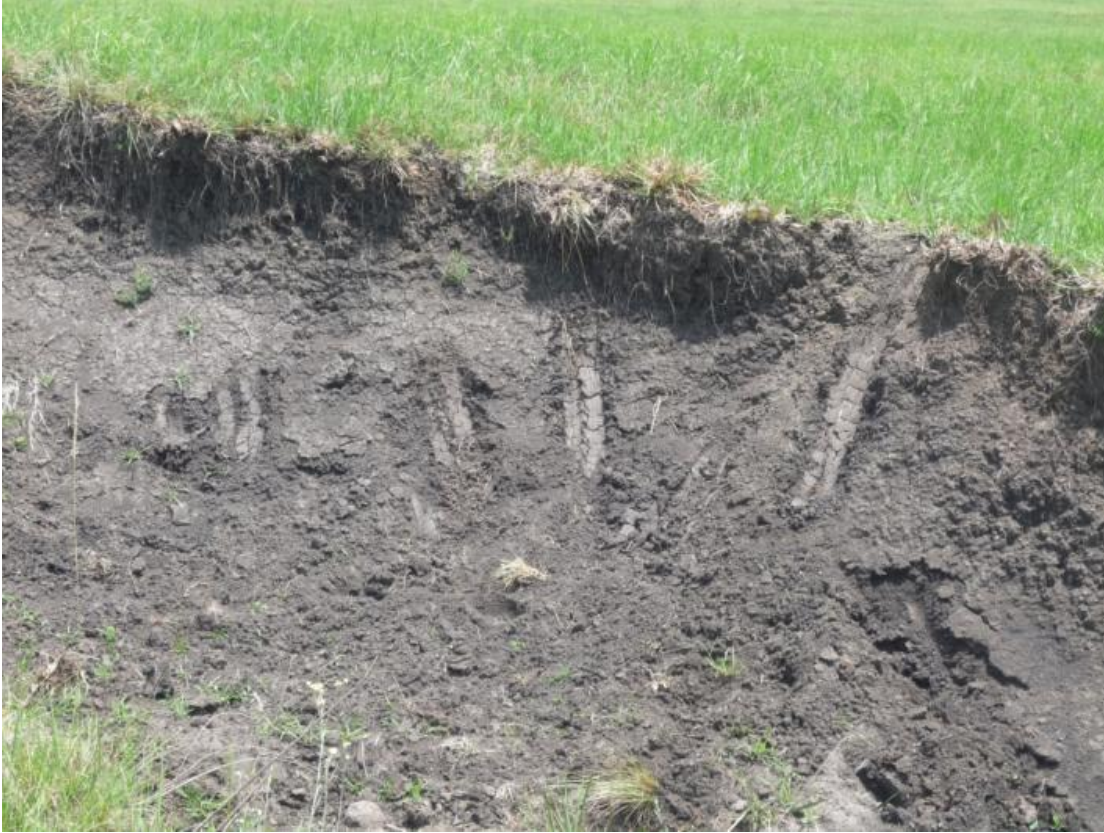
There is also evidence that cattle are contributing to the retreat back of channel banks. In many areas cattle trampling was evident on banks down which they move to cross or access channels. This leaves the channels exposed and mobilises the sediment, allowing it to be washed down the channel as silt. There is thus much evidence to suggest that cattle are contributing to the channelisation of wetlands.

Figure 25 - Evidence of sediment mobilisation and bank erosion caused by through cattle movement

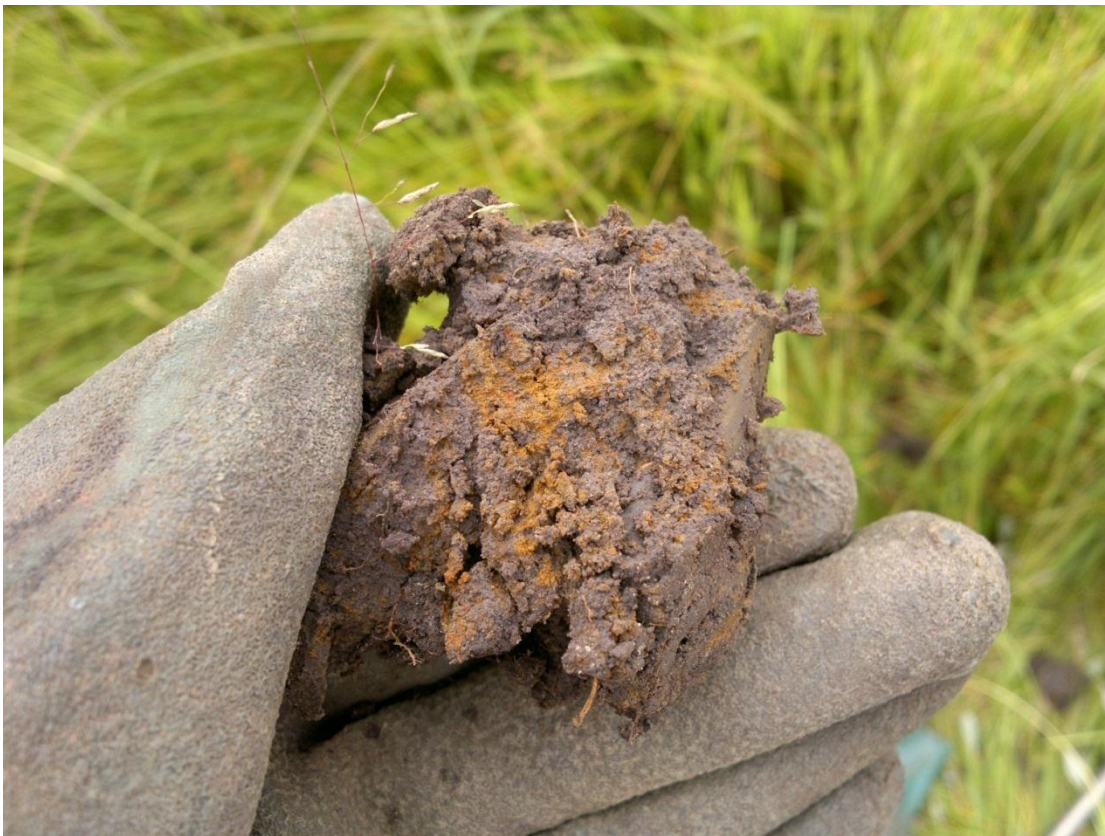
Figure 26 – Iron mottling within gleyed soils

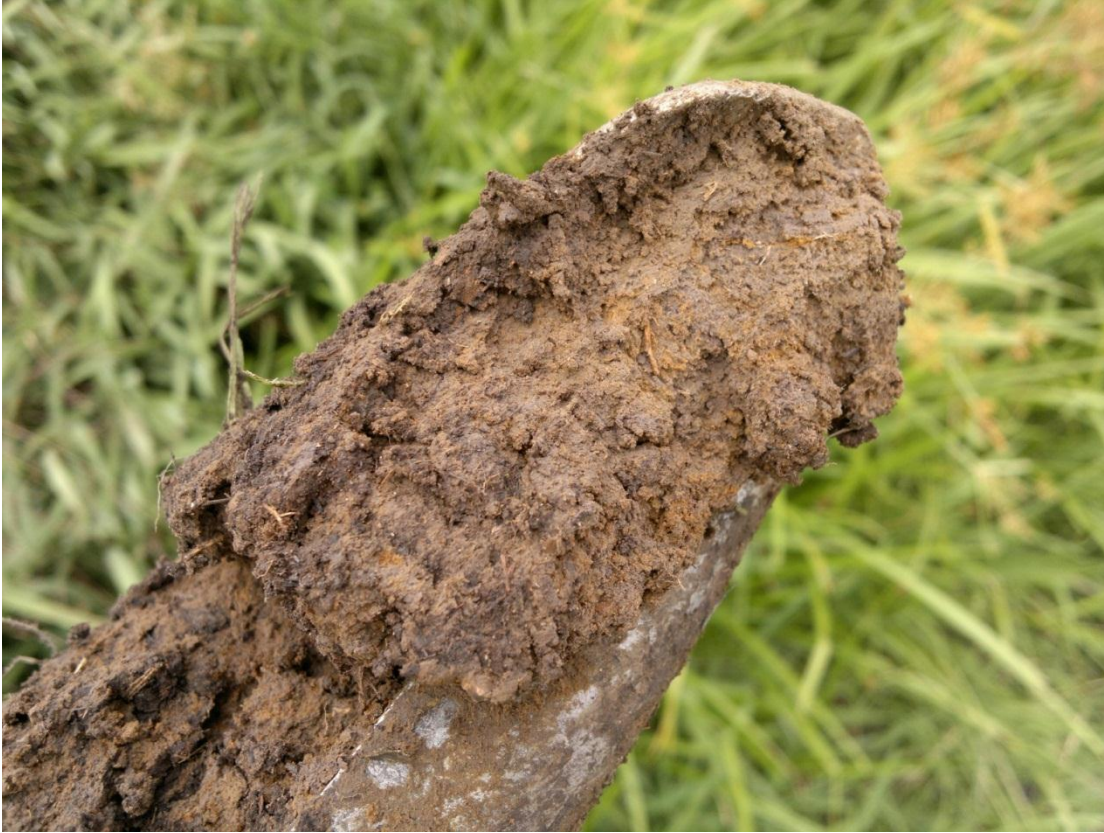
Figure 27 – Soils from a G horizon in the hillslope seepage wetland adjacent to the Witbankspruit

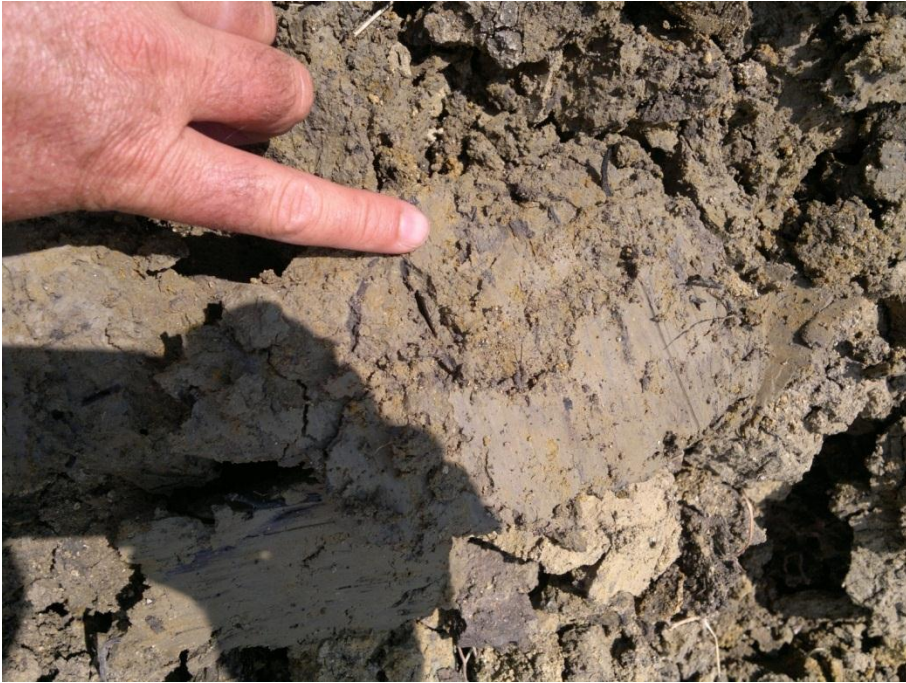
Figure 28 – Soils from a G horizon within the channel of the Witbankspruit

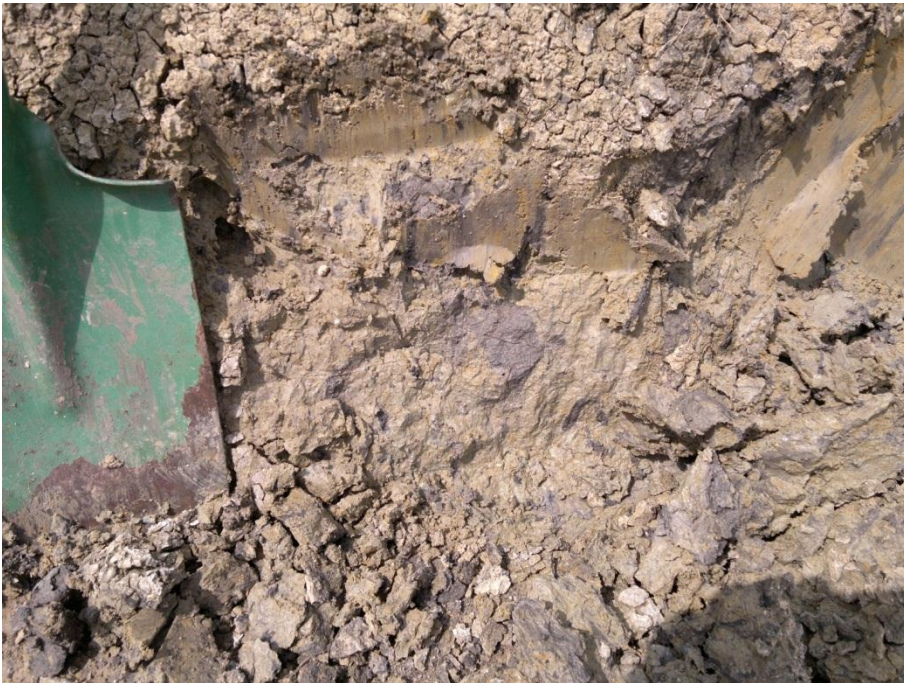
In the core area of shale occurrence (to the immediate north of, and south of the gas pipeline bridge crossing of the Witbankspruit), the most commonly-occurring underlying horizon at the low flow level was noted to be a soft plinthic B horizon.

Figure 29 – Soft plinthic B soils to the north of the gas pipeline crossing of the Witbankspruit

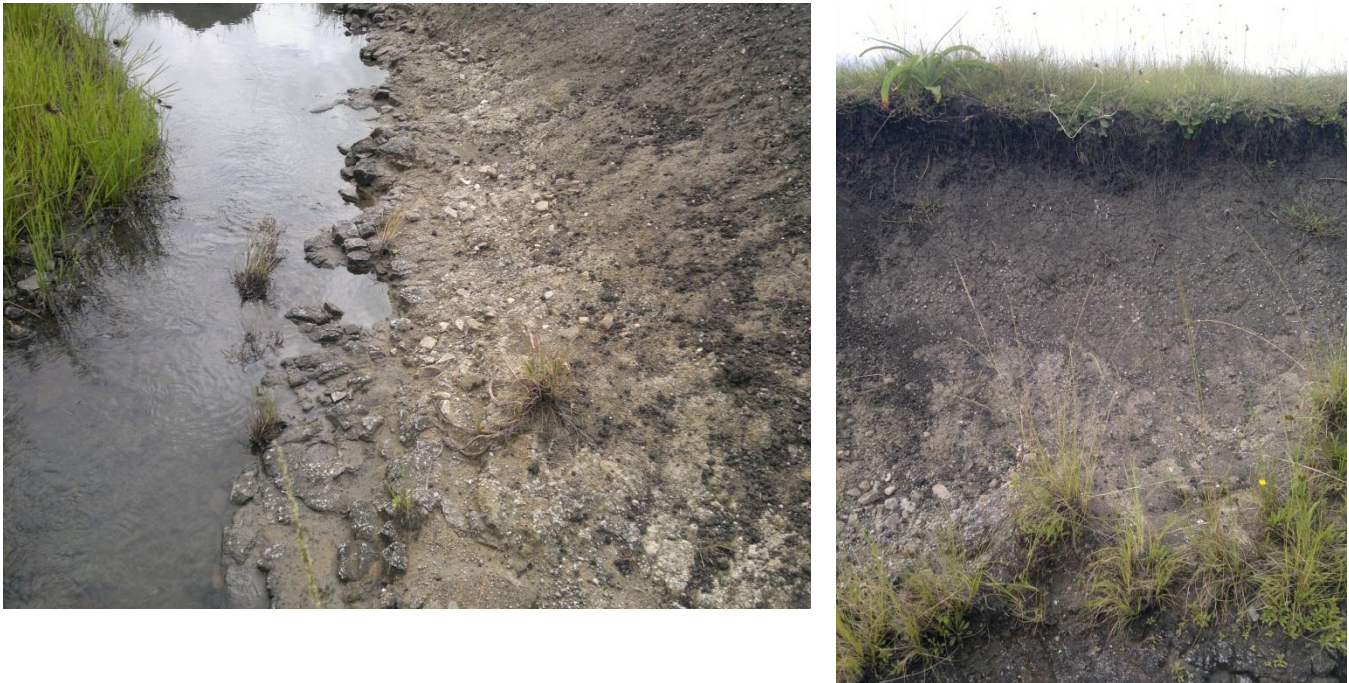
Figure 30 – Soil Profiles along the Witbankspruit in an area of shale geology – note the (gleyed) G horizon overlying the shale bedrock

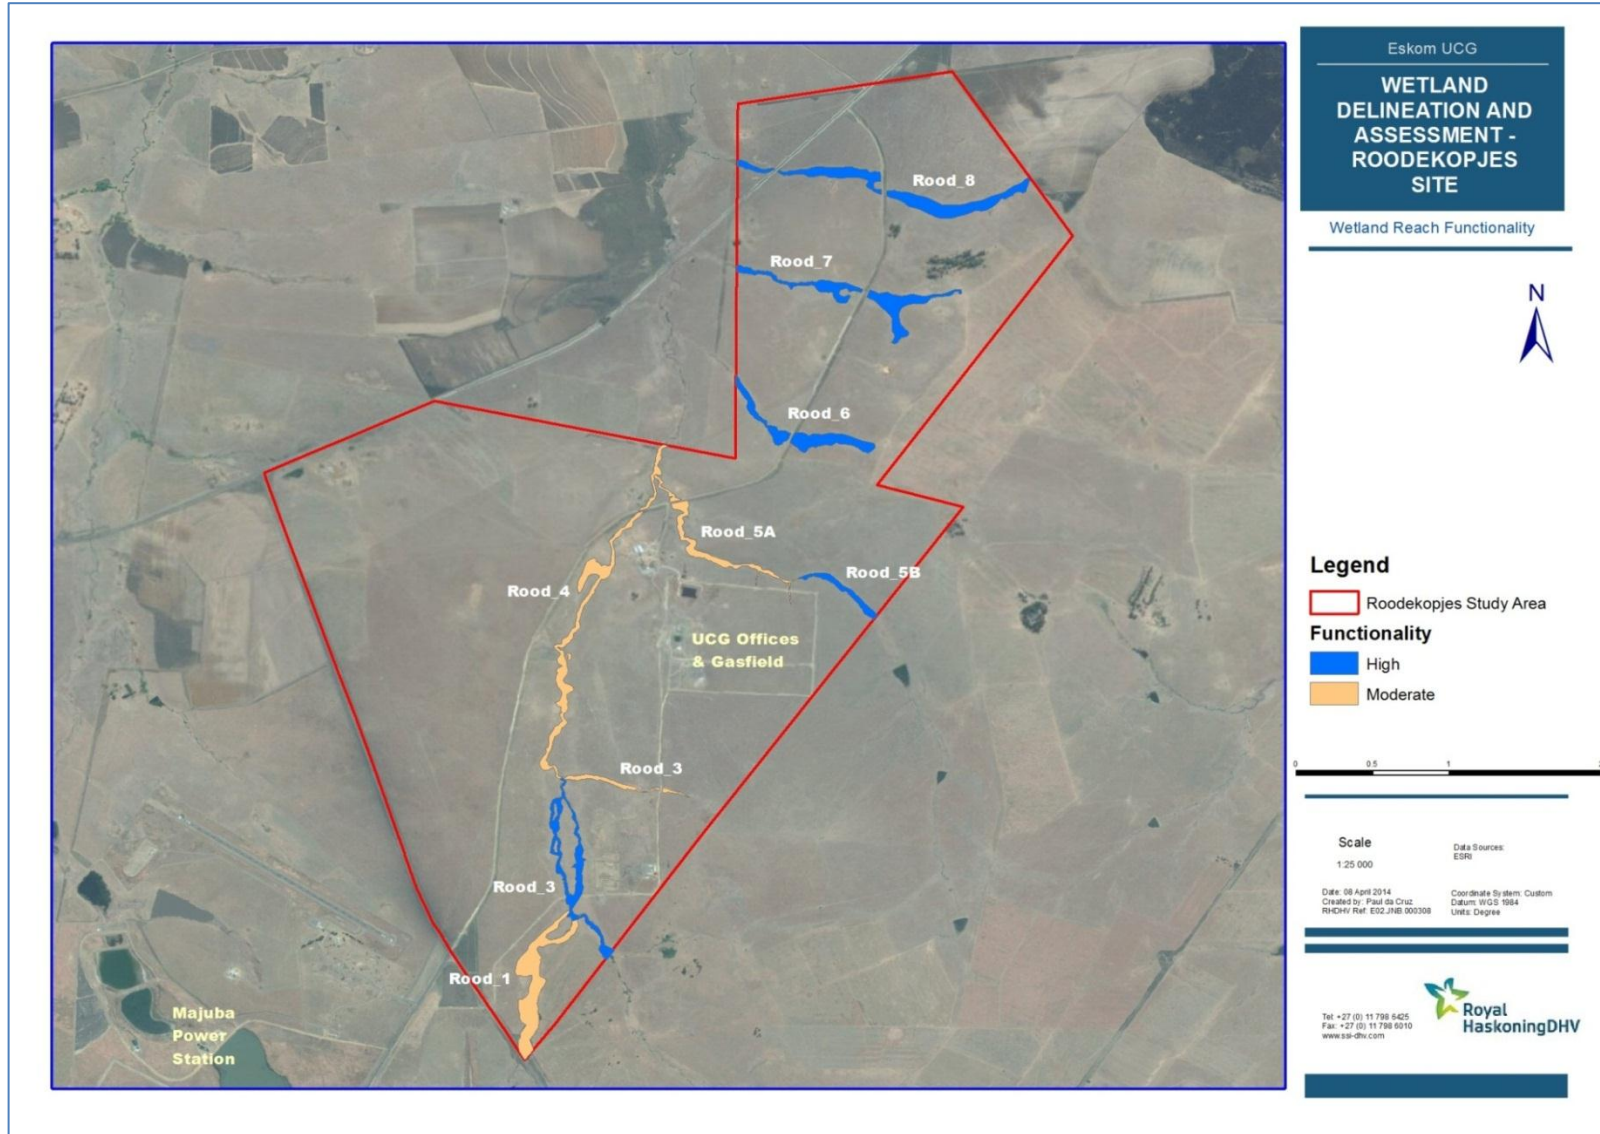
Figure 64 – Functionality Assessment for wetlands on the Roodekopjes Site

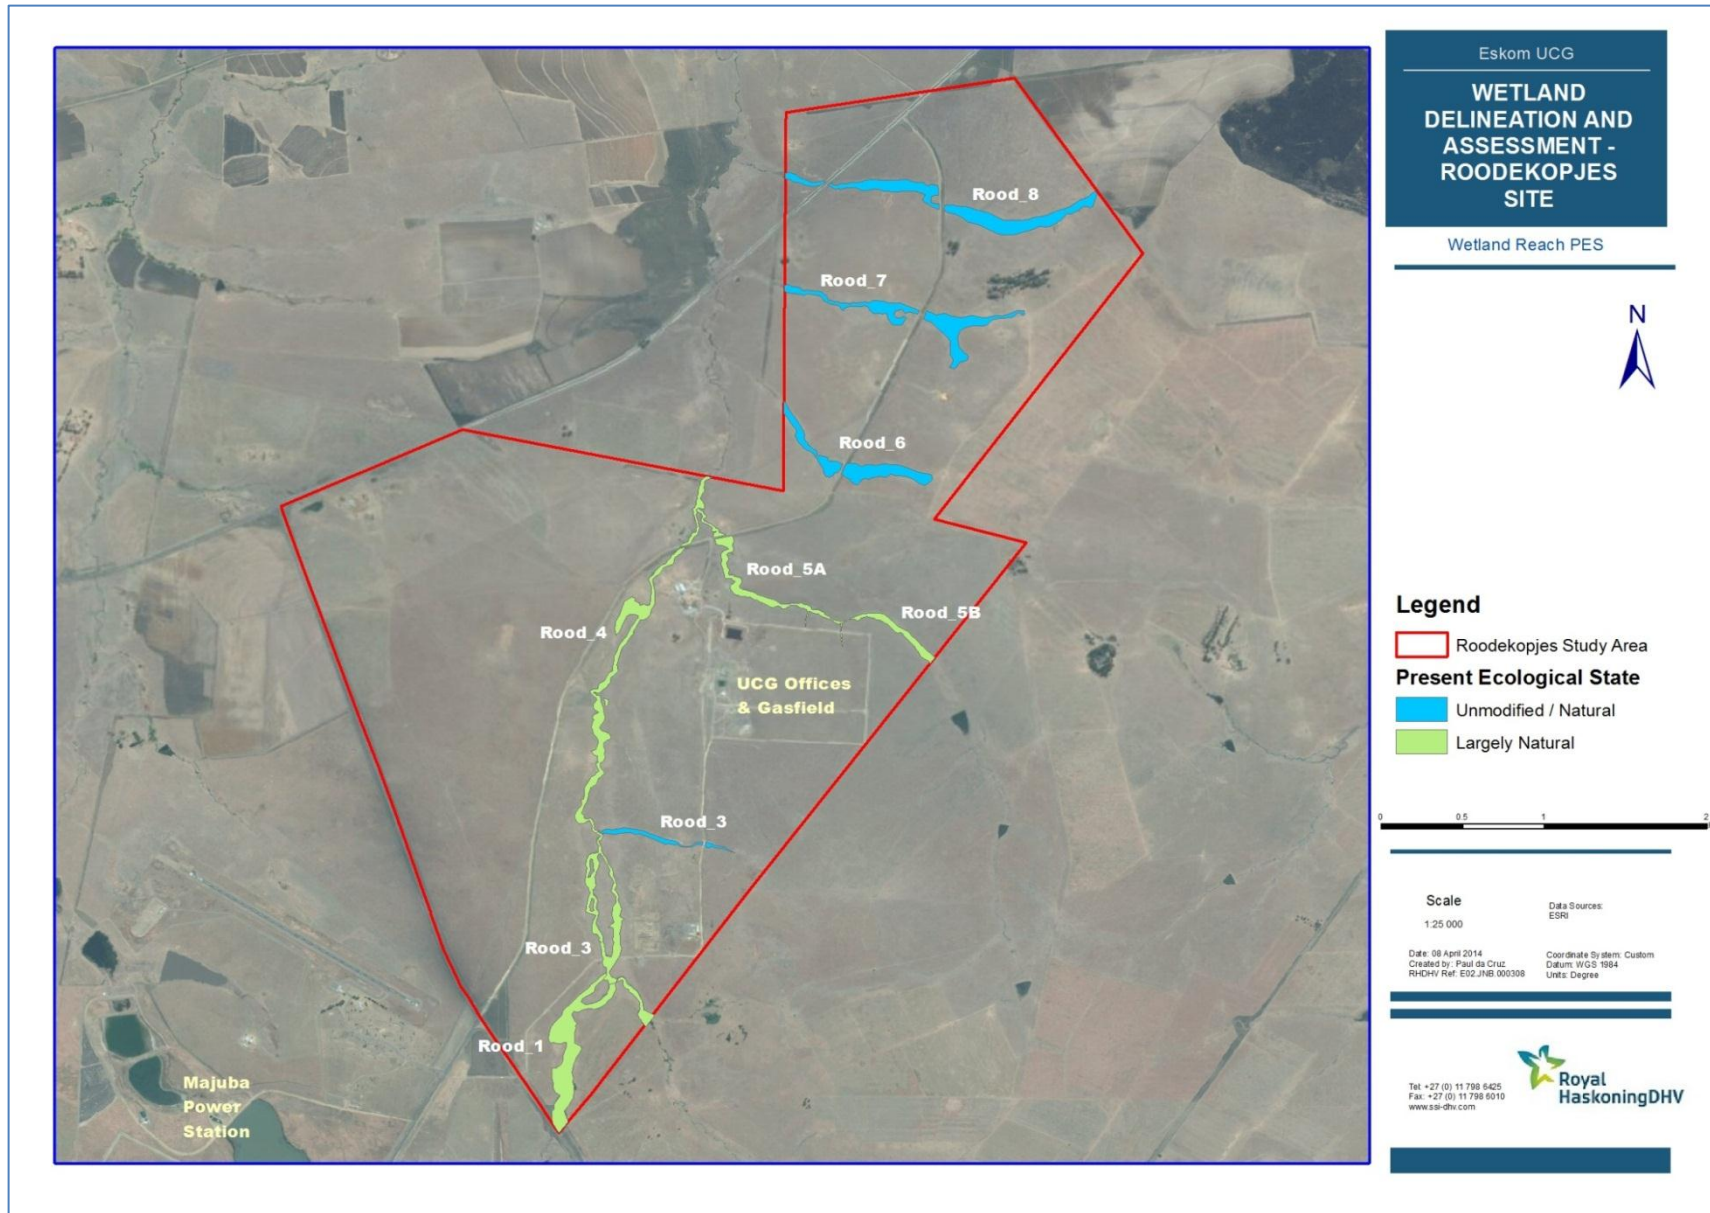
Figure 65 – Assessment of state (PES) of wetlands on the Roodekopjes Site

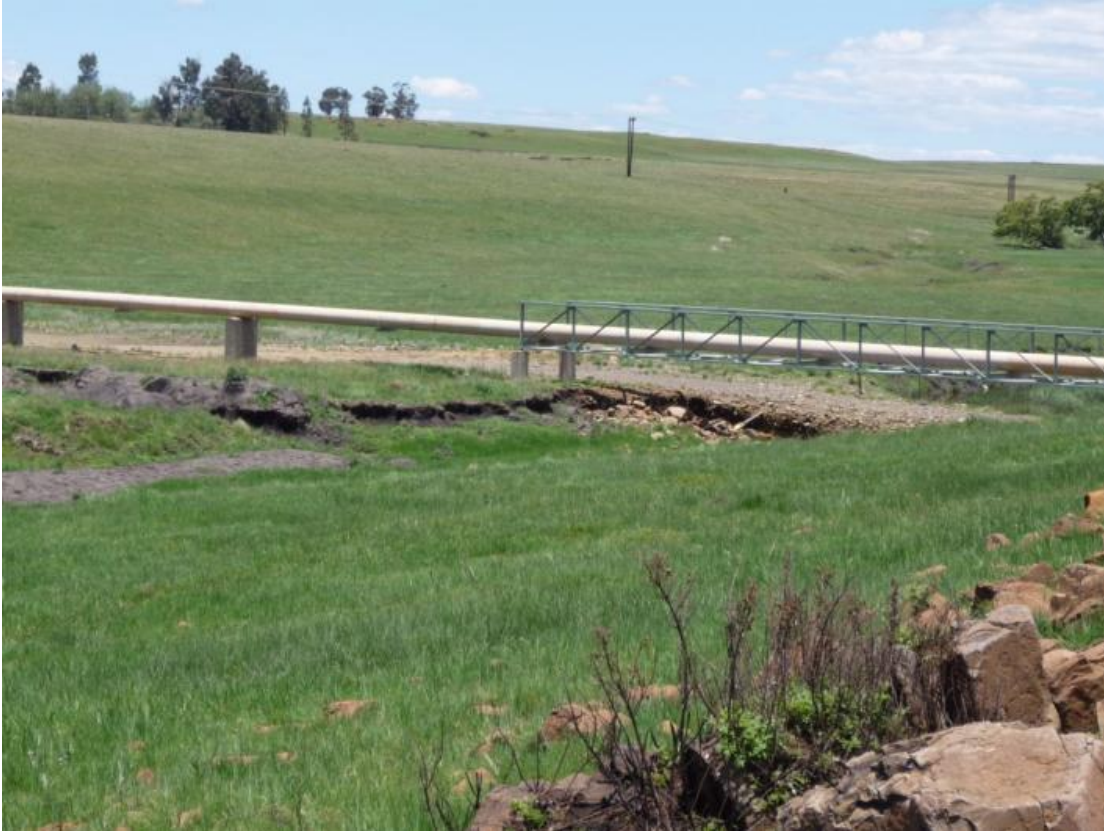
Figure 72 – Existing pipeline crossing the Witbankspruit near the demonstration plant
