**APPENDIX K:
FRESHWATER ECOLOGY REPORT**

**AQUATIC ECOLOGICAL ASSESSMENT AS PART OF THE
WATER USE LICENSE AUTHORISATION PROCESS FOR
THE ESKOM UCG PROJECT**

Report authors **Leandra Jonker**
 S. van Staden (Pr. Sci. Nat)
 Earl Herdien (Pr Sci Nat)
Report Reference: **SAS 214095**
Date: **April 2014**

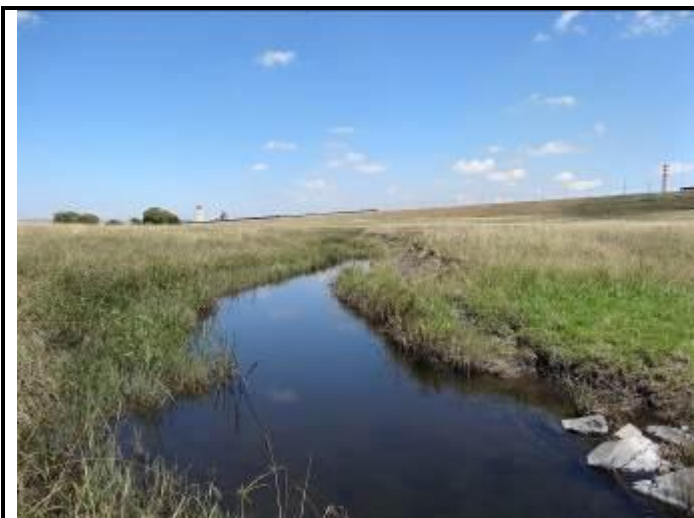
Figure 4: Upstream view of the GK1 site on the Geelklipspruit indicating the slow flows and bankside vegetation at this point.

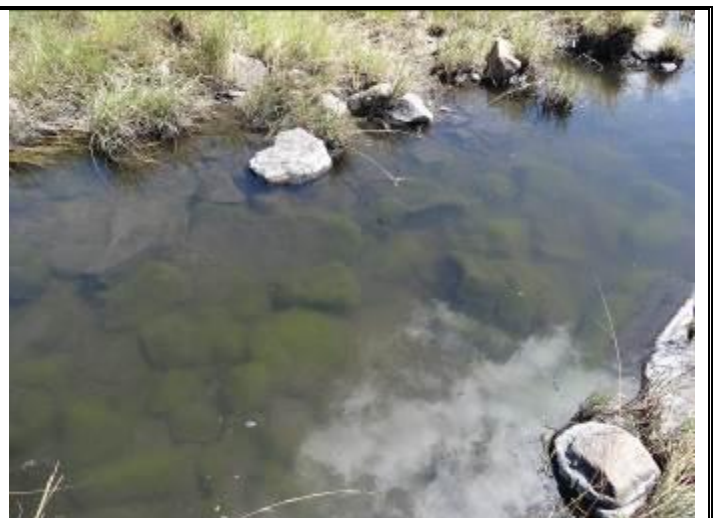
Figure 5: Local view of the GK1 site indicating the rocky substrate and algal proliferation at this point.

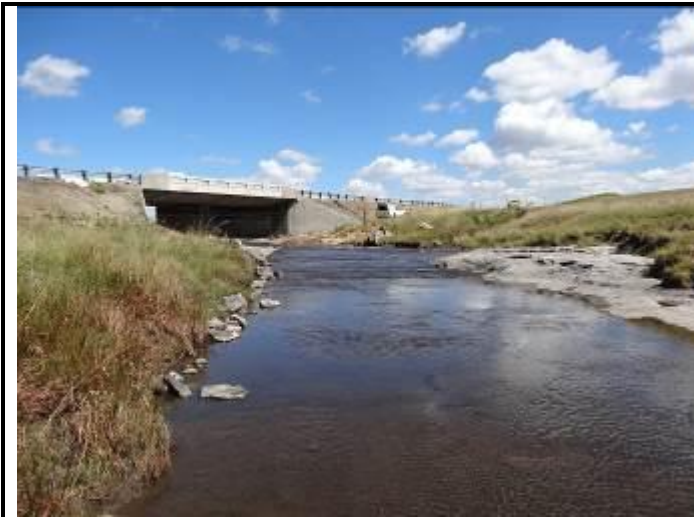
Figure 6: Upstream view of the GK2 site on the Geelklipspruit indicating the low flows at this point.

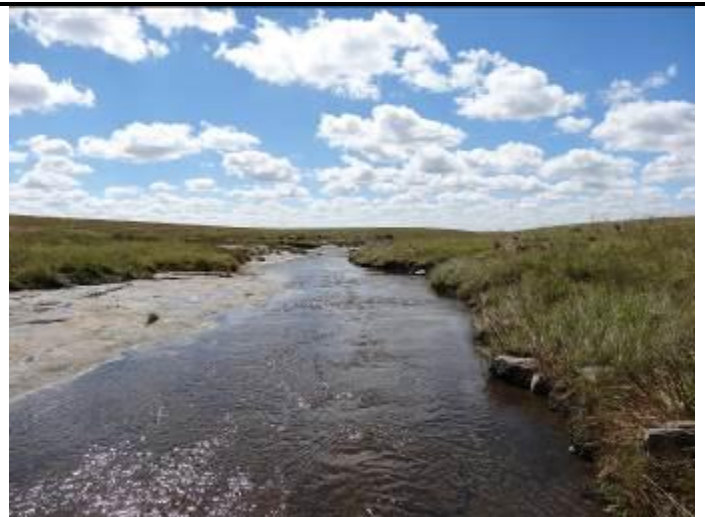
Figure 7: Downstream view of the GK2 site on the Geelklipspruit indicating the bedrock present at the site.

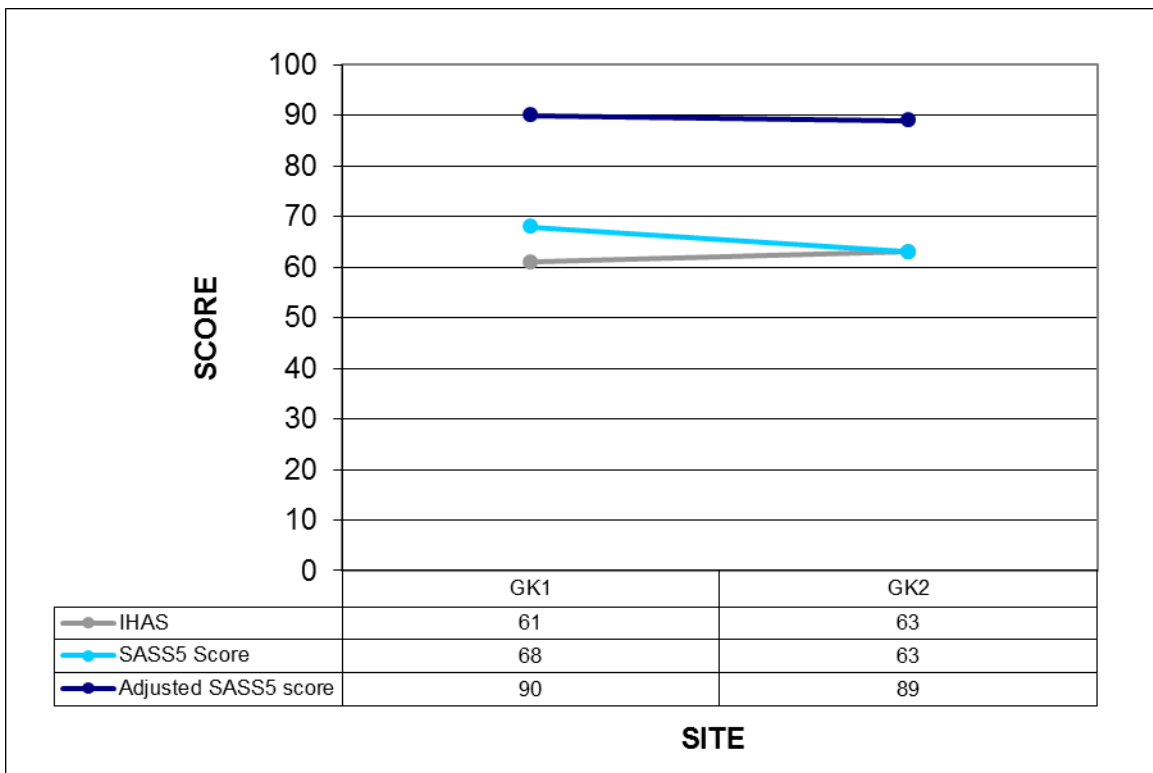
- Habitat structure and diversity was inadequate for supporting a diverse aquatic macro-invertebrate community.
- Habitat conditions at both sites vary slightly with an increase of 3.3% in habitat conditions at the downstream site and as such, it is expected that a slight variation (increased diversity and sensitivity) in the aquatic communities can be expected at the downstream point.

Figure 9: SASS and IHAS score variation between the upstream GK1 and downstream GK2 sites

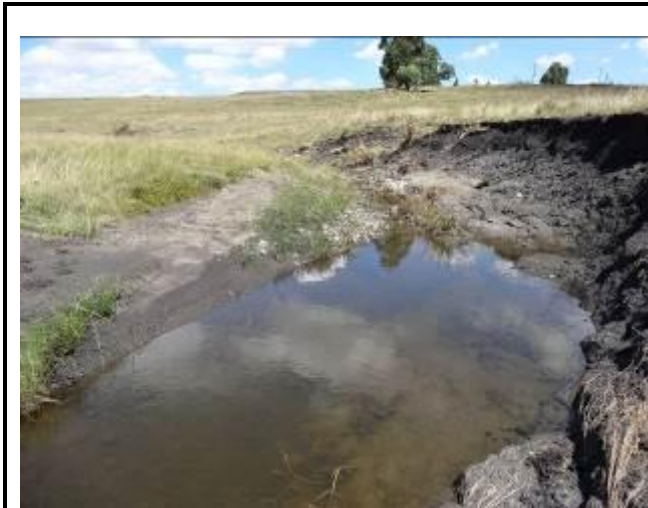
Figure 12: Upstream view of the P. Stream site indicating the large pool habitats present at this point at the time of the assessment.

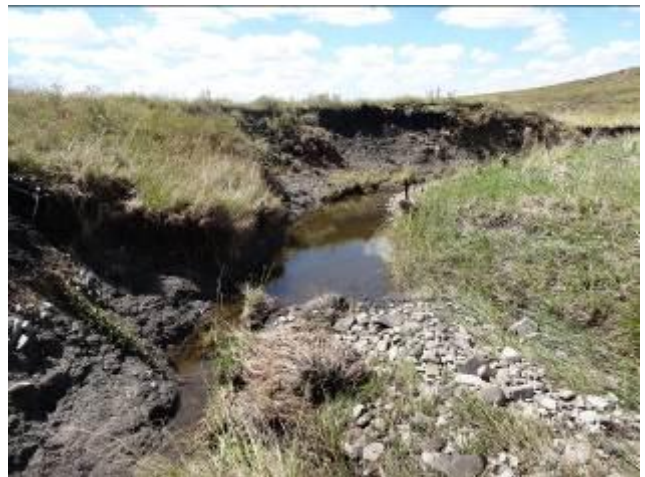
Figure 13: Local view of the P. Stream site indicating the pool habitats and low flow conditions at this point.

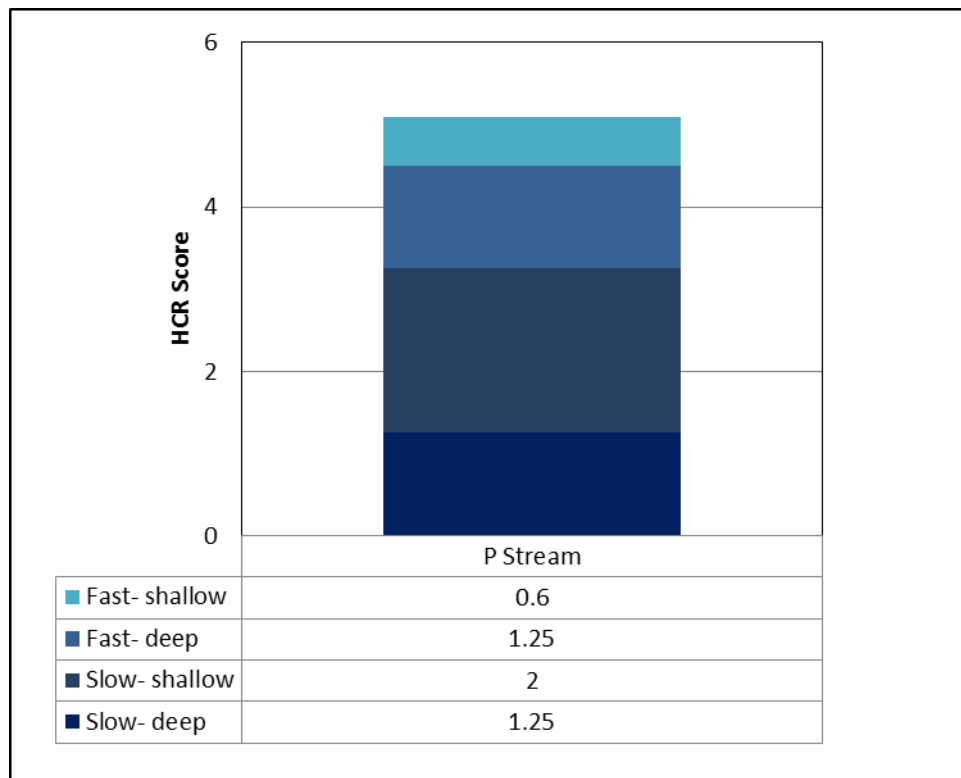
Figure 14: HCR scores for the four sites assessed

It is clear that slow-shallow conditions predominate in the system followed by slow-deep conditions. The fish expected in the area will therefore be limited to fish with high intolerance values for flowing water and to a lesser degree species with a high intolerance value for deep habitats and water column
