Department:
Transport
Province of KwaZulu-Natal

REHABILITATION OF P50-1 DETAILED DESIGN REPORT From km 18+000 to km 26+000

DETAILED DESIGN REPORT

Report No: T01.PZB.000519

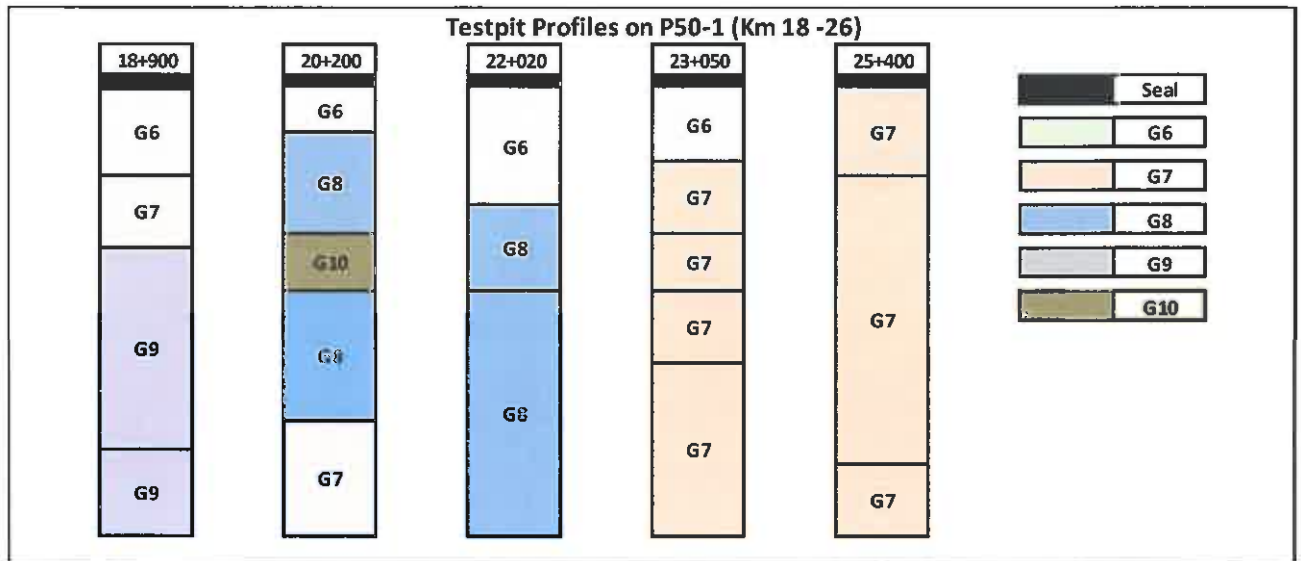
Test Pit No 1 at km 18+900 (LHS)

The existing surfacing consists of various seals. The surface is brittle, cracked and aggregate appeared to be polished. The pavement structure is in a severe condition with base failures and potholes extensive throughout the section.

- The underlying base layer consists of slightly moist weathered Sandstone gravel of **G6** material quality. Testing with phenolphthalein and hydrochloric acid indicates that carbonation is still taking place. The phenolphthalein turned pink when sprayed onto the material, indicates previous stabilisation and the hydrochloric acid fizzed. The Plasticity Index (PI) and Liquid Limit (LL) were recorded as non-plastic, with a medium dense consistency. This is poor for the base material and it is possibly the result of deterioration of the material.

- The subbase material consists of slightly moist fine Sand and highly weathered Sandstone gravel. The subbase material can be classified as G7 quality mainly due to CBR values.

- The existing selected layer observed was of a dark orange brown to dark grey weathered Sandstone with consistency of a medium dense and slightly moist. It is classified as G9 material.

- The Insitu material was observed to be medium dense slightly moist dark yellow brown to light grey weathered Sandstone. It is classified as G9 material.

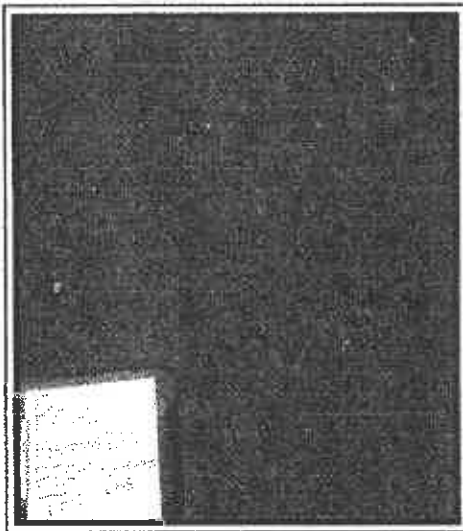
| 1 | |

| Water Table | Soil Legend | Depth (mm) | SOIL DESCRIPTION Moisture, Colour, Consistency, Structure, Soil Type, Origin, General | SAMPLING TYPE AND NUMBER |
|---|---|---|--|---|
| | | 0 | ASPHALT - Semi-gap-graded, double seal, semi-porous, Tacky, bonded, rutting=0 | |

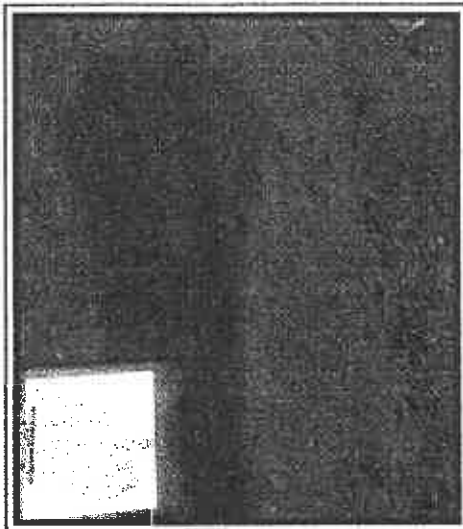
| 2 | |

| Water Table | Soil Legend | Depth (mm) | SOIL DESCRIPTION Moisture, Colour, Consistency, Structure, Soil Type, Origin, General | SAMPLING TYPE AND NUMBER |
|---|---|---|--|---|
| | | 0 | ASPHALT - Crocodile cracking on surface, patching, potholing, Double seal, semi-gaped graded, semi-porous, fresh, bonding, rutting=10mm | |

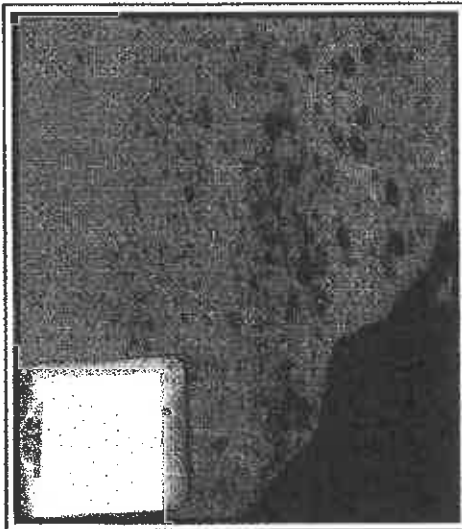
| 3 | |

| Water Table | Soil Legend | Depth (mm) | SOIL DESCRIPTION Moisture, Colour, Consistency, Structure, Soil Type, Origin, General | SAMPLING TYPE AND NUMBER |
|---|---|---|---|---|
| | | 0 | ASPHALT- Crocodile cracking, patches and potholing, double seal, semi-porous, semi-gaped graded, fresh, bonded, rutting=0 | |

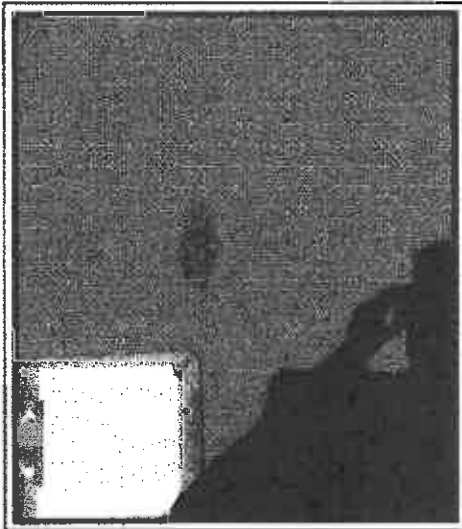
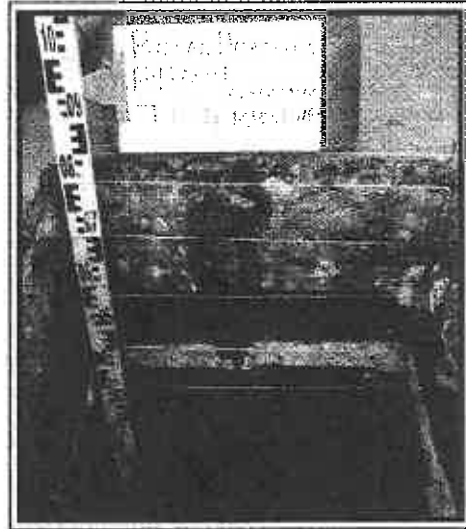
| 4 | |

| Water Table | Soil Legend | Depth (mm) | SOIL DESCRIPTION Moisture, Colour, Consistency, Structure, Soil Type, Origin, General | SAMPLING TYPE AND NUMBER |
|---|---|---|---|---|
| | | 0 | ASPHALT - Cracking on surface, potholing, semi-gaped graded, Semi-porous, fresh, bonded, rutting=0 | |

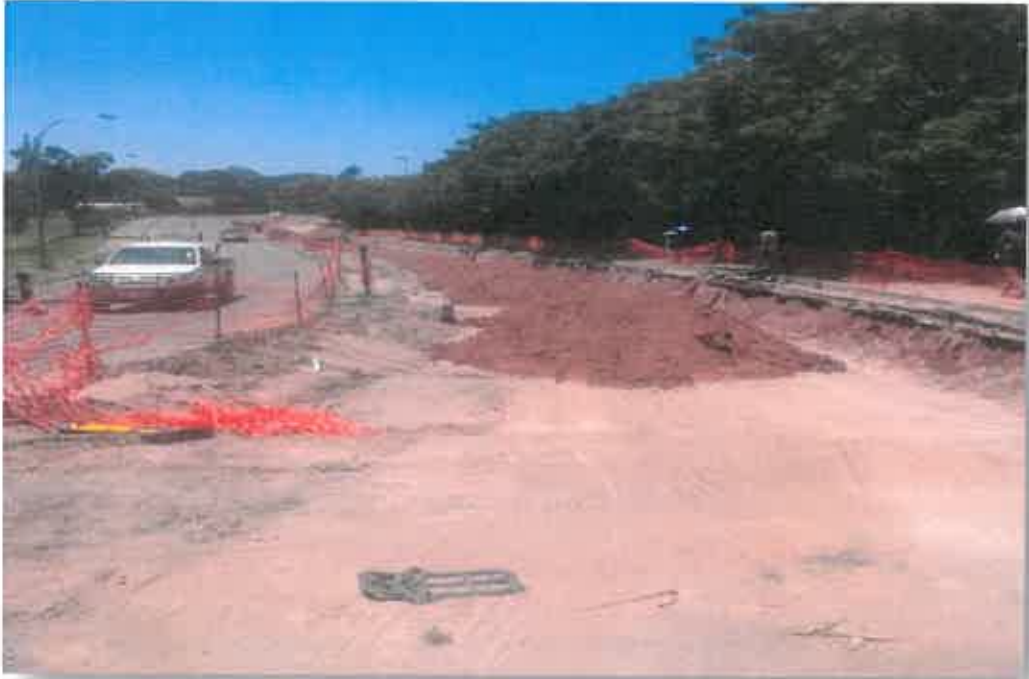
The Rehabilitation of the first 2 Km through Eshowe
