# MBOZA RIVER BRIDGE No.3513 STORM WATER MANAGEMENT pLAN

## Client: Department of Transport KZN

Reference: MD1676 Revision:02

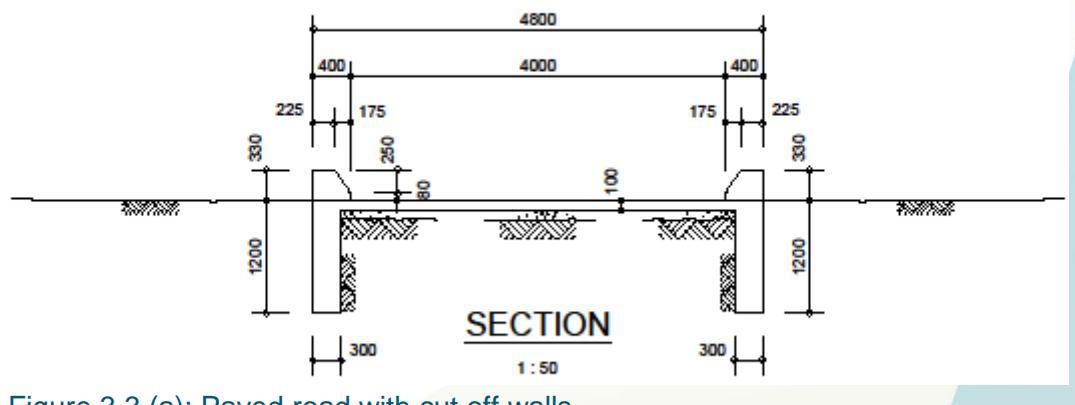
- a) Provision of 50m long ramps on either side protected with gabions founded 500mm into the ground and secured to the fill slopes and reinforced concrete paving (see Annexure B).
- 3.3 Erosion Mitigation Flood Plain Road: Design Measures
- a) The access road in the flood plain will be provided with a concrete paving at natural ground level or up to 300mm above natural ground level and keyed into the ground (see Figure 3.3 (a) below).

Figure 3.3 (a): Paved road with cut off walls

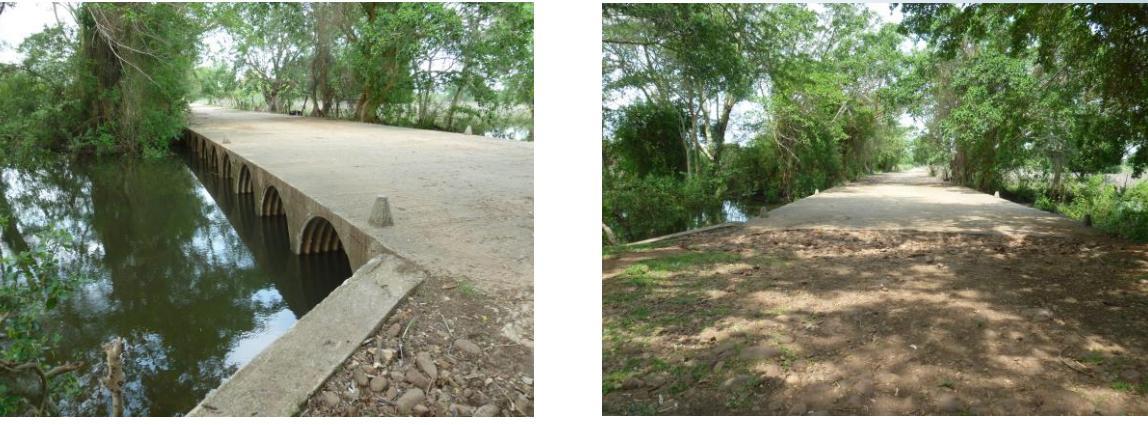
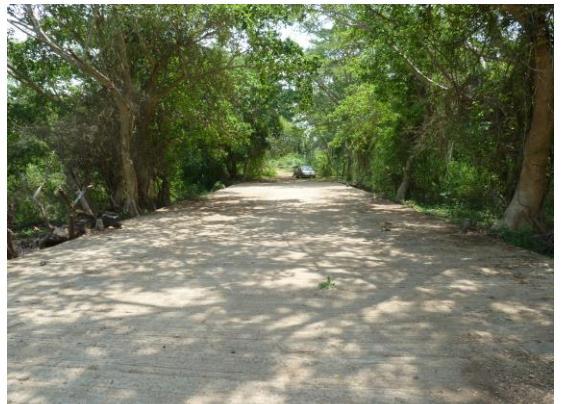
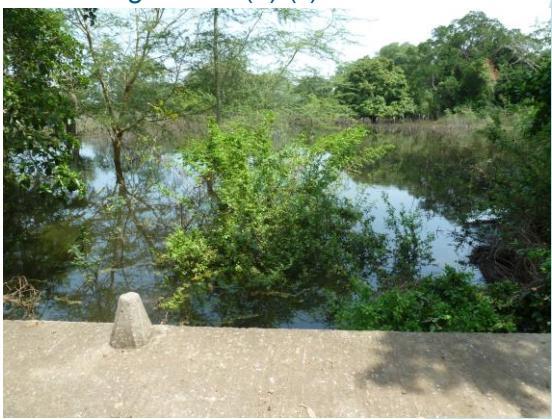
Figure 3.4 (a) (i):ZPC3691

- 3.4 Erosion Mitigation Flood Plain Storm Water Pipes: Design Measures
- a) The deeper areas in the flood plain will be provided with low lying 1800x1800mm culverts to allow water under as well as allow peak floods over without causing erosion and without trapping debris. The large culvert openings are to prevent blockings and to allow ease of maintenance. Smaller culverts would easily block and would not allow a person to fit through during maintenance. See example photos in Figure 3.4 (a) below.

These photos are for culvert number ZPC3691 on D1861 on the Pongola River about 25km downstream of the Mboza site. This solution is working very well and is the planned solution at Mboza. Except the corrugated pipes will be replaced by concrete pipes which are more durable. These photos were taken in 2012.

c) The scenario on D1861 as per example in Figure 3.4 (a) above would keep the status quo as well as providing the locals with a firm access road to the all-weather bridge.

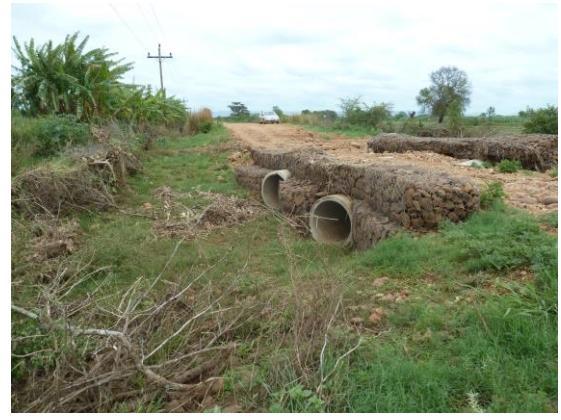
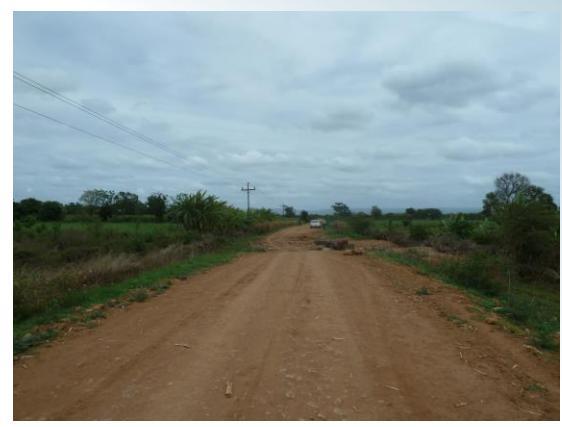
Figure 3.4 (b) (i):STC3780

b) To demonstrate that this solution works we refer to Figure 3.4 (b) below. The photos below are on the Pongola River about 12 km upstream on D2375 culvert number STC3780. Apart from the pipes being too small, the pipes do not have a concrete cover slab and the gabions impede flow instead of allowing flow over the structures. These pipes cause high velocities and erosion and are always damaged. This (Figure 3.4 (b) is an example of what not to do on the Pongola at Mboza. These photos were taken in 2012.
